## Sample Property Snagging Report in Dubai – Professional Inspection PDF

This PDF is issued by Dubai Property Snagging, a professional property inspection company in Dubai, providing snagging reports, pre-handover inspections, and defect reports for villas and apartments across the UAE.

Client  
06/02/2026

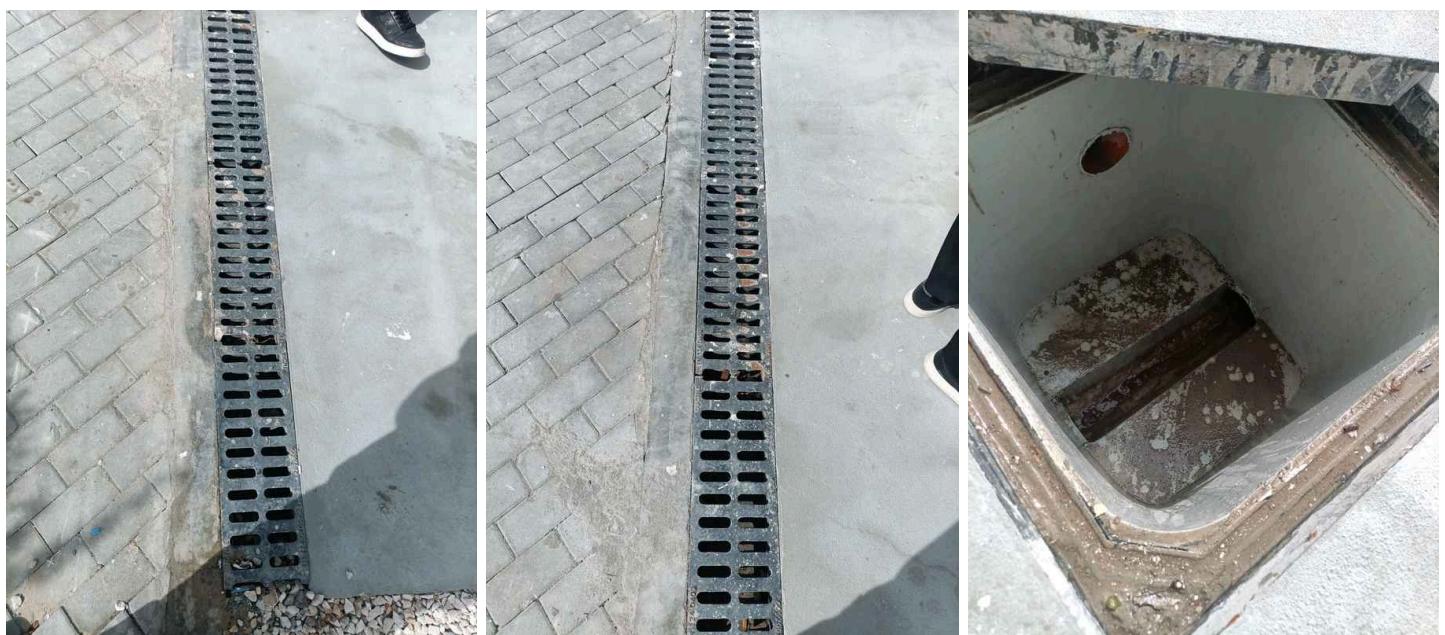
Drainage is clogged and cover sealant is defective; drainage to be cleaned and proper sealant to be applied to ensure leak-free operation and neat finish.

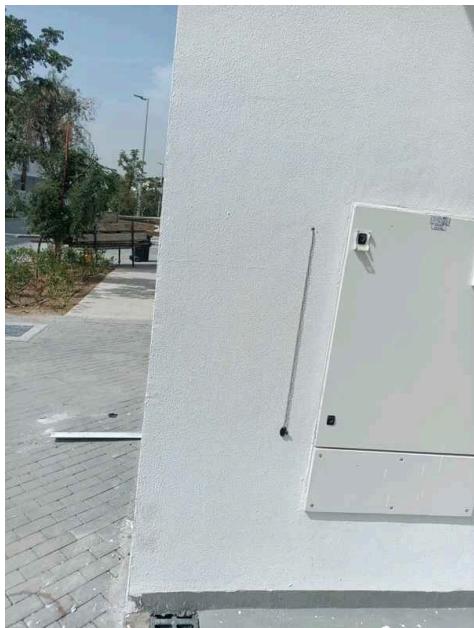
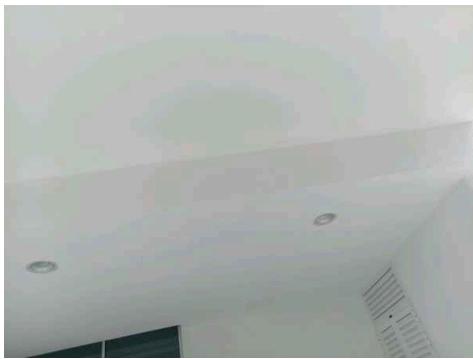
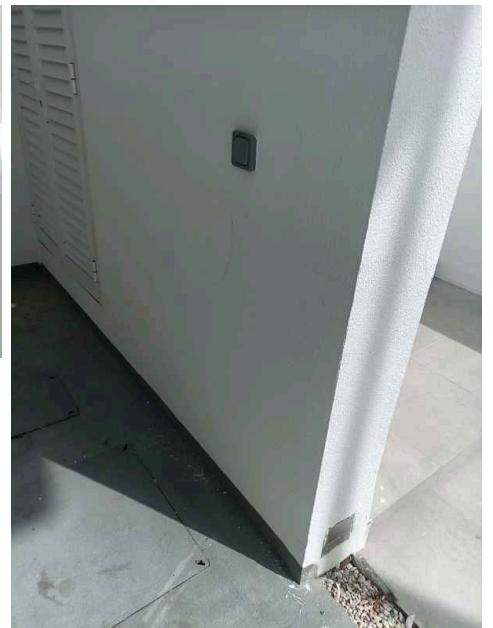
#### 2.1.2 Car porch

### PAINT FINISHING ISSUES

The paint finish was observed to be inconsistent, with visible brush marks, patchy areas, and uneven coverage in multiple locations. These defects affect the overall aesthetic quality and may indicate inadequate surface preparation or poor application. Repainting with proper surface treatment is recommended to achieve a uniform and durable finish.

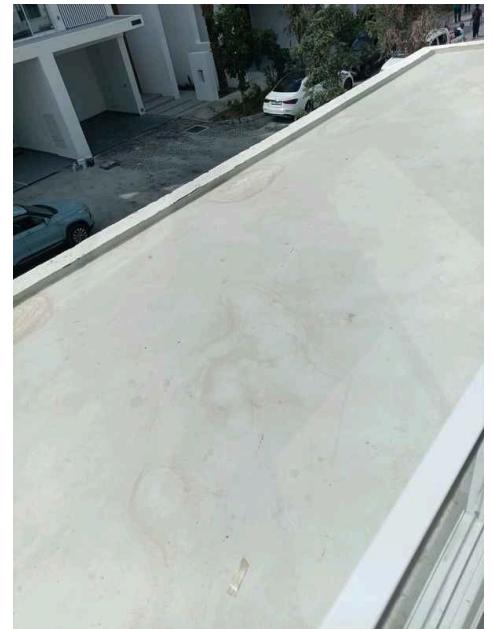
#### 2.1.3 Car porch

Repair Needed

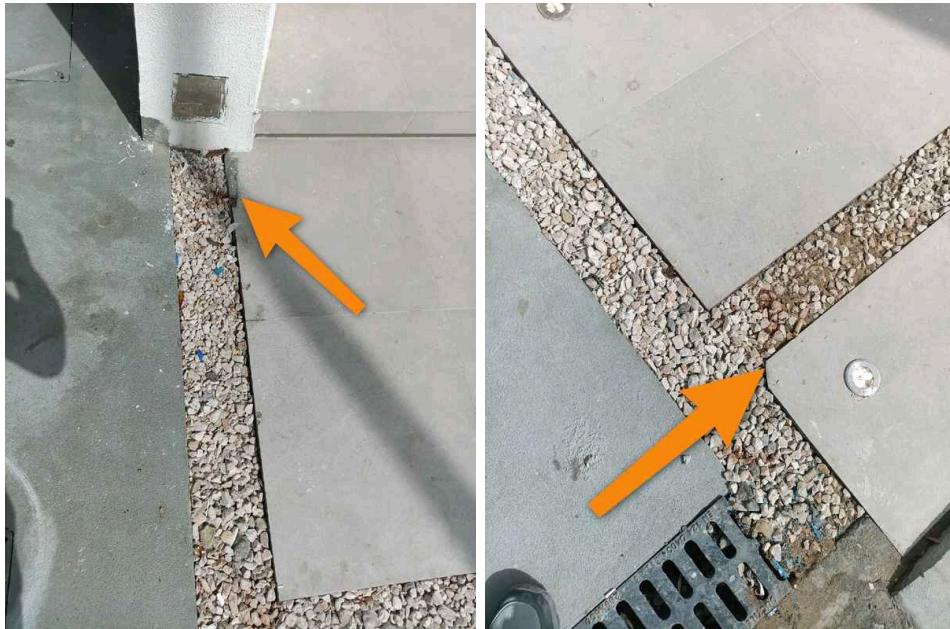
#### 2.1.4 Car porch

### TILES CRACK

Immediate Action Needed

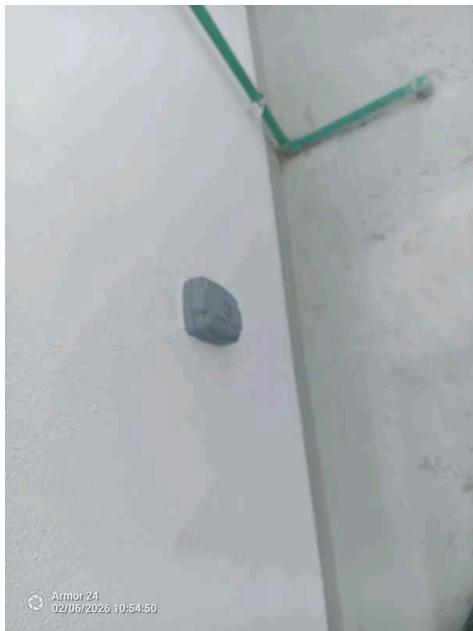
## 2.3.1 Lighting Fixtures, Switches &amp; Receptacles

**COVER PLATES DAMAGED**

Repair Needed

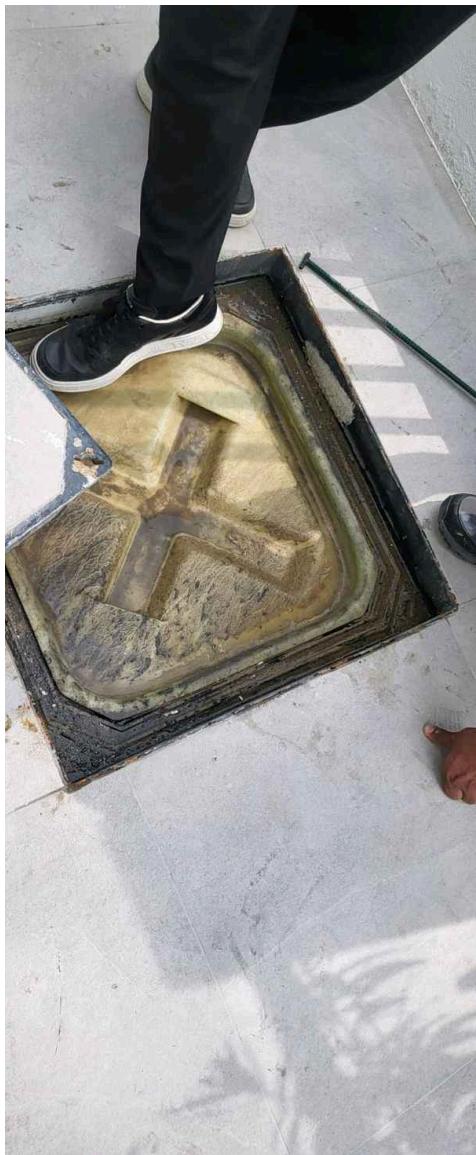
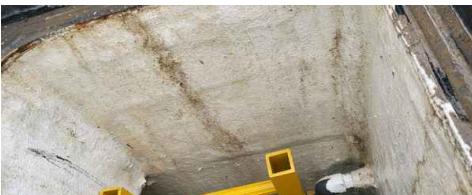
2.4.1 Pump Room

### **WATER TANK COVER SEALING ISSUE**

Repair Needed

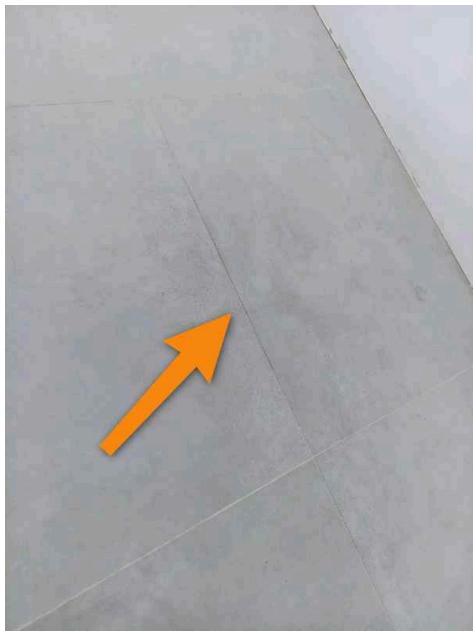
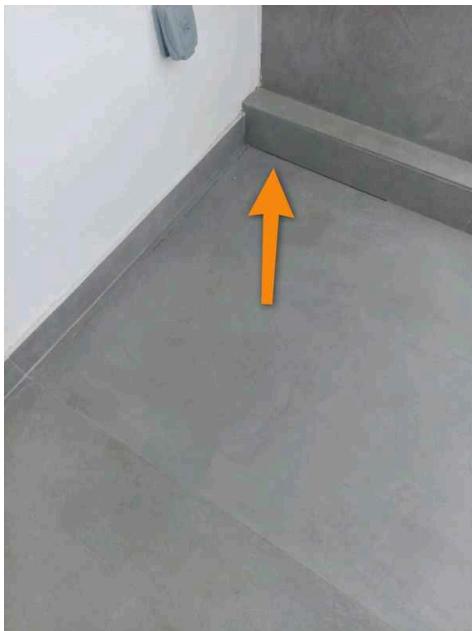
#### 2.6.1 Patio

#### **TILE GROUTING AND FINISHING ISSUE**

Repair Needed

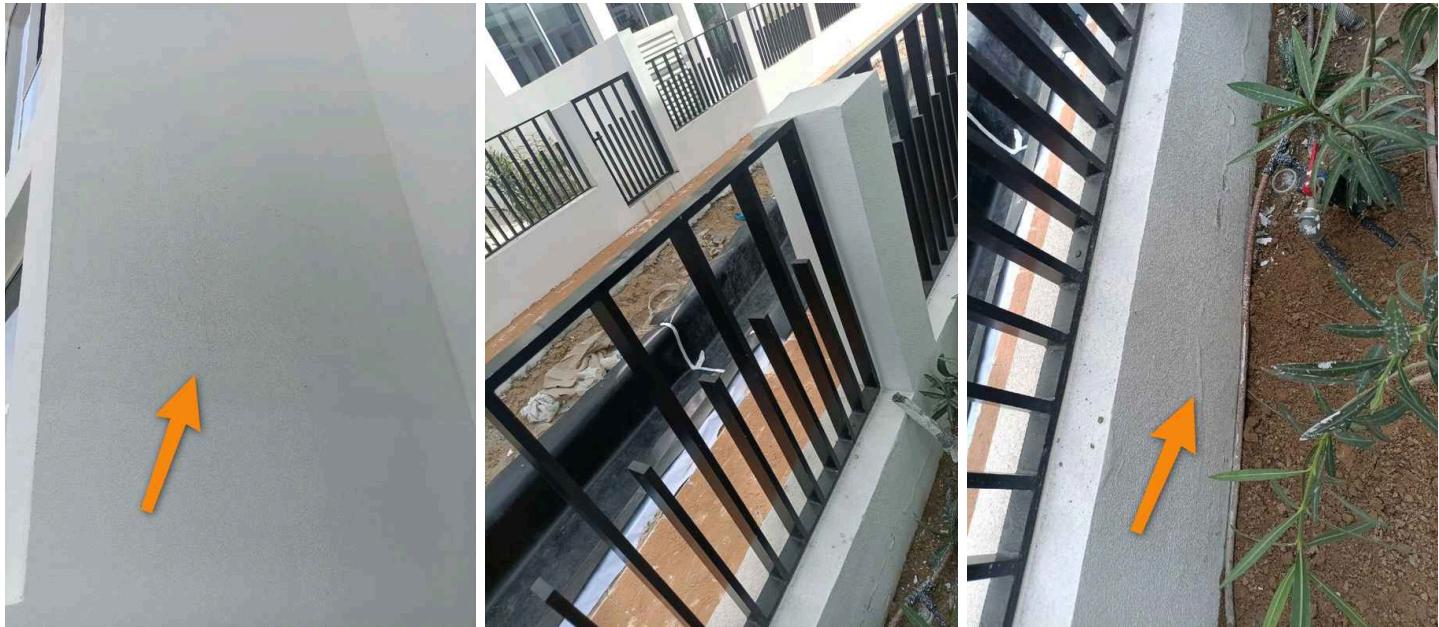
The fence shows signs of paint patches, Cracks, and Seepage, compromising stability and security. Visible rust, paint deterioration, or wood decay reduces aesthetic appeal and lifespan. Repairs or replacement with proper sealing and alignment are recommended.

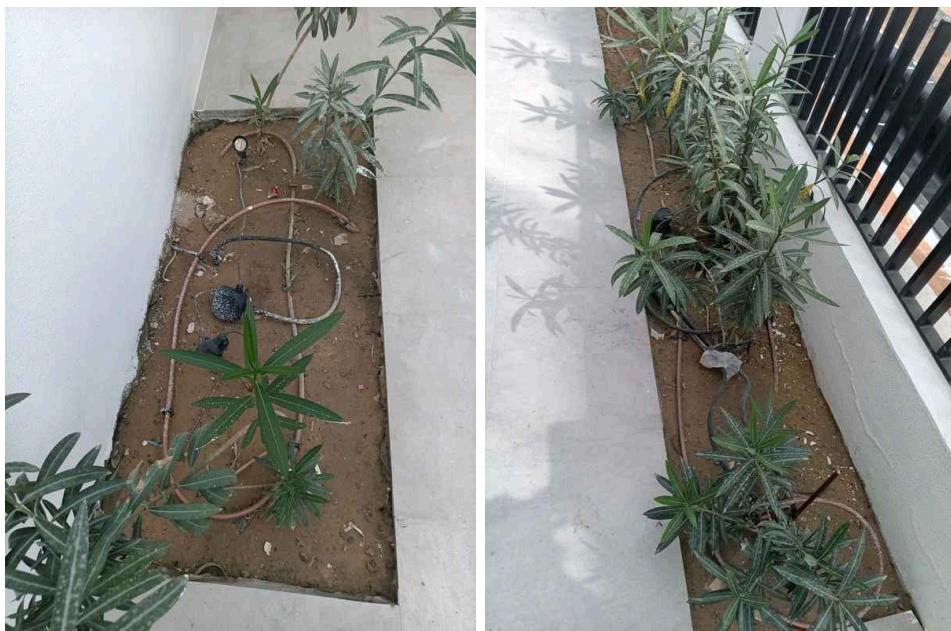
### 2.7.3 Backyard **IRRIGATION PROBLEM**

The irrigation system has inconsistent water flow and coverage, leading to dry patches and overwatered areas. Leaks, clogged nozzles, or faulty timers are contributing to inefficient water distribution. System inspection and calibration are needed to restore optimal performance.

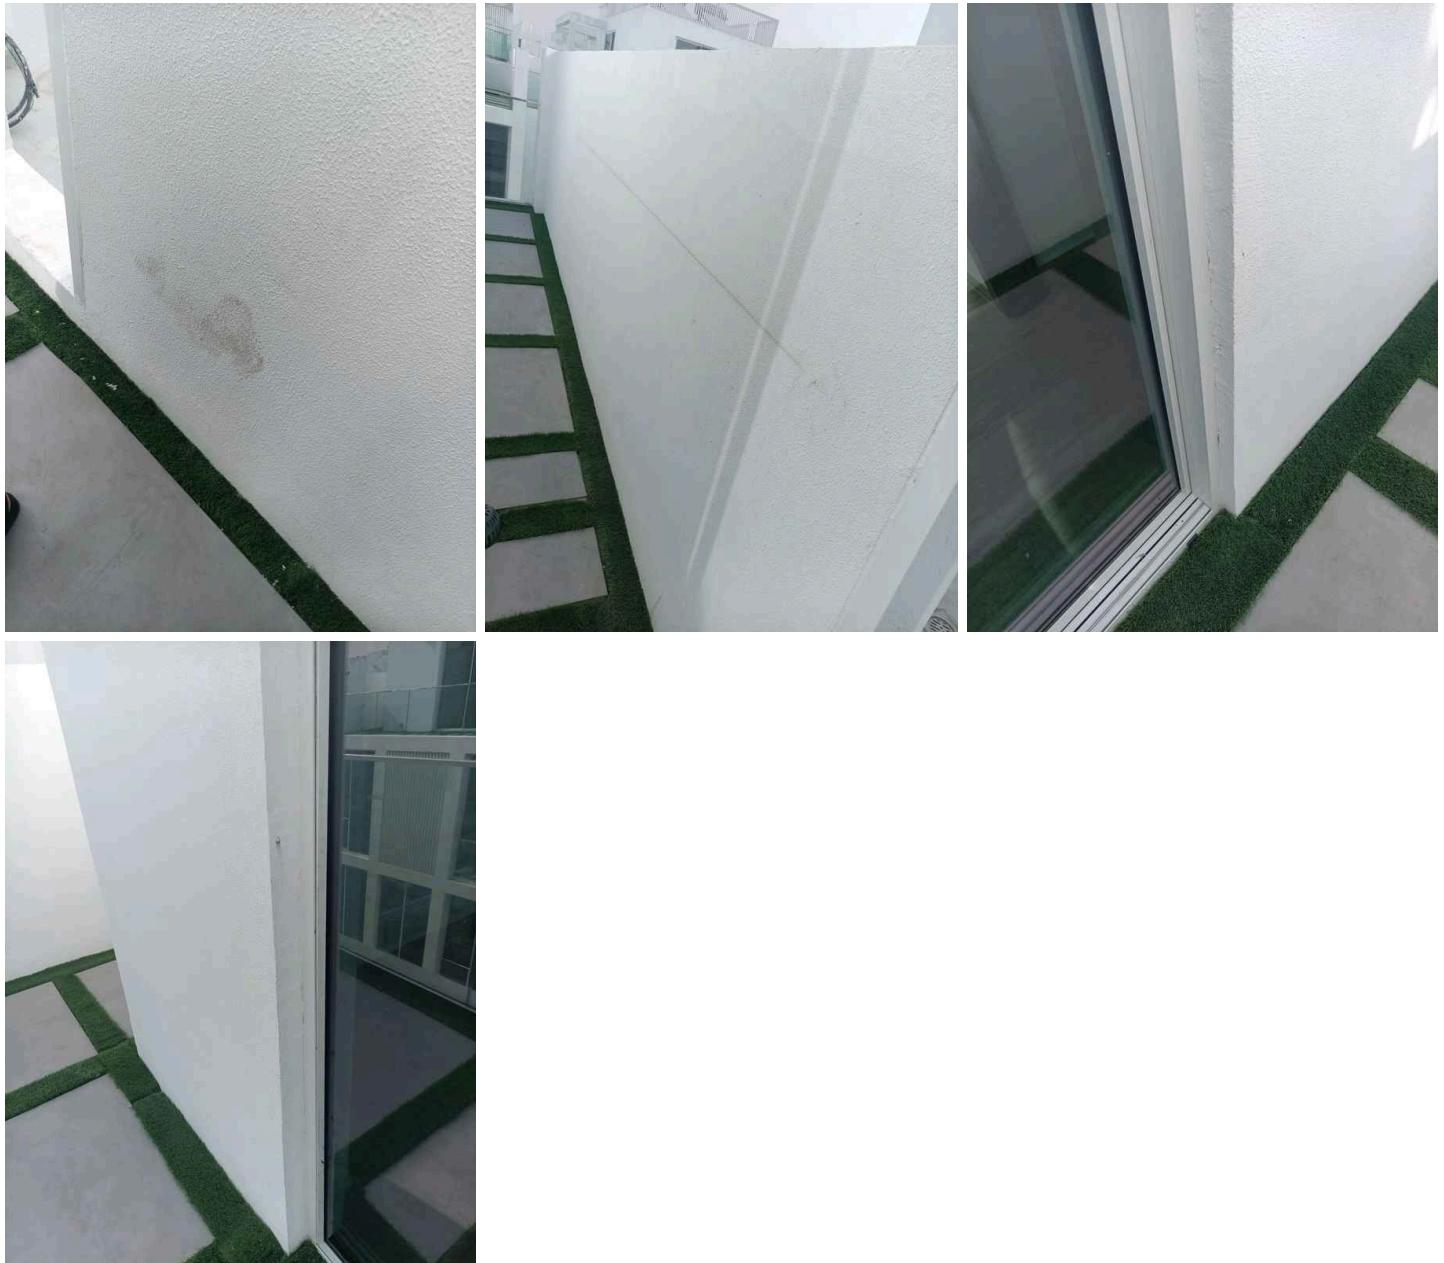
### 2.8.1 Backyard 3rd floor **BOUNDARY FINISHING ISSUE**

The fence shows signs of paint patches, Cracks, and inadequate anchoring, compromising stability and security. Visible rust, paint deterioration, or wood decay reduces aesthetic appeal and lifespan. Repairs or replacement with proper sealing and alignment are recommended.

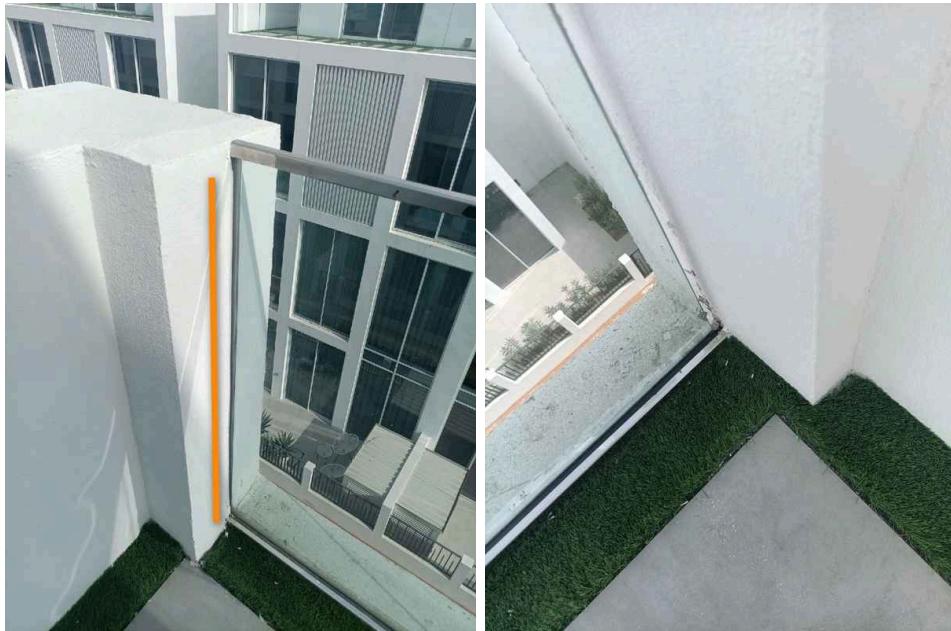
## 2.7.1 Backyard

**TILE FINISHING ISSUES**

Immediate Action Needed

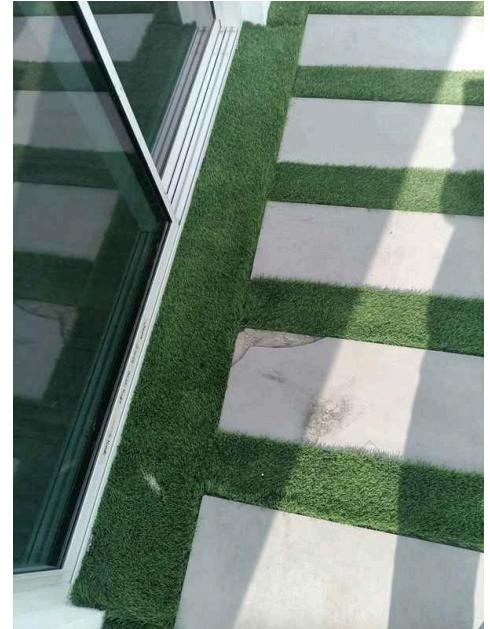
## 2.8.3 Backyard 3rd floor

**TILES CRACK**

Immediate Action Needed

Cracks are visible on the backyard tiles, which may affect appearance and safety. Repair or replacement of the damaged tiles is required to restore a smooth and durable surface.

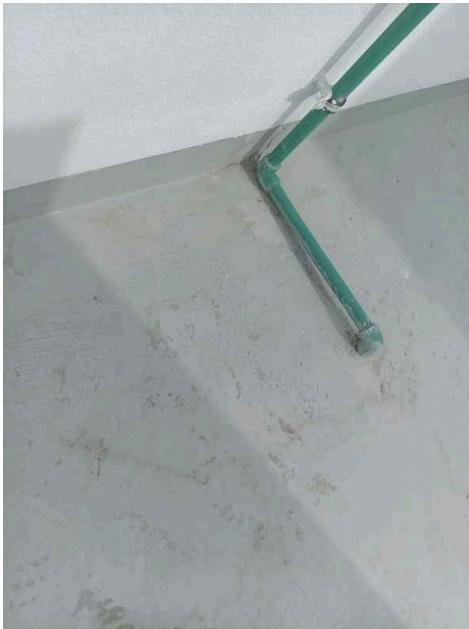
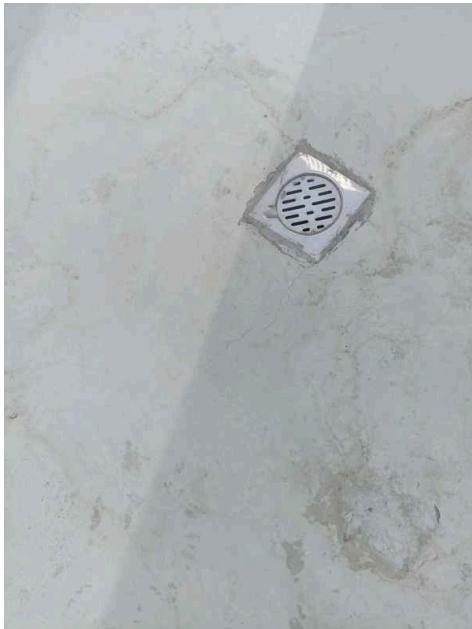
## 2.9.1 Rooftop

**WATERPROOFING ISSUE**

Repair Needed

The rooftop shows signs of failed or deteriorated waterproofing, leading to seepage and water stains. Cracks, poor membrane adhesion, and inadequate slope are contributing factors. Immediate repair and reapplication of the waterproofing system are necessary to prevent structural damage.

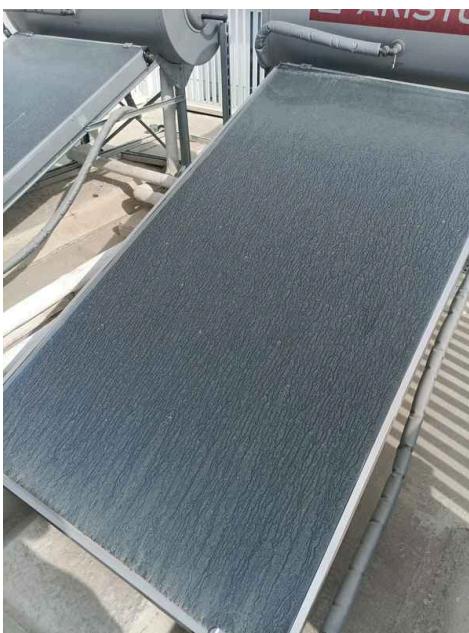
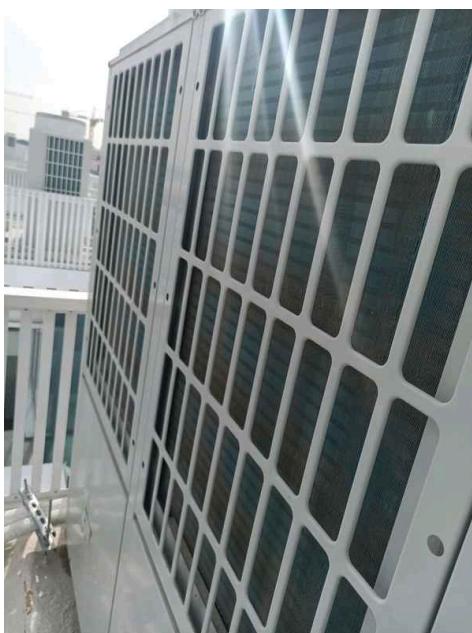
## 2.9.2 Rooftop

**SOLAR PANEL AND AC OUTDOOR SERVICE REQUIRED**

The AC outdoor unit shows signs of dust accumulation, reduced cooling efficiency, and possible vibration or noise. Regular servicing is required to clean the condenser coil, check gas pressure, and ensure optimal performance. Timely maintenance will extend unit life and improve energy efficiency.

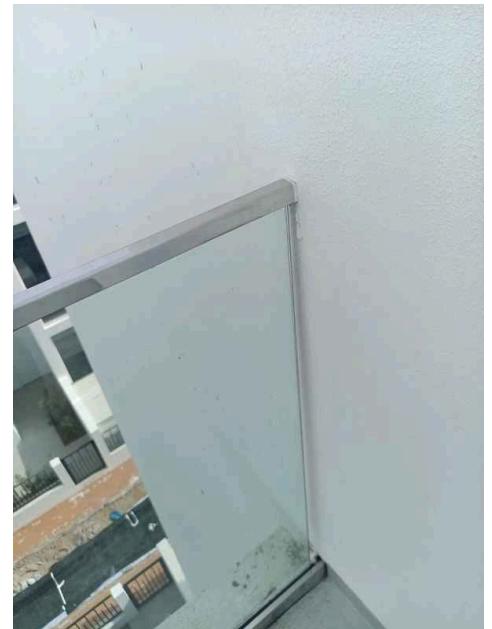
## 2.9.4 Rooftop

**STABILITY ISSUE**

Immediate Action Needed

Railing is unstable and lacks proper rigidity; fixings to be secured and stability to be ensured in accordance with safety standards.

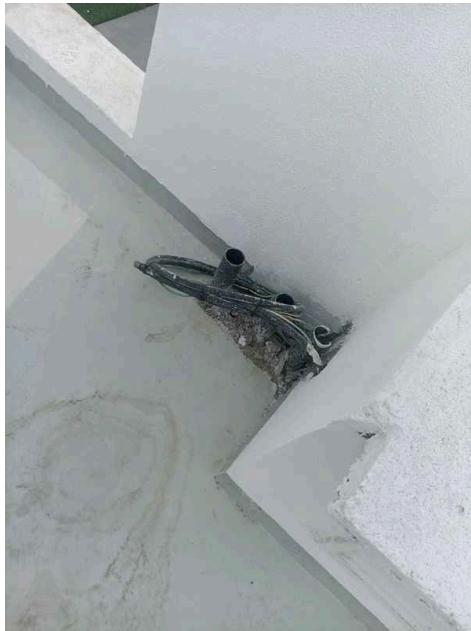
## 2.9.5 Rooftop

**PENDING WORK ELECTRICAL**

Immediate Action Needed

Electrical works are incomplete and must be completed, secured, and tested in accordance with approved drawings and applicable safety standards.

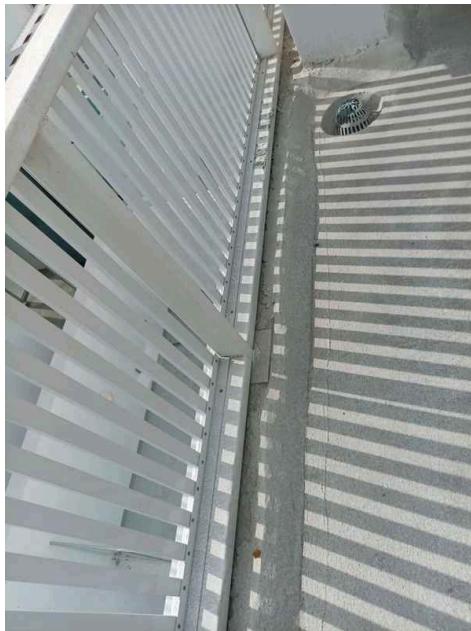
2.9.6 Rooftop

**RAILING BASE LEVELING ISSUE**

Repair Needed

Railing base is not properly leveled; base alignment to be corrected and securely fixed to ensure stability and proper installation

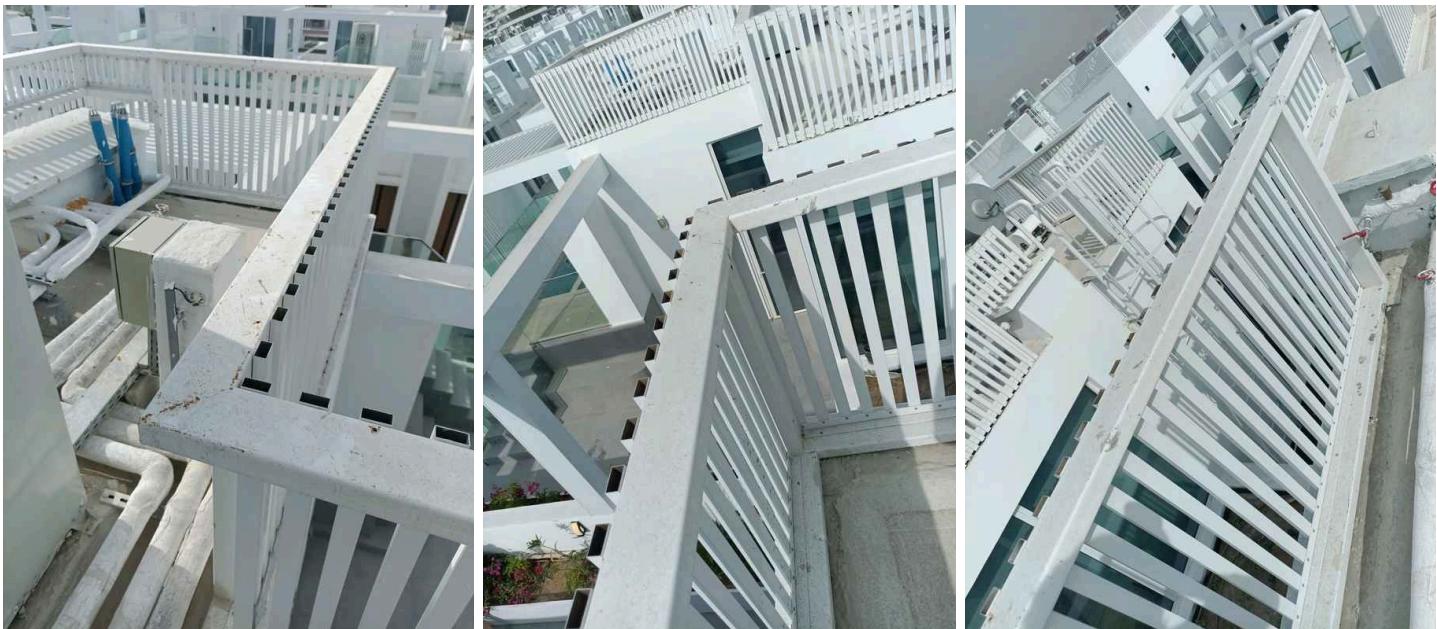
Corrosion observed on the railing; rust to be treated and railing to be repaired or refinished with suitable anti-corrosion protection.

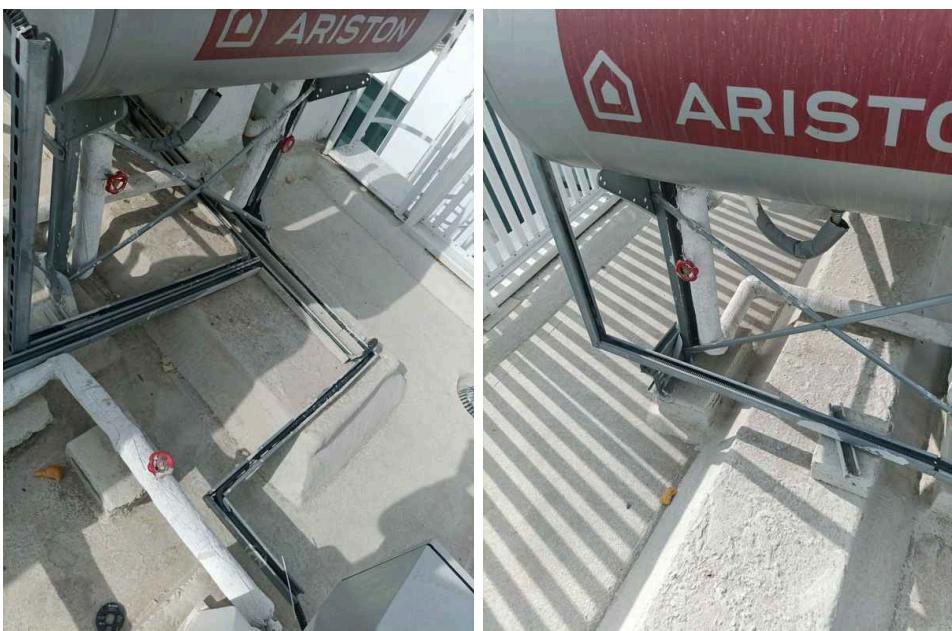
## 2.9.8 Rooftop

Cable tray is exposed without cover; suitable cover to be provided and securely installed to protect cables and ensure compliance with safety standards.

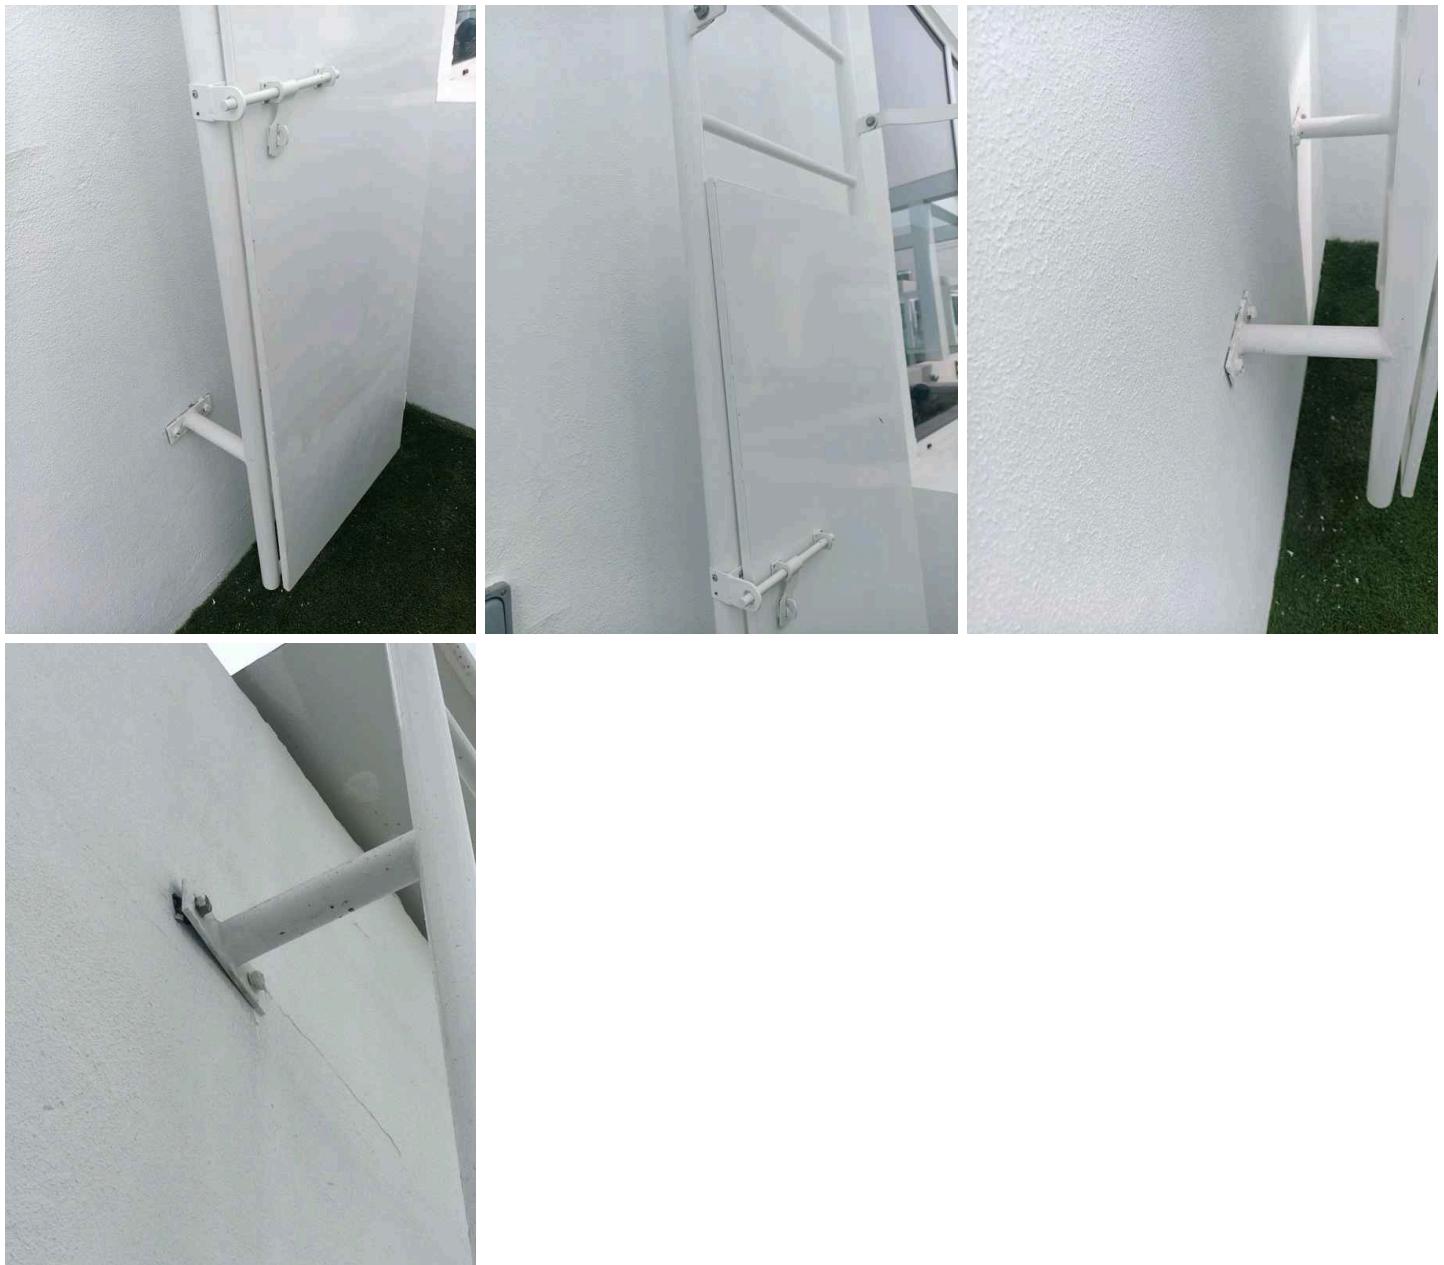
## 2.9.9 Rooftop

Defects observed in stair fittings and finishing; alignment, fixings, and surface finishes to be corrected to achieve safe and acceptable workmanship

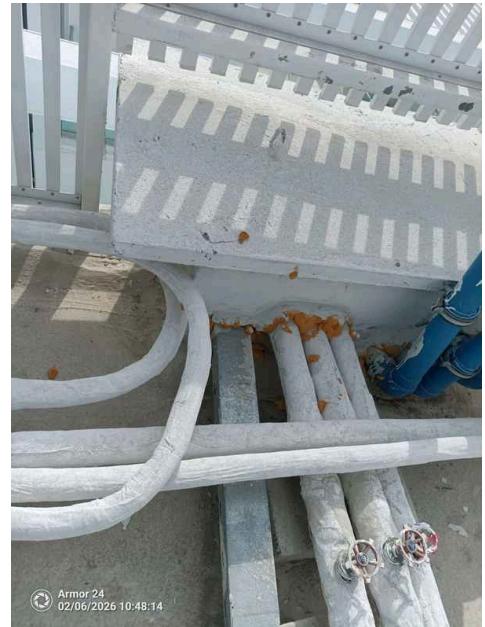
#### 2.9.11 Rooftop **NEED FOAM FINISHING**

Repair Needed

Foam application is incomplete or uneven; proper trimming and finishing to be carried out to achieve a neat and sealed finish.

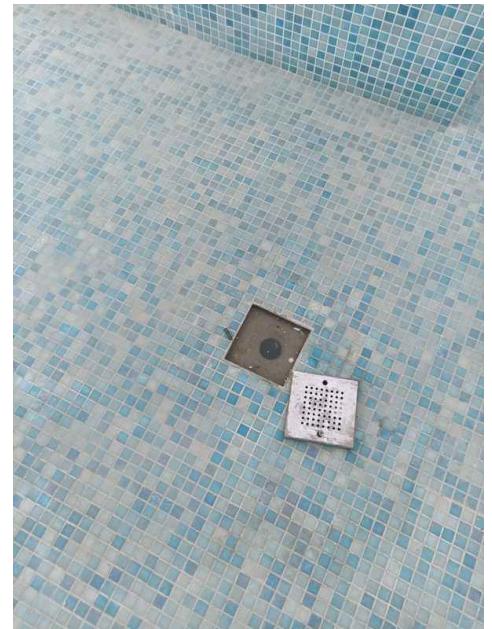
## 2.12.3 Swimming pool area

**DRAINAGE CLOGGING**

Swimming pool drainage is clogged, restricting proper water flow; drainage to be cleaned and tested to ensure free and effective discharge.

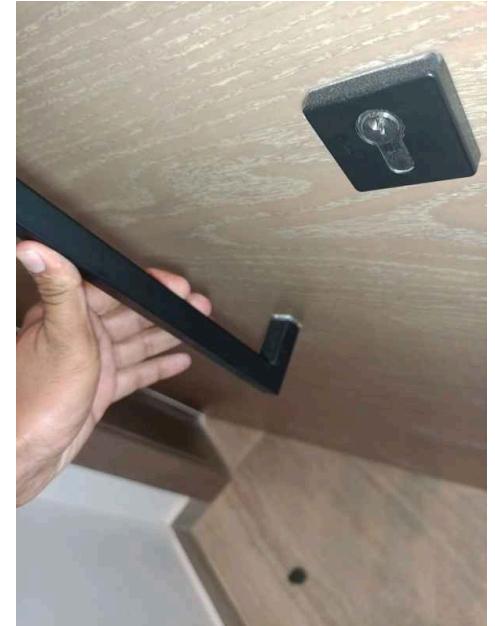
## 3.1.2 Door

**HANDLE LOOSE ISSUE**

Immediate Action Needed

The door lock handle is loose and wobbly, affecting secure locking and smooth operation. It requires tightening or proper fixing to ensure functionality and safety.

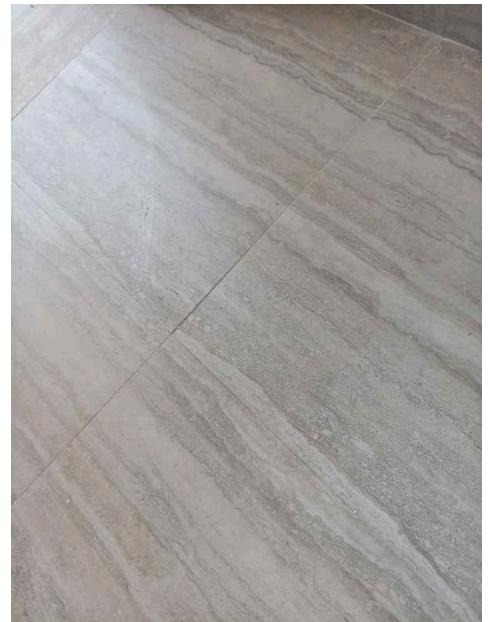
#### 4.5.1 Floor

#### **UNEVEN TILE LEVEL ISSUE**

Floor tiles are not uniformly leveled, resulting in height variations that create tripping hazards and a poor visual finish. This is often due to improper installation and subfloor irregularities. Reinstallation or leveling correction is needed for a smooth and safe surface.

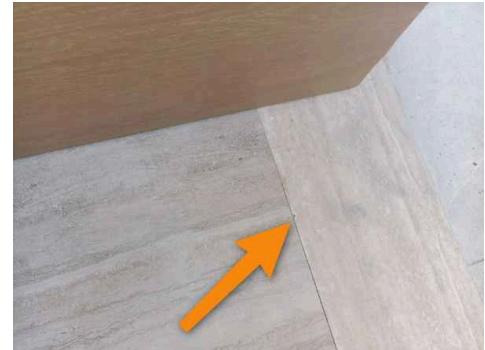
## 4.5.2 Floor

**CHIPPING ISSUE**

Surfaces show signs of chipping and cracking, typically due to impact damage, material weakness, improper installation. These defects compromise both the appearance and structural integrity. Repair or replacement is needed to restore the surface to acceptable standards.

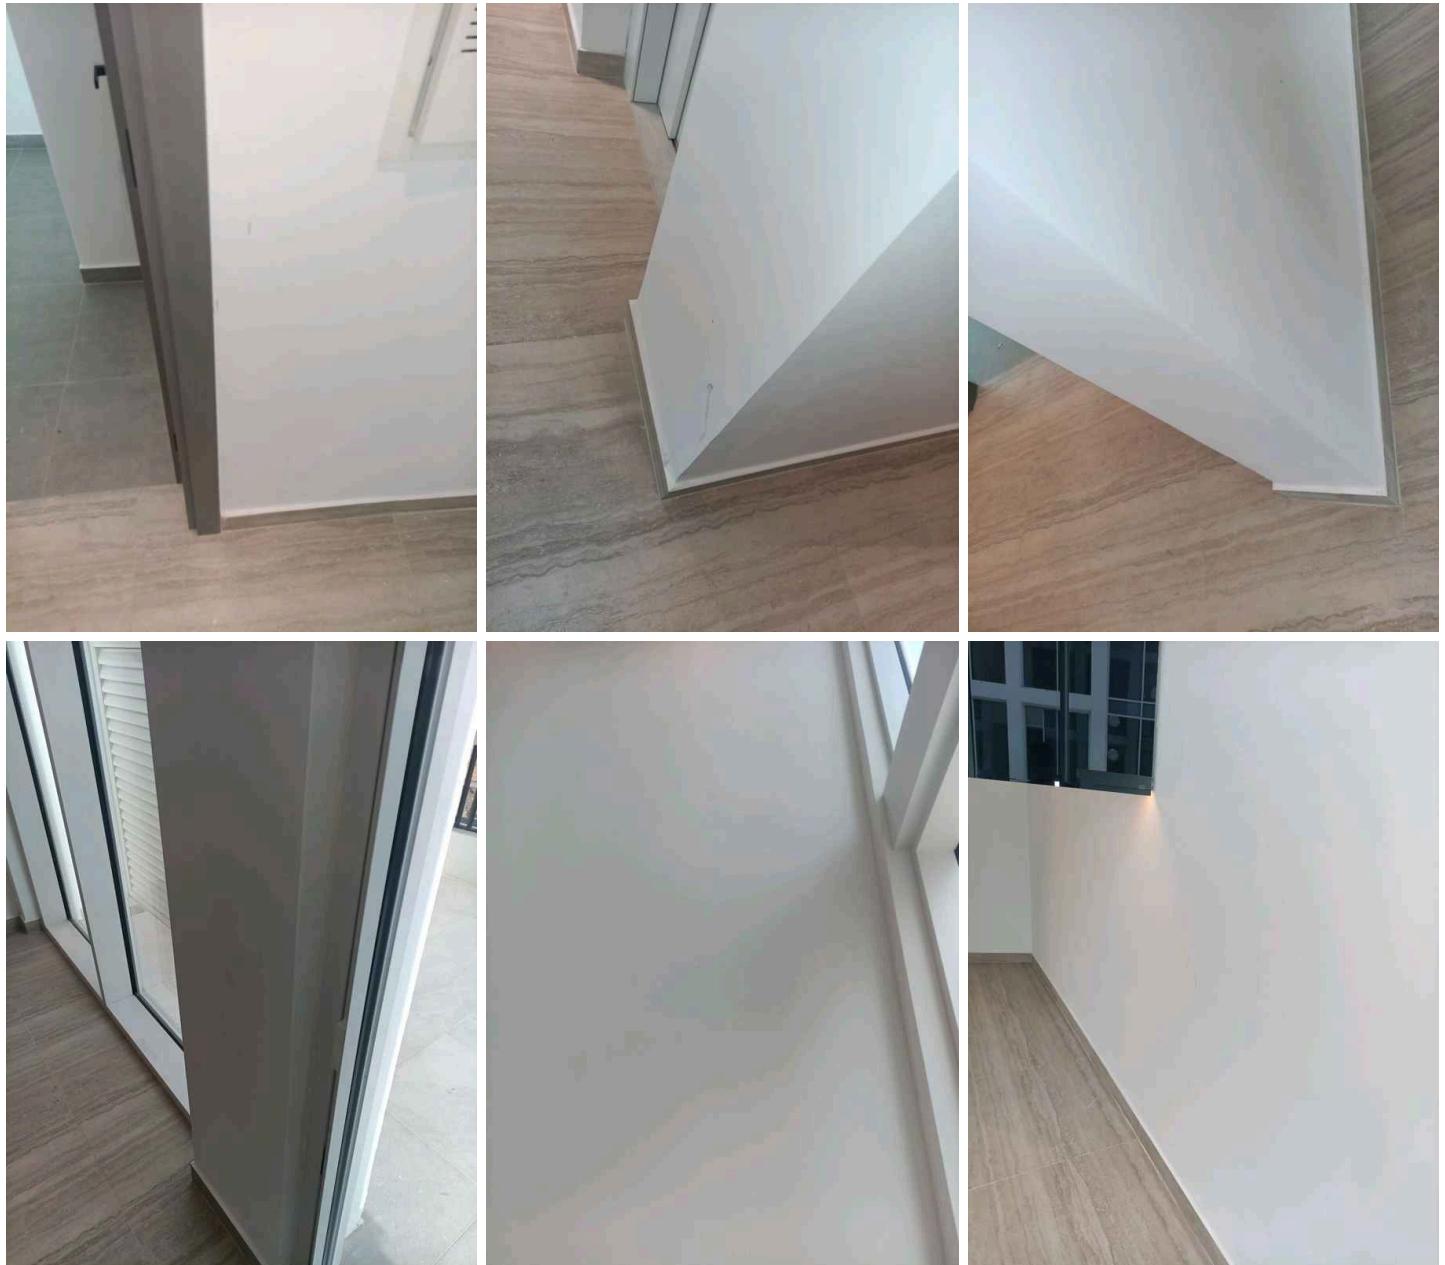
#### 5.4.1 Walls

The wall shows visible touch-up spots and uneven paint application, resulting in an inconsistent and patchy appearance. Edges and blending are poorly executed. Proper surface preparation and repainting are required for a seamless finish.

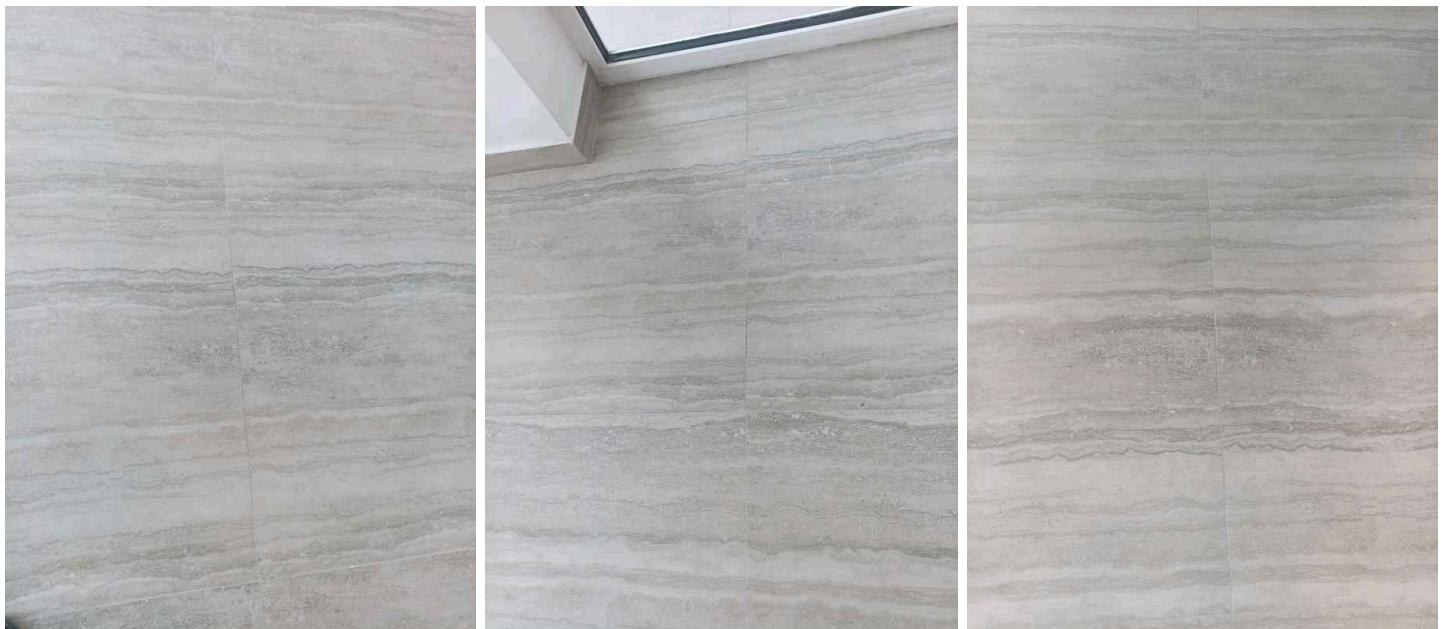
## 5.5.2 Floor

Floor areas have missing and incomplete grout between tiles. Creates gaps that affect appearance and may cause water ingress. Requires proper grouting to finish the surface.

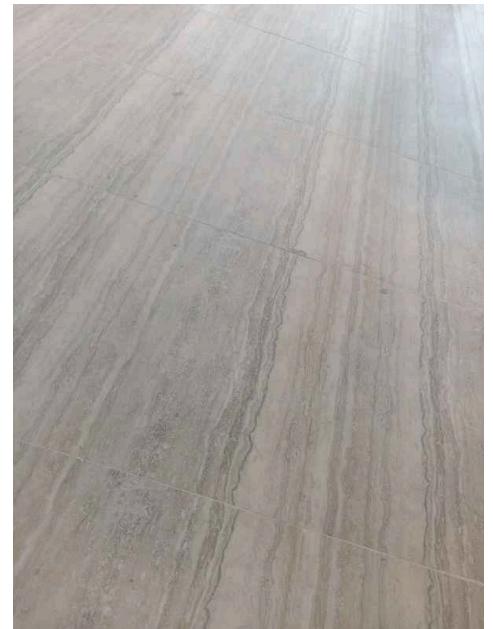
## 5.5.3 Floor

**STAINING ISSUE**

Floor shows visible stains affecting appearance and finish. Caused by spills, construction residue and improper cleaning. Requires proper cleaning or treatment to restore uniform look.

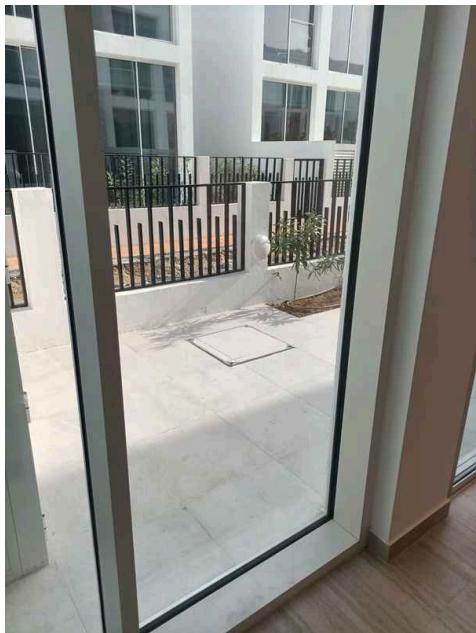
## 5.8.1 Window

**DEEP CLEANING REQUIRED**

Windows have accumulated dirt, dust and construction residue. Affects appearance and clarity. Requires thorough cleaning to restore proper finish.

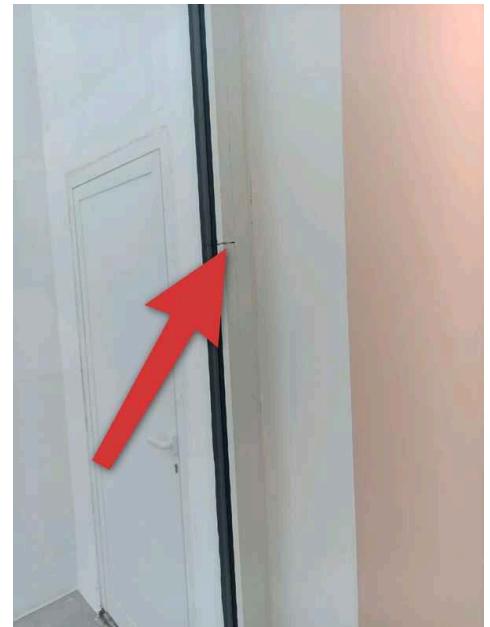
## 5.8.3 Window

**POWDER COATING ISSUES**

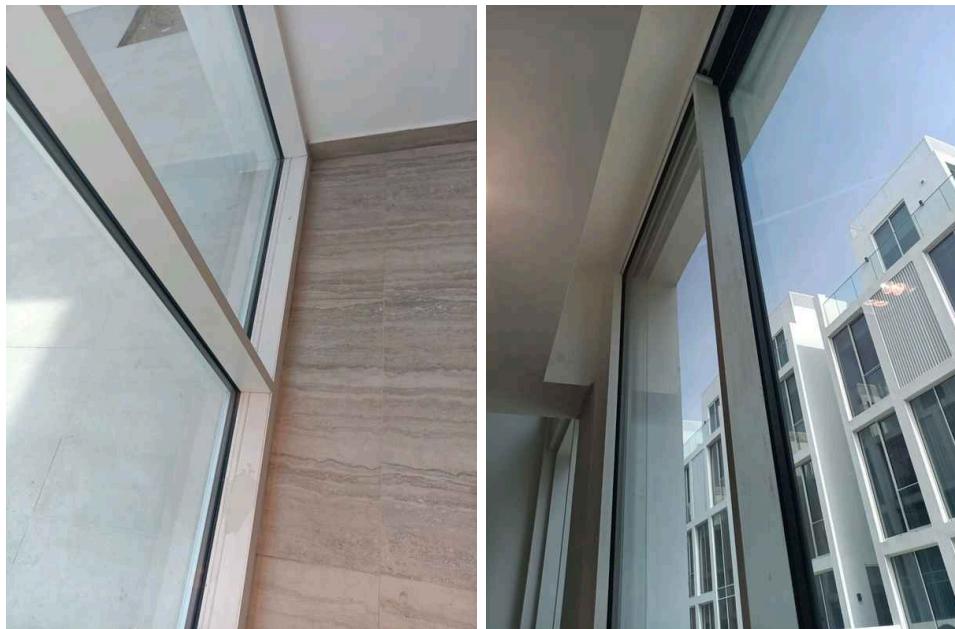
Window powder coating is uneven, chipped and peeling. Affects appearance and surface protection. Requires re-coating and touch-up for proper finish.

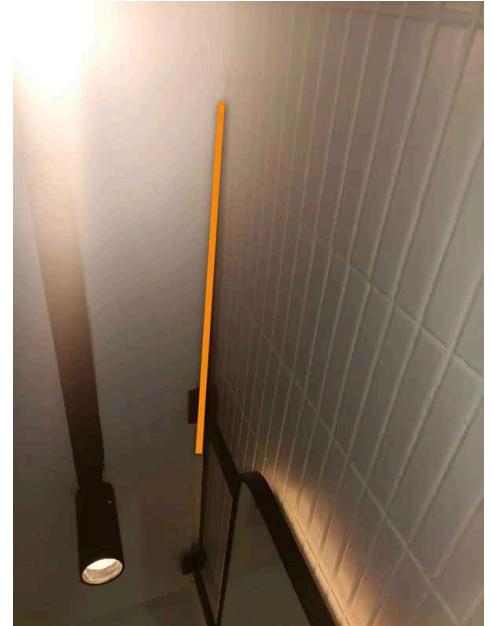
## 6.4.1 Walls

**GROUT MISSING**

wall areas have missing and incomplete grout between tiles. Creates gaps that affect appearance and may cause water ingress. Requires proper grouting to finish the surface.

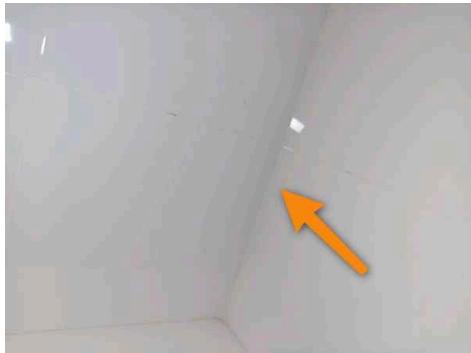
## 6.5.1 Floor

**UNEVEN TILE LEVEL ISSUE**

Floor tiles are not uniformly leveled, resulting in height variations that create tripping hazards and a poor visual finish. This is often due to improper installation and subfloor irregularities. Reinstallation or leveling correction is needed for a smooth and safe surface.

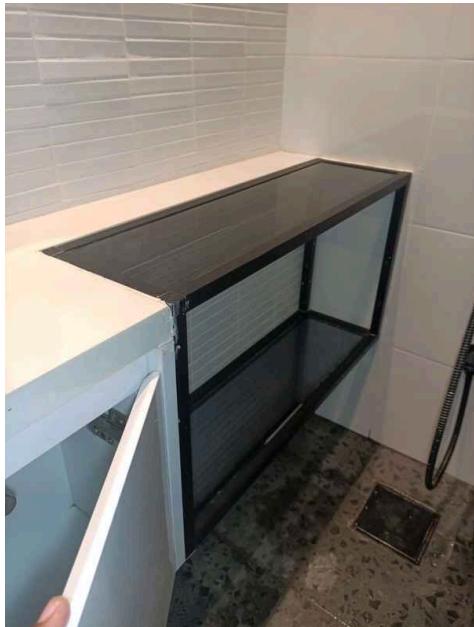
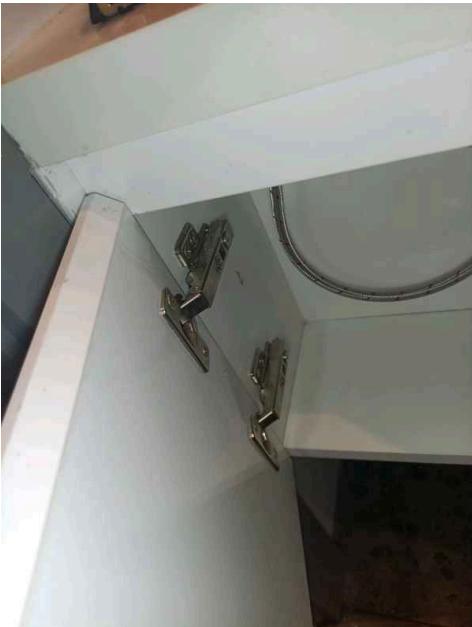
## 6.14.2 Vanity

**SILICONE FILLING REQUIRED**

Silicone sealing at vanity area is missing or incomplete; proper silicone filling to be applied to ensure watertight sealing and neat finish.
