## Sample Property Snagging Report in Dubai – Professional Inspection PDF

This PDF is issued by Dubai Property Snagging, a professional property inspection company in Dubai, providing snagging reports, pre-handover inspections, and defect reports for villas and apartments across the UAE.

Client  
06/02/2026

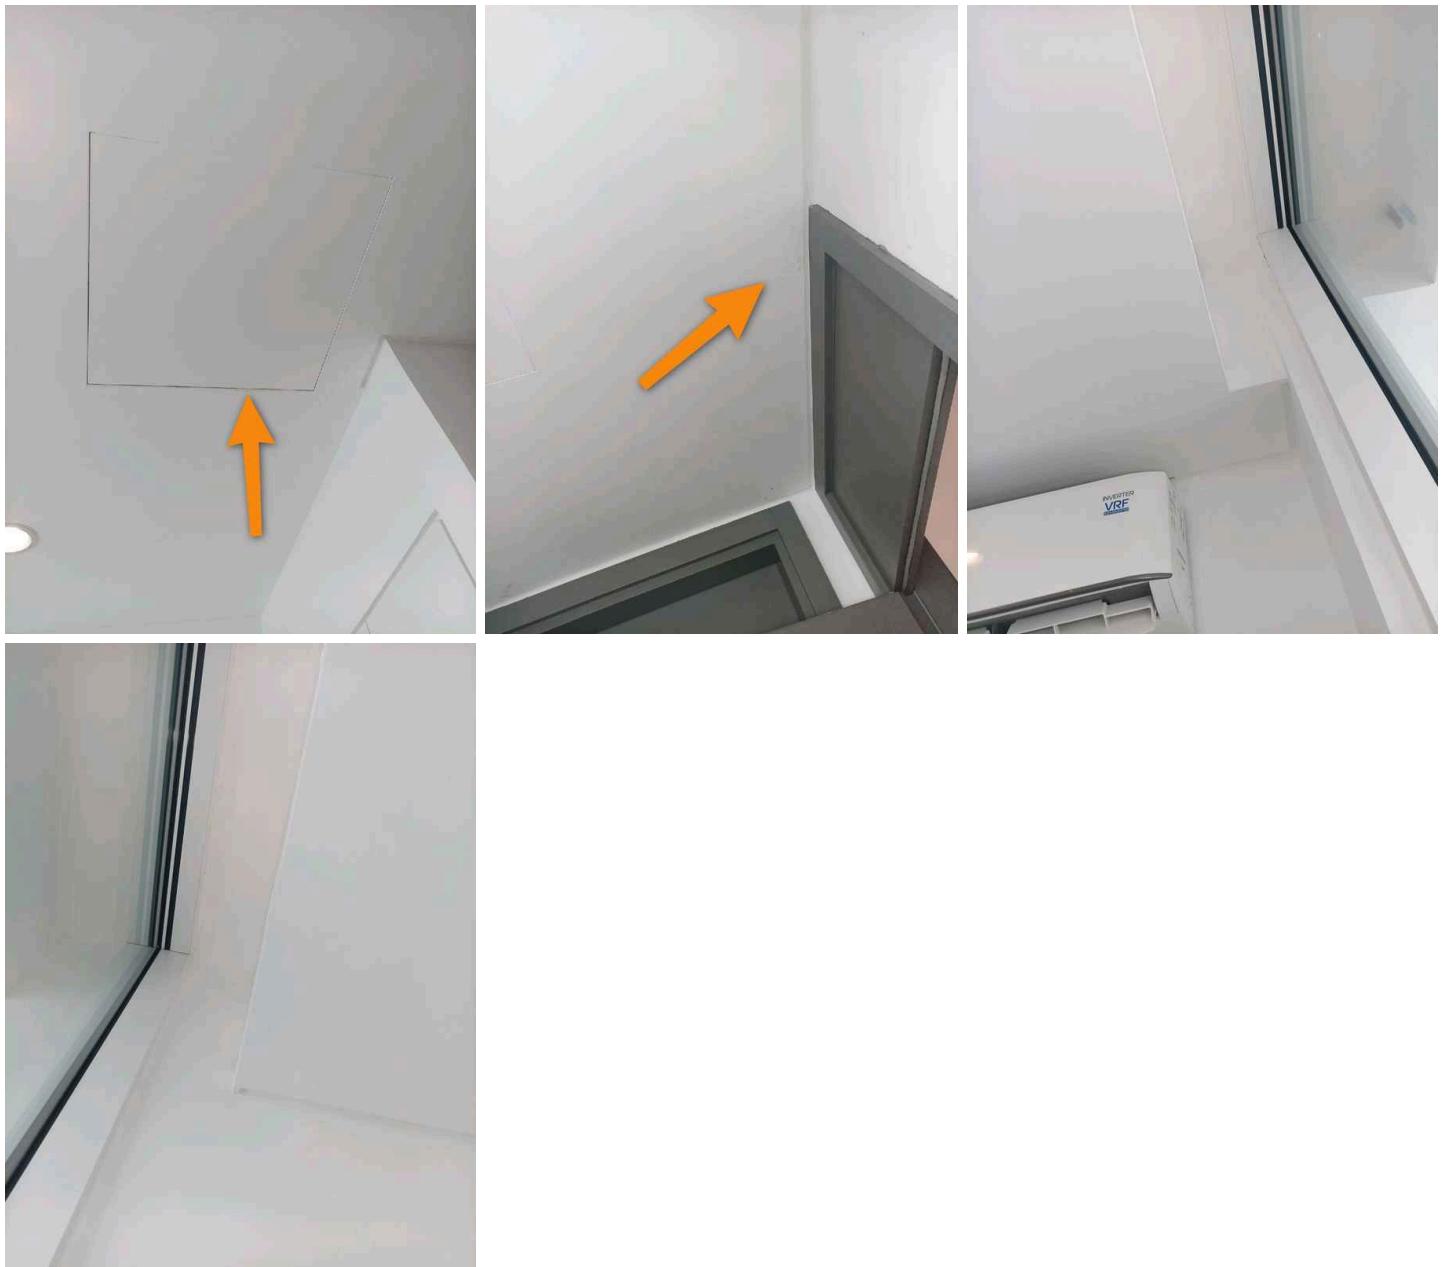
#### 7.4.1 Walls

#### **PAINT TOUCH-UP AND FINISHING ISSUE**

The wall shows visible touch-up spots and uneven paint application, resulting in an inconsistent and patchy appearance. Edges and blending are poorly executed. Proper surface preparation and repainting are required for a seamless finish.

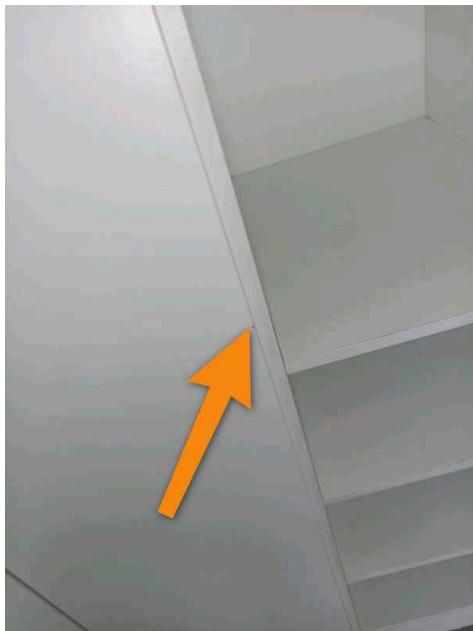
## 7.7.2 Cabinets

**FILLING REQUIRED**

Gaps and finishing defects observed on the cabinet; filling and proper finishing to be carried out to achieve a neat and acceptable appearance.

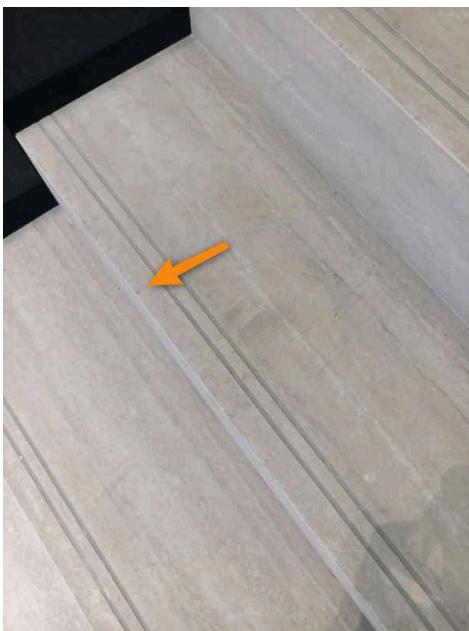
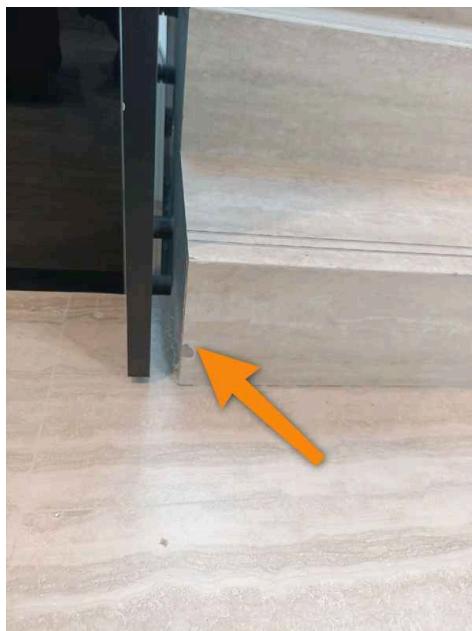
## 9.5.2 Steps

**GROUT MISSING**

Floor areas have missing and incomplete grout between tiles. Creates gaps that affect appearance and may cause water ingress. Requires proper grouting to finish the surface.

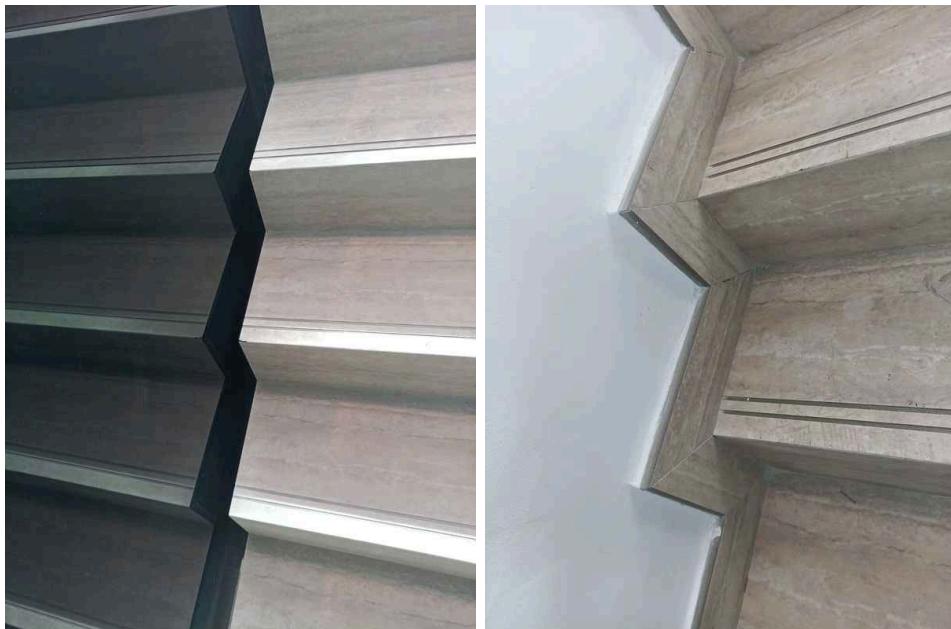
## 9.5.3 Steps

**STAINING ISSUE**

Floor shows visible stains affecting appearance and finish. Caused by spills, construction residue and improper cleaning. Requires proper cleaning or treatment to restore uniform look.

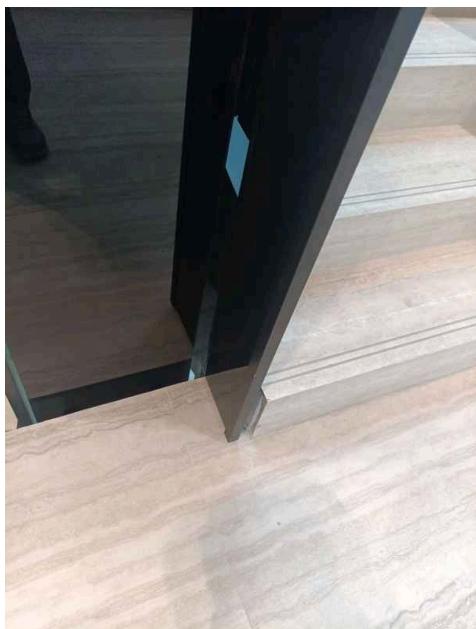
#### 9.7.2 Railing **ALIGNMENT ISSUE**

Railing is misaligned; alignment to be corrected and fixings secured to ensure proper installation and safety.

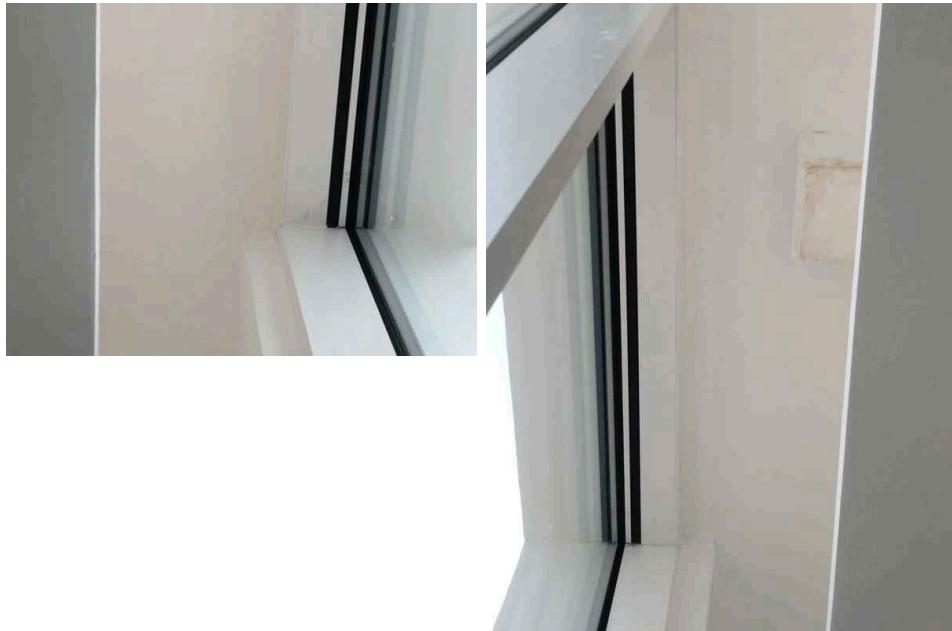
## 10.3.2 Ceiling

Water stains visible on ceiling indicating leakage and moisture ingress. Discoloration affects finish and appearance. Requires rectification to prevent further damage.

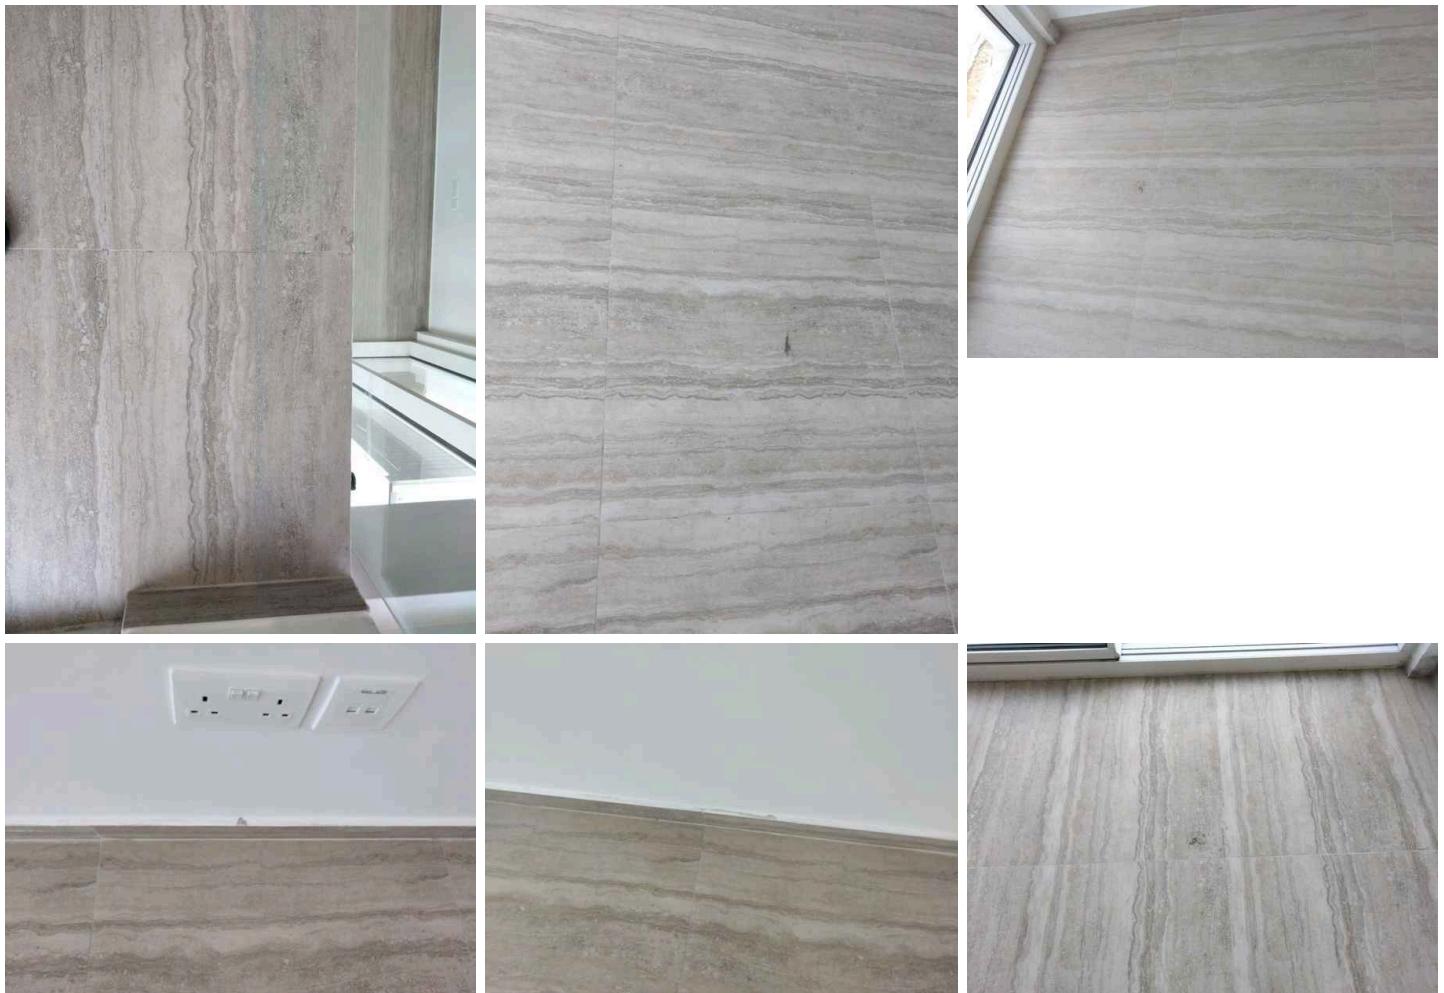
#### 10.5.3 Floor

### SKIRTING GAP ISSUES

Gaps observed between skirting and wall floor due to poor filling. Affects finish and visual appearance. Requires proper fixing and sealing.

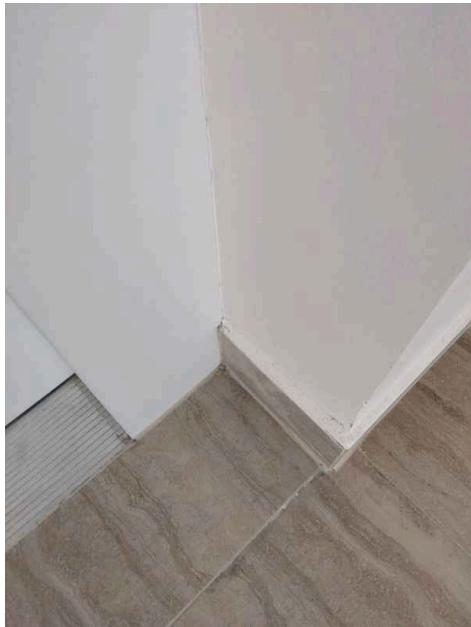
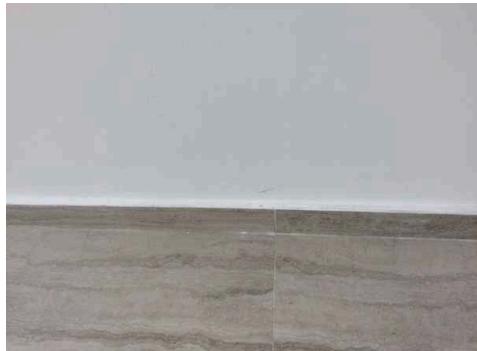
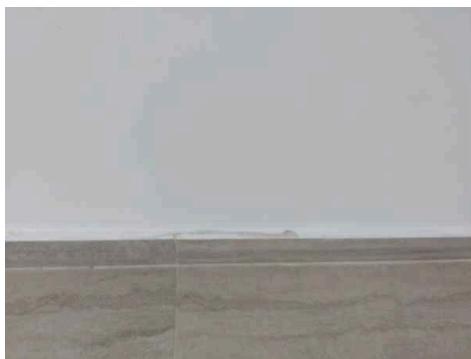
#### 10.5.4 Floor

#### **GROUTING COLOR VARIATION**

Grout color is inconsistent across the floor, affecting uniformity and appearance. Indicates poor workmanship and improper material mixing. Requires cleaning, correction, or re-grouting for a consistent finish.

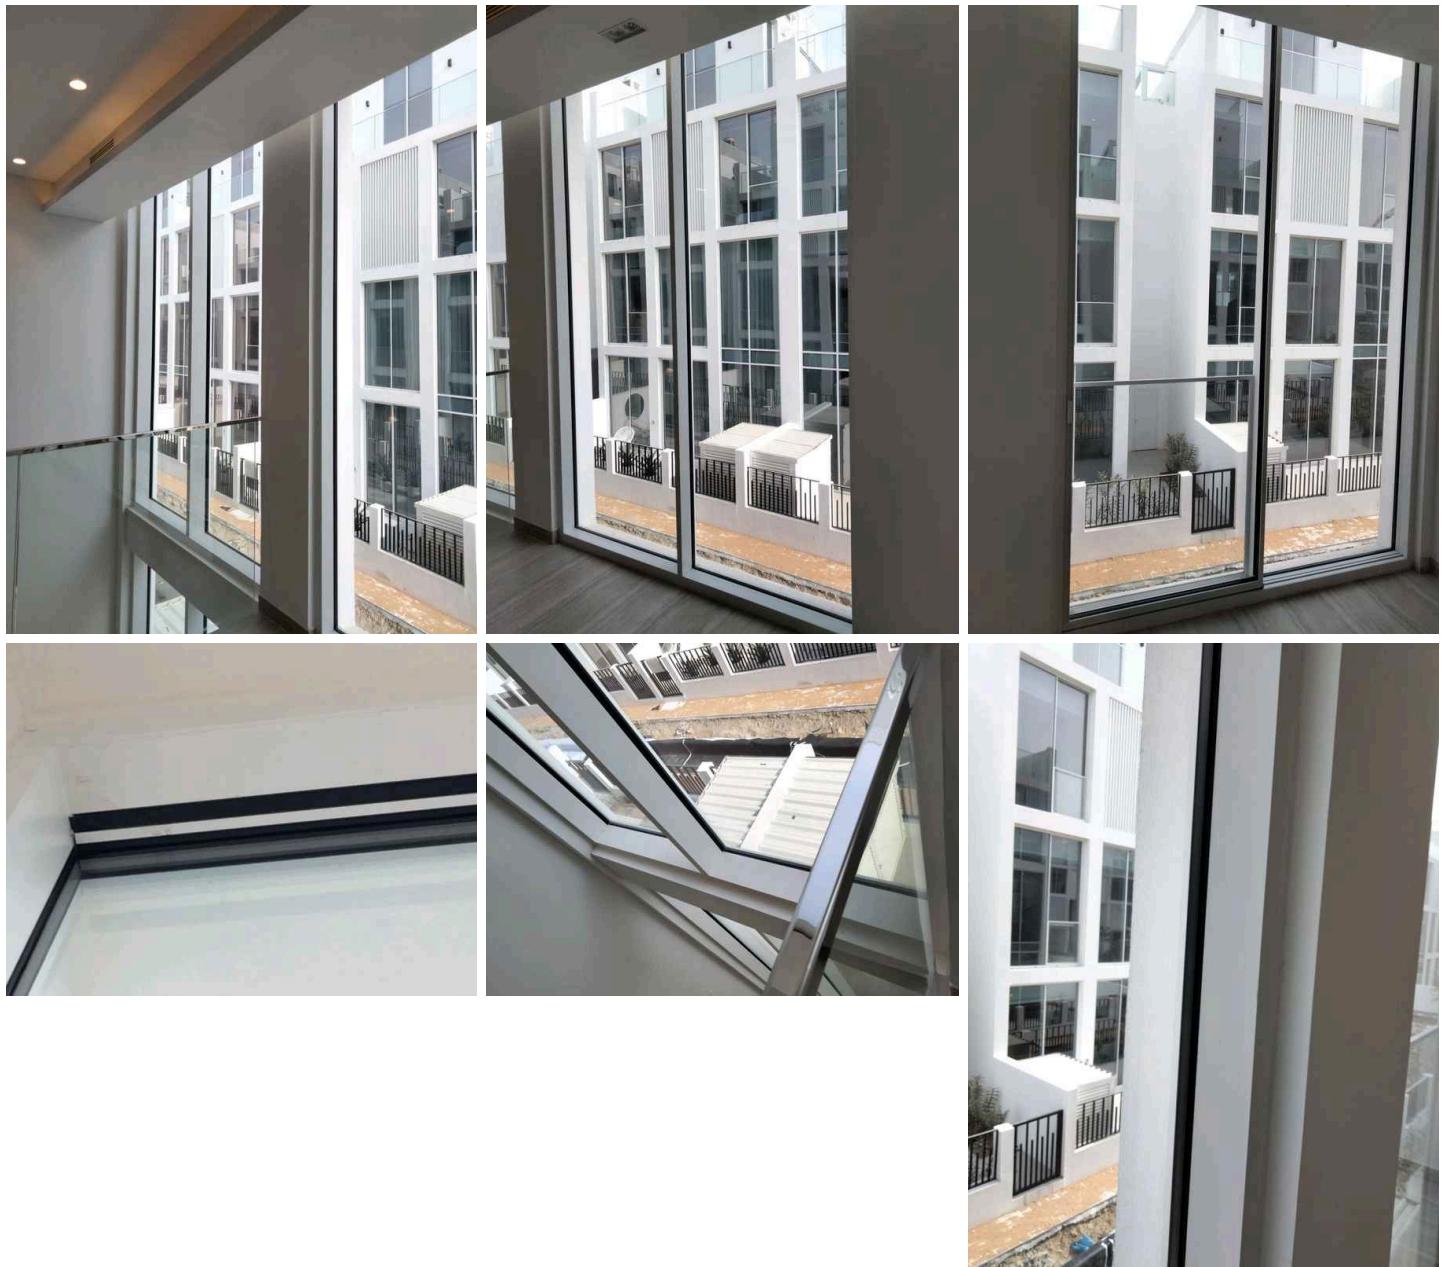
## 10.8.3 Window

Windows have accumulated dirt, dust and construction residue. Affects appearance and clarity. Requires thorough cleaning to restore proper finish.

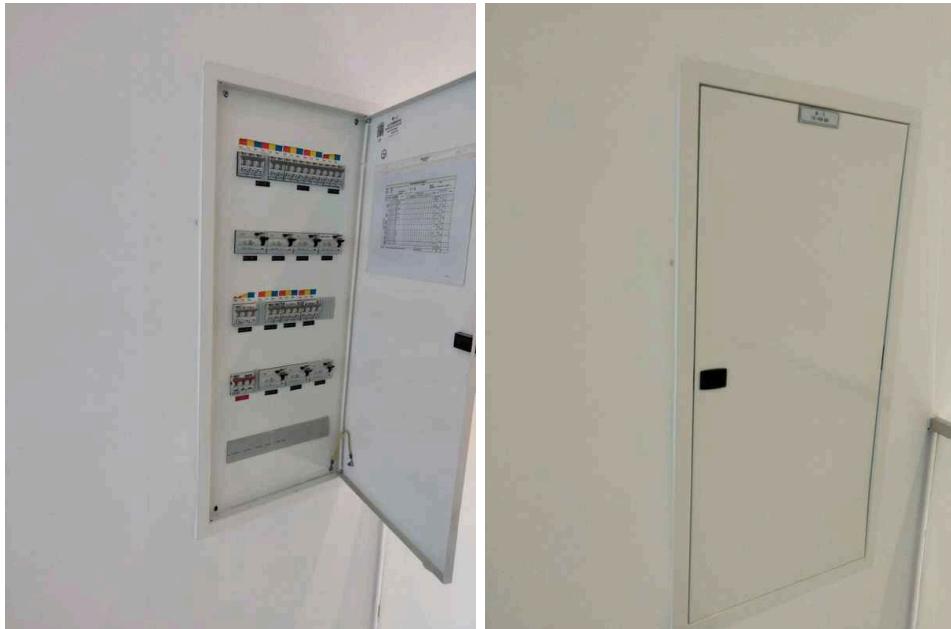
## 10.9.2 Db board

**CLOSING ISSUES**- Repair Needed

Distribution board door is not closing properly; hinges, alignment, and fixings to be adjusted or repaired to ensure safe enclosure.

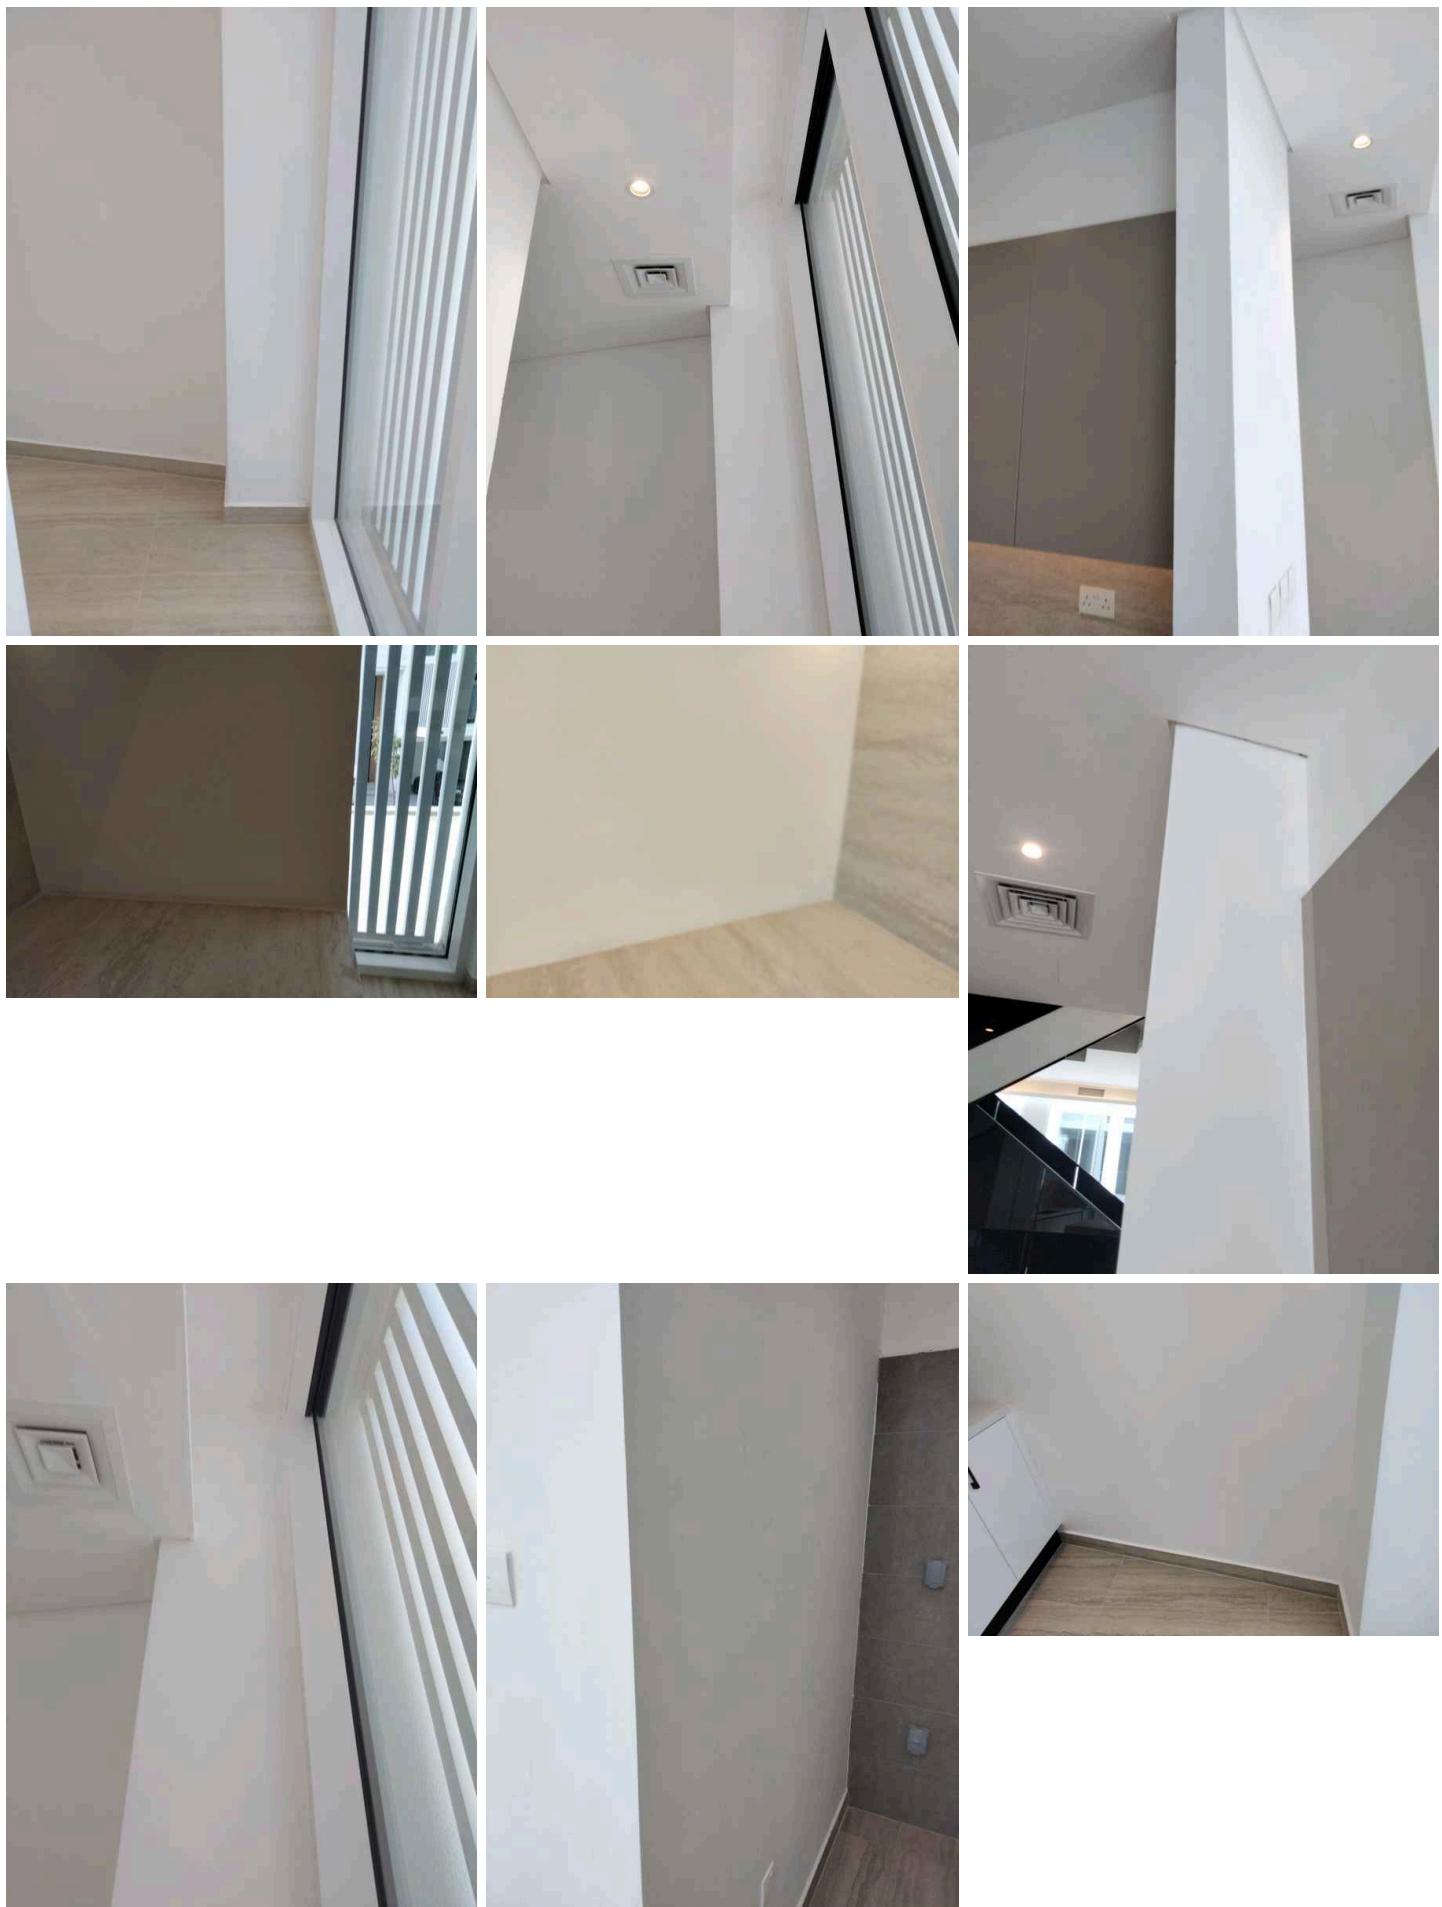
#### **PAINT TOUCH-UP AND FINISHING ISSUE**

Repair Needed

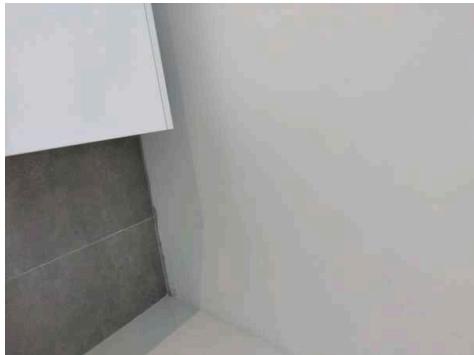
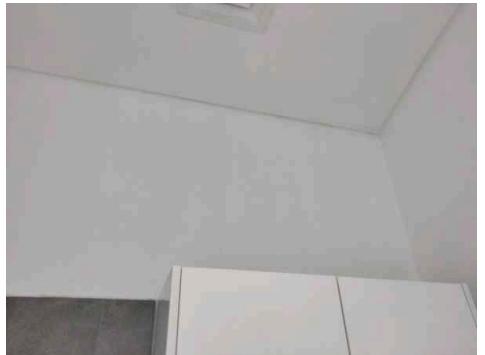
## 11.4.1 Floor

**HOLLOW TILES**

Some floor tiles sound hollow feel loose when stepped on, indicating poor bonding with the substrate. This can lead to cracking, lifting, or safety hazards over time. Reinstallation with proper adhesive is needed to secure the tiles firmly.

Repair Needed

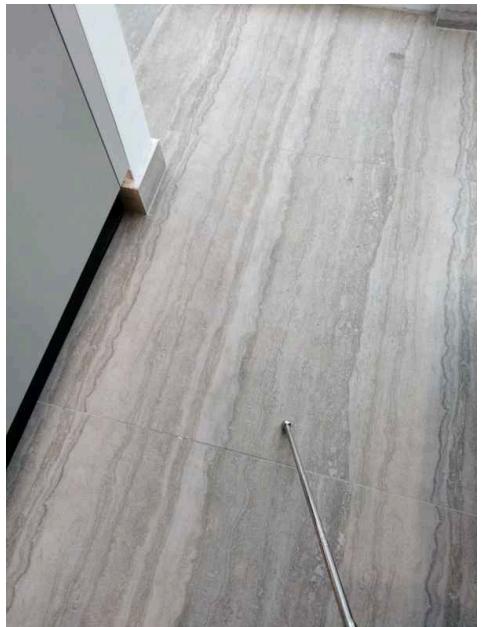
## 11.4.2 Floor

**STAINING ISSUE**

Floor shows visible stains affecting appearance and finish. Caused by spills, construction residue and improper cleaning. Requires proper cleaning or treatment to restore uniform look.

Repair Needed

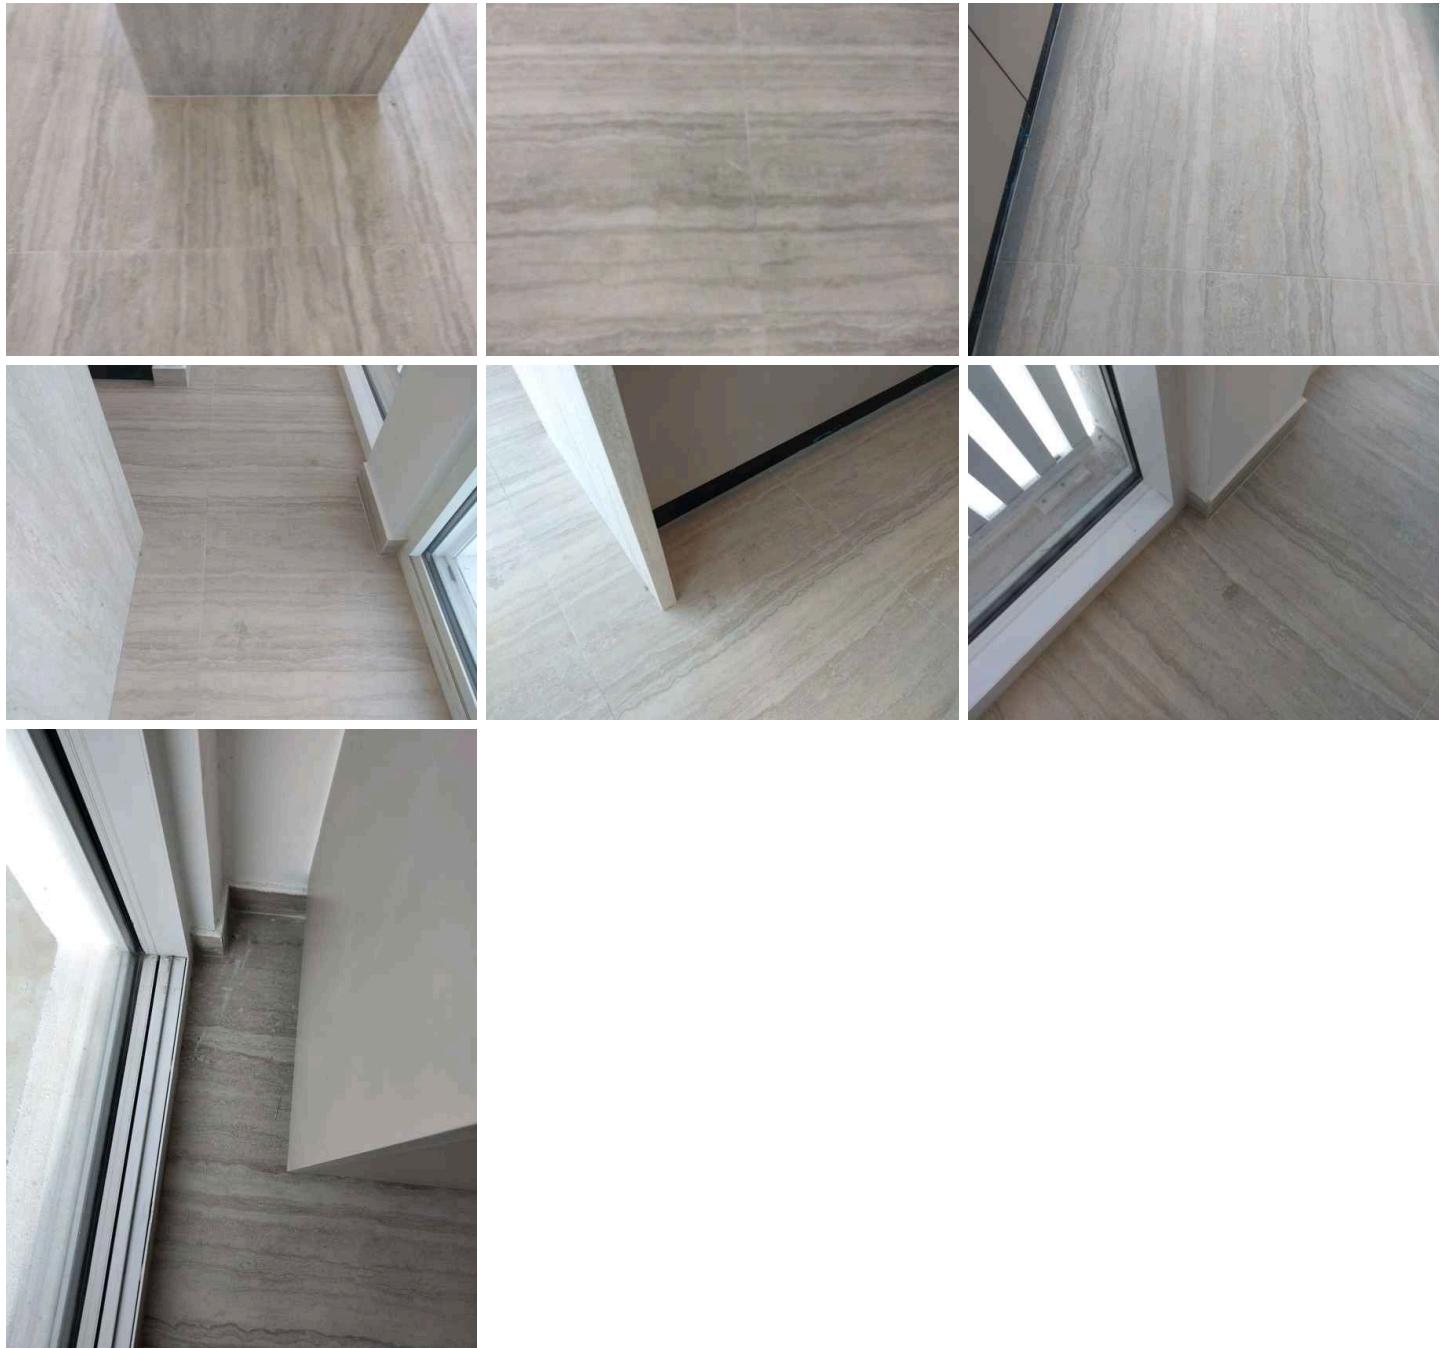
#### 11.4.3 Floor

#### **SKIRTING GAP ISSUES**

Gaps observed between skirting and wall floor due to poor filling. Affects finish and visual appearance. Requires proper fixing and sealing.

Immediate Action Needed

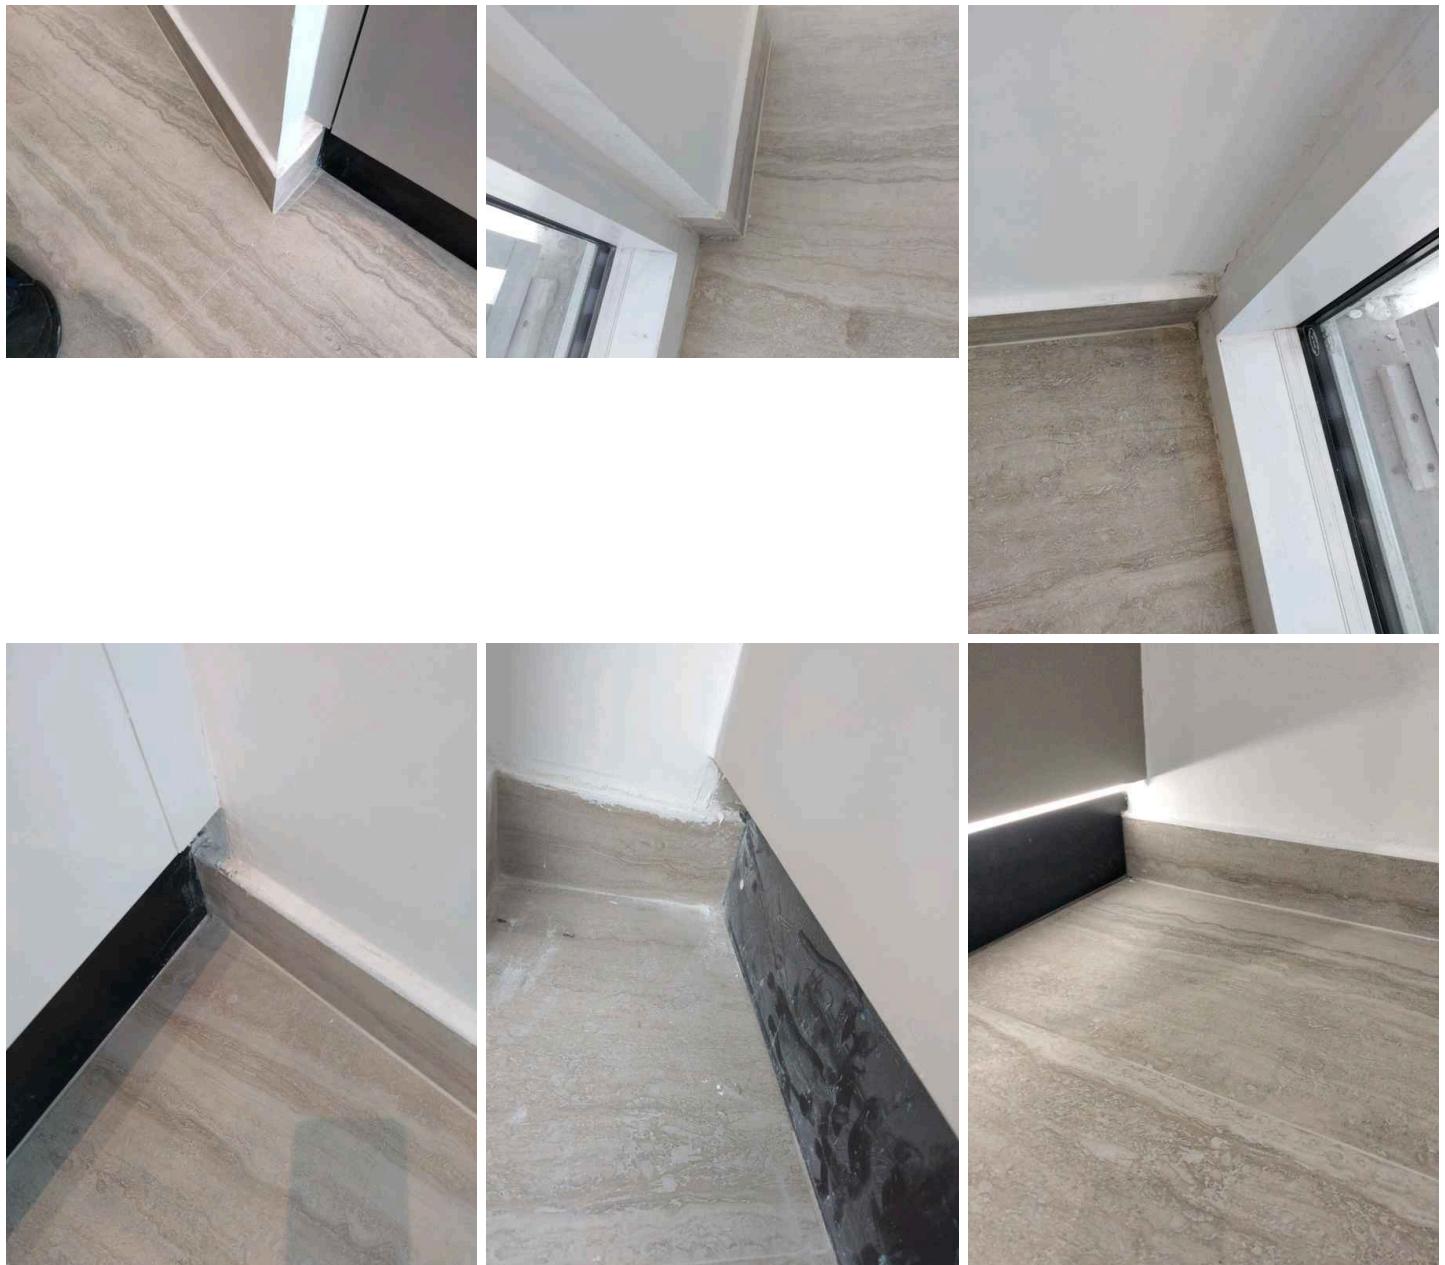
## 11.4.4 Floor

**GROUTING COLOR VARIATION**

Grout color is inconsistent across the floor, affecting uniformity and appearance. Indicates poor workmanship and improper material mixing. Requires cleaning, correction, or re-grouting for a consistent finish.

Repair Needed

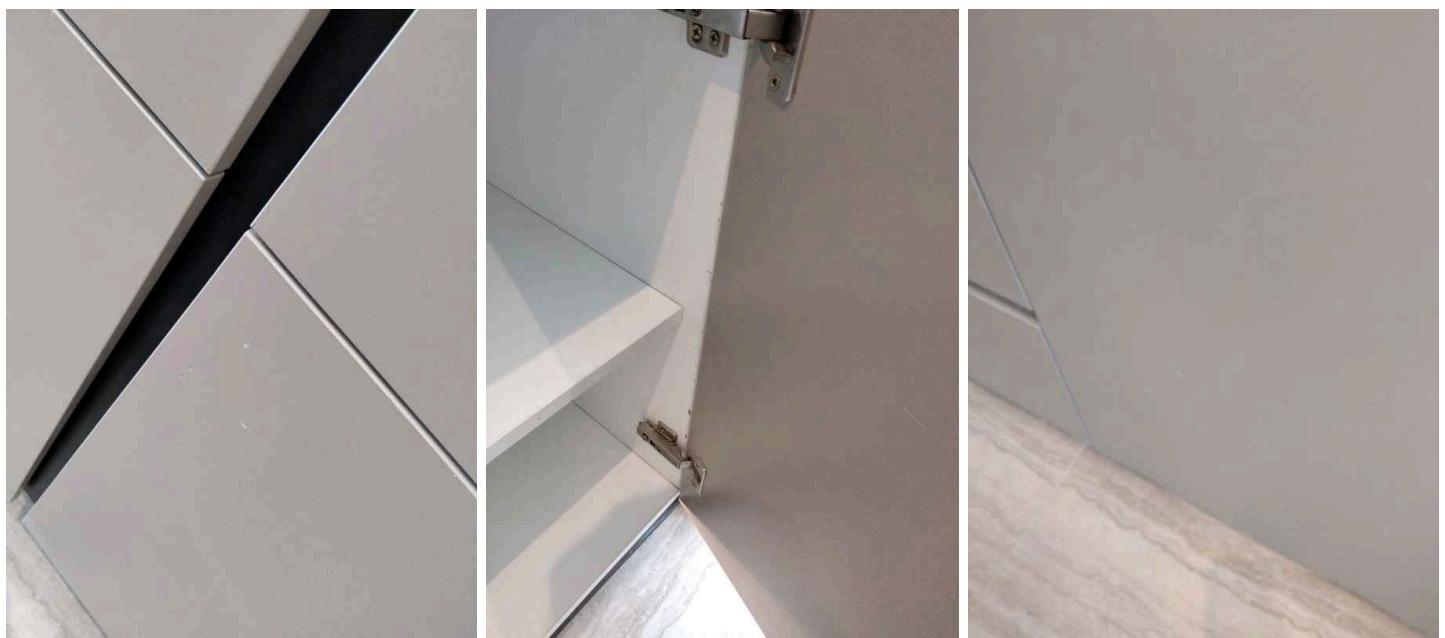
Cabinet surfaces show visible chips and damage. Affects appearance and finish quality. Requires repair or replacement of affected areas.

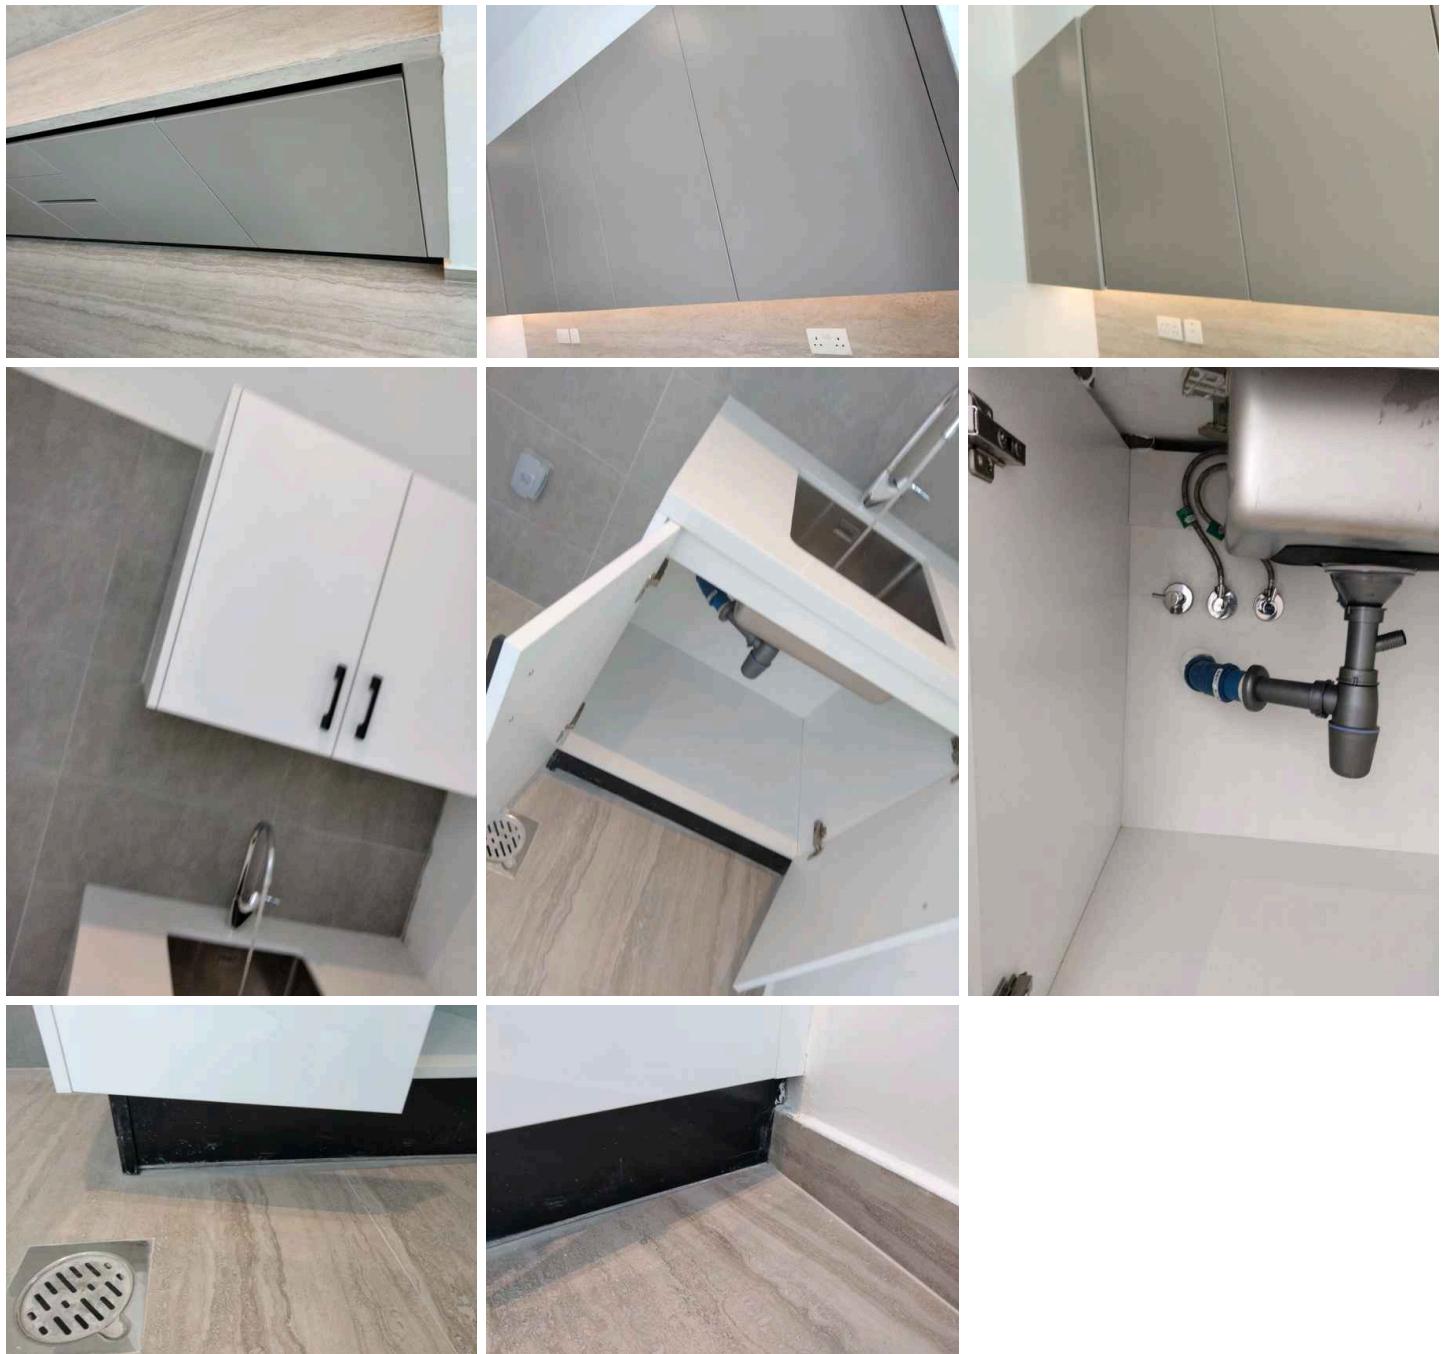
#### 11.6.4 Cabinets

### HINGES ALIGNMENT ISSUES

Hinges are misaligned, affecting smooth operation; alignment and fixing to be corrected to ensure proper door functionality.

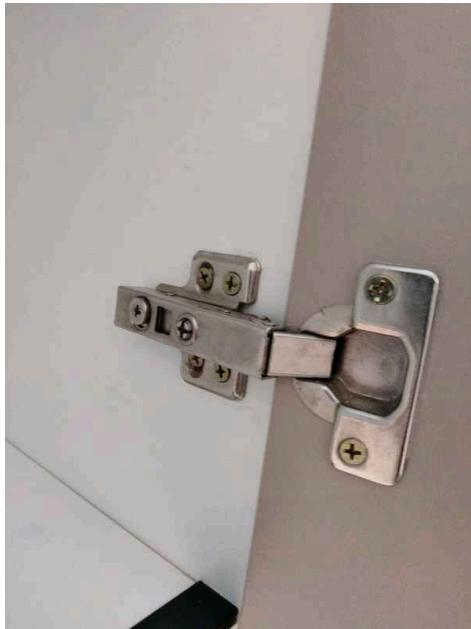
## 11.6.5 Cabinets

**STOPPER MISSING**

Cabinet door stopper is missing; suitable stopper to be supplied and installed to prevent impact damage and ensure controlled operation.

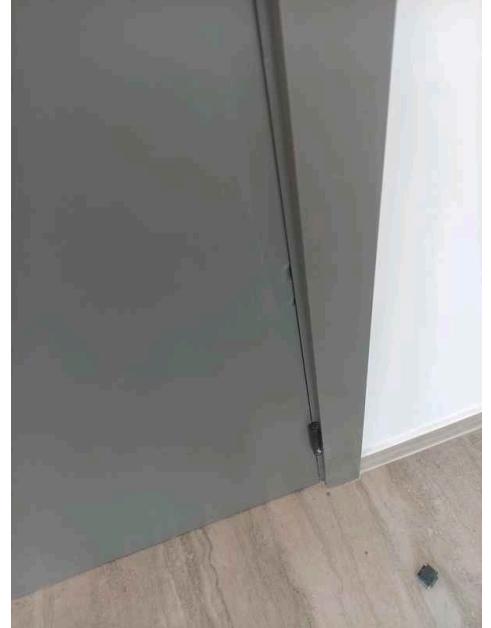
Chipping observed on the affected surface finish. Repair or replace the damaged area and ensure proper finishing to restore acceptable appearance.

Repair Needed

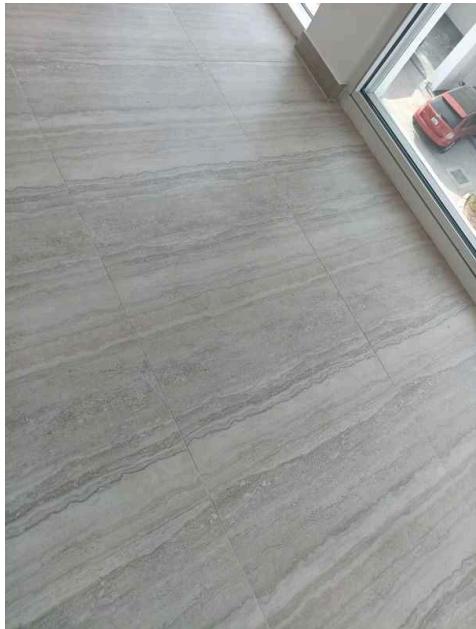
## 12.5.1 Floor

**UNEVEN TILE LEVEL ISSUE**

Floor tiles are not uniformly leveled, resulting in height variations that create tripping hazards and a poor visual finish. This is often due to improper installation and subfloor irregularities. Reinstallation or leveling correction is needed for a smooth and safe surface.

Repair Needed

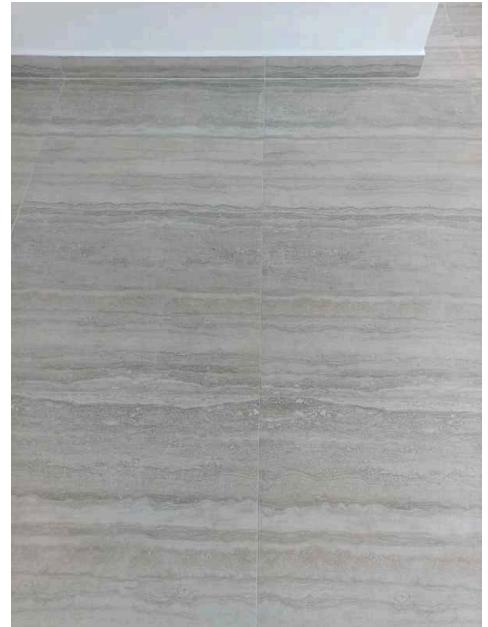
## 12.5.2 Floor

**GROUT MISSING**

Floor areas have missing and incomplete grout between tiles. Creates gaps that affect appearance and may cause water ingress. Requires proper grouting to finish the surface.

Repair Needed

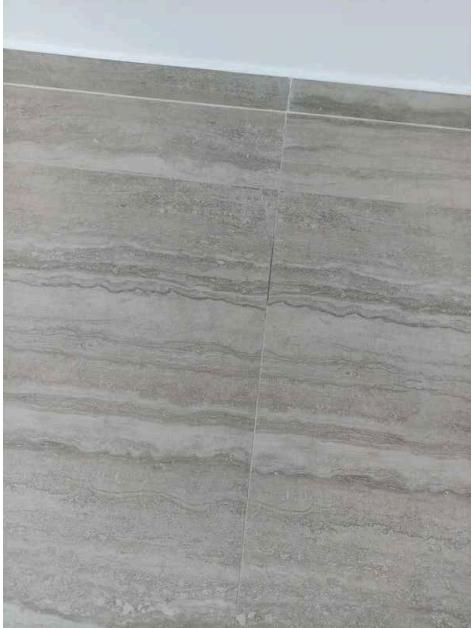
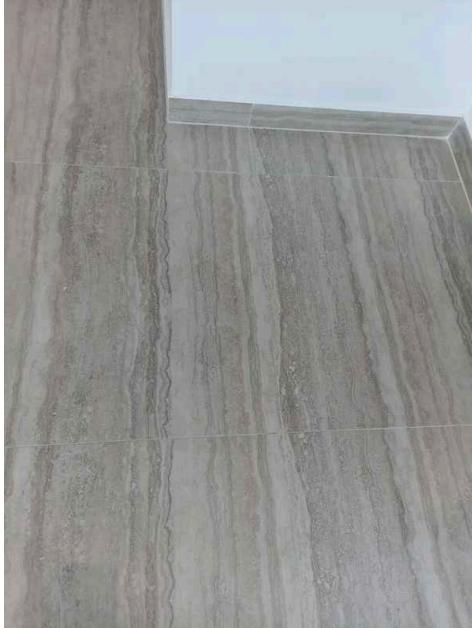
## 12.5.3 Floor

**GROUTING COLOR VARIATION**

Grout color is inconsistent across the floor, affecting uniformity and appearance. Indicates poor workmanship and improper material mixing. Requires cleaning, correction, or re-grouting for a consistent finish.

Repair Needed

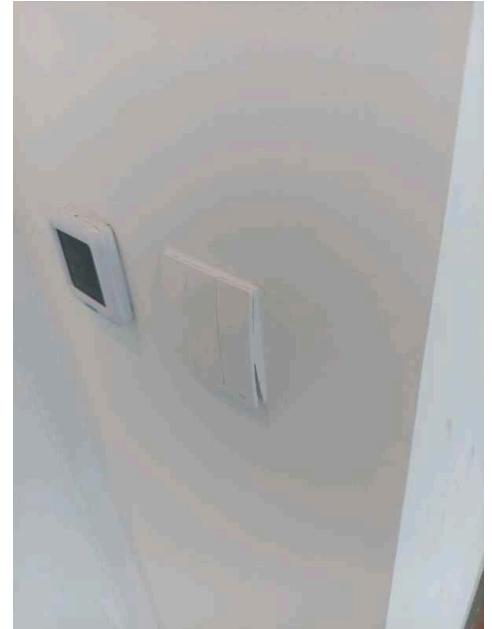
## 12.6.1 Lighting Fixtures, Switches &amp; Receptacles

**PAINT CLEANING REQUIRED**

Paint stains observed on switch board; cleaning to be carried out carefully to restore neat appearance without affecting electrical components.

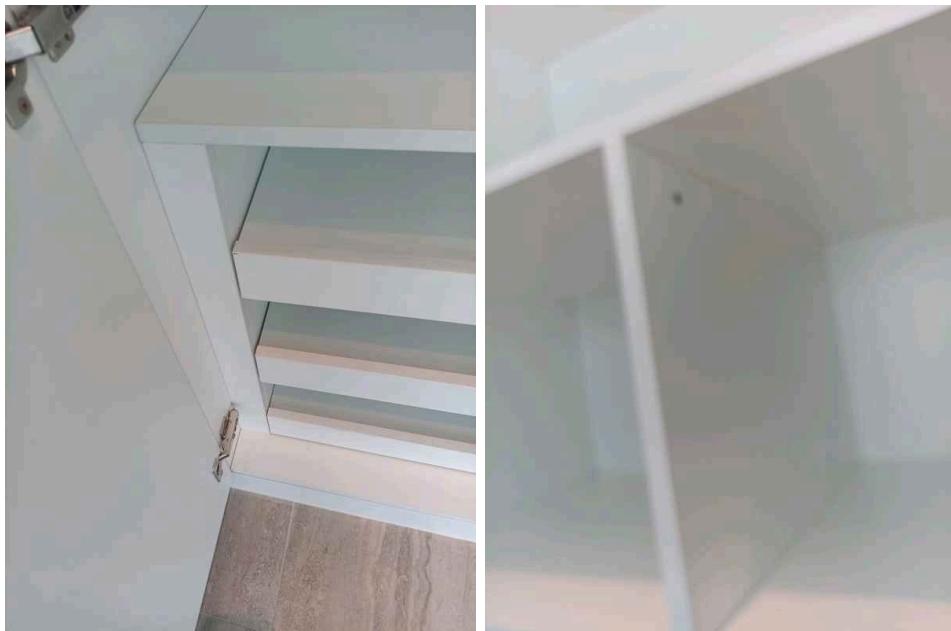
## 12.7.1 Cabinets

**CHIPPING ISSUE**

Cabinet surfaces show visible chips and damage. Affects appearance and finish quality. Requires repair or replacement of affected areas.
