## Sample Property Snagging Report in Dubai – Professional Inspection PDF

This PDF is issued by Dubai Property Snagging, a professional property inspection company in Dubai, providing snagging reports, pre-handover inspections, and defect reports for villas and apartments across the UAE.

Client  
06/02/2026

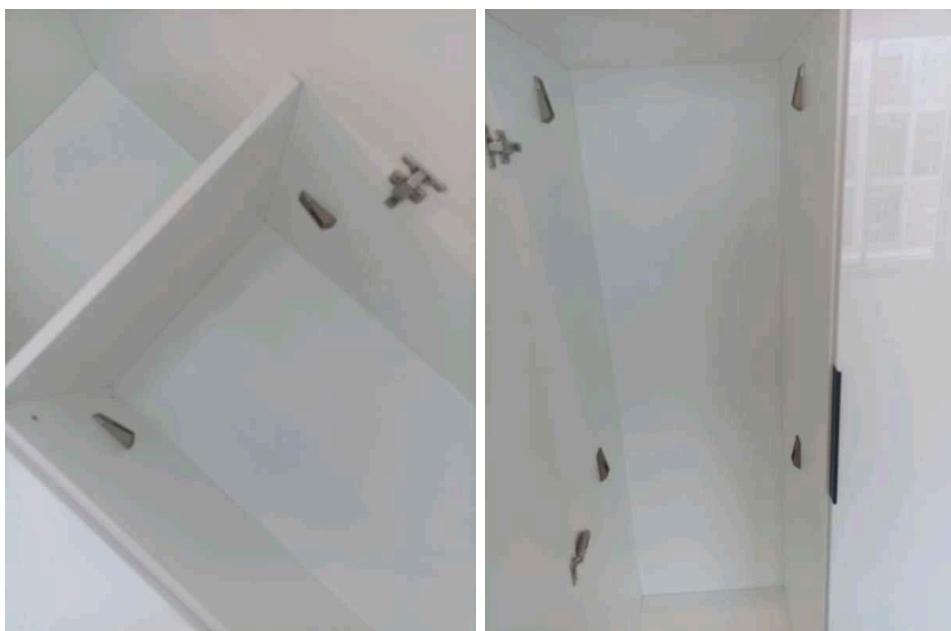
## 12.7.2 Cabinets

Required hanger is missing; suitable hanger to be supplied and securely installed as per approved specifications.

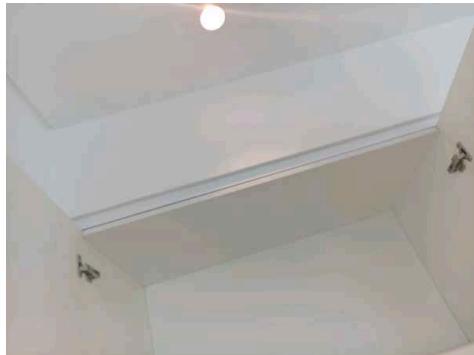
Gaps and finishing defects observed on the cabinet; filling and proper finishing to be carried out to achieve a neat and acceptable appearance.

Repair Needed

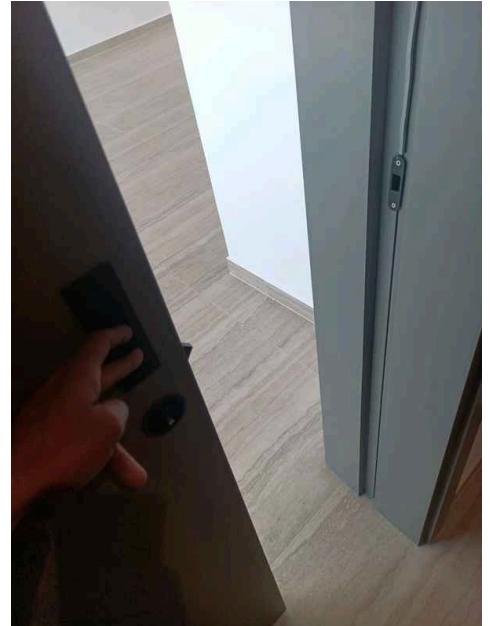
## 13.2.3 Door

**LOCK ISSUE**

Lock is not functioning properly; adjustment or replacement required to ensure smooth and secure operation.

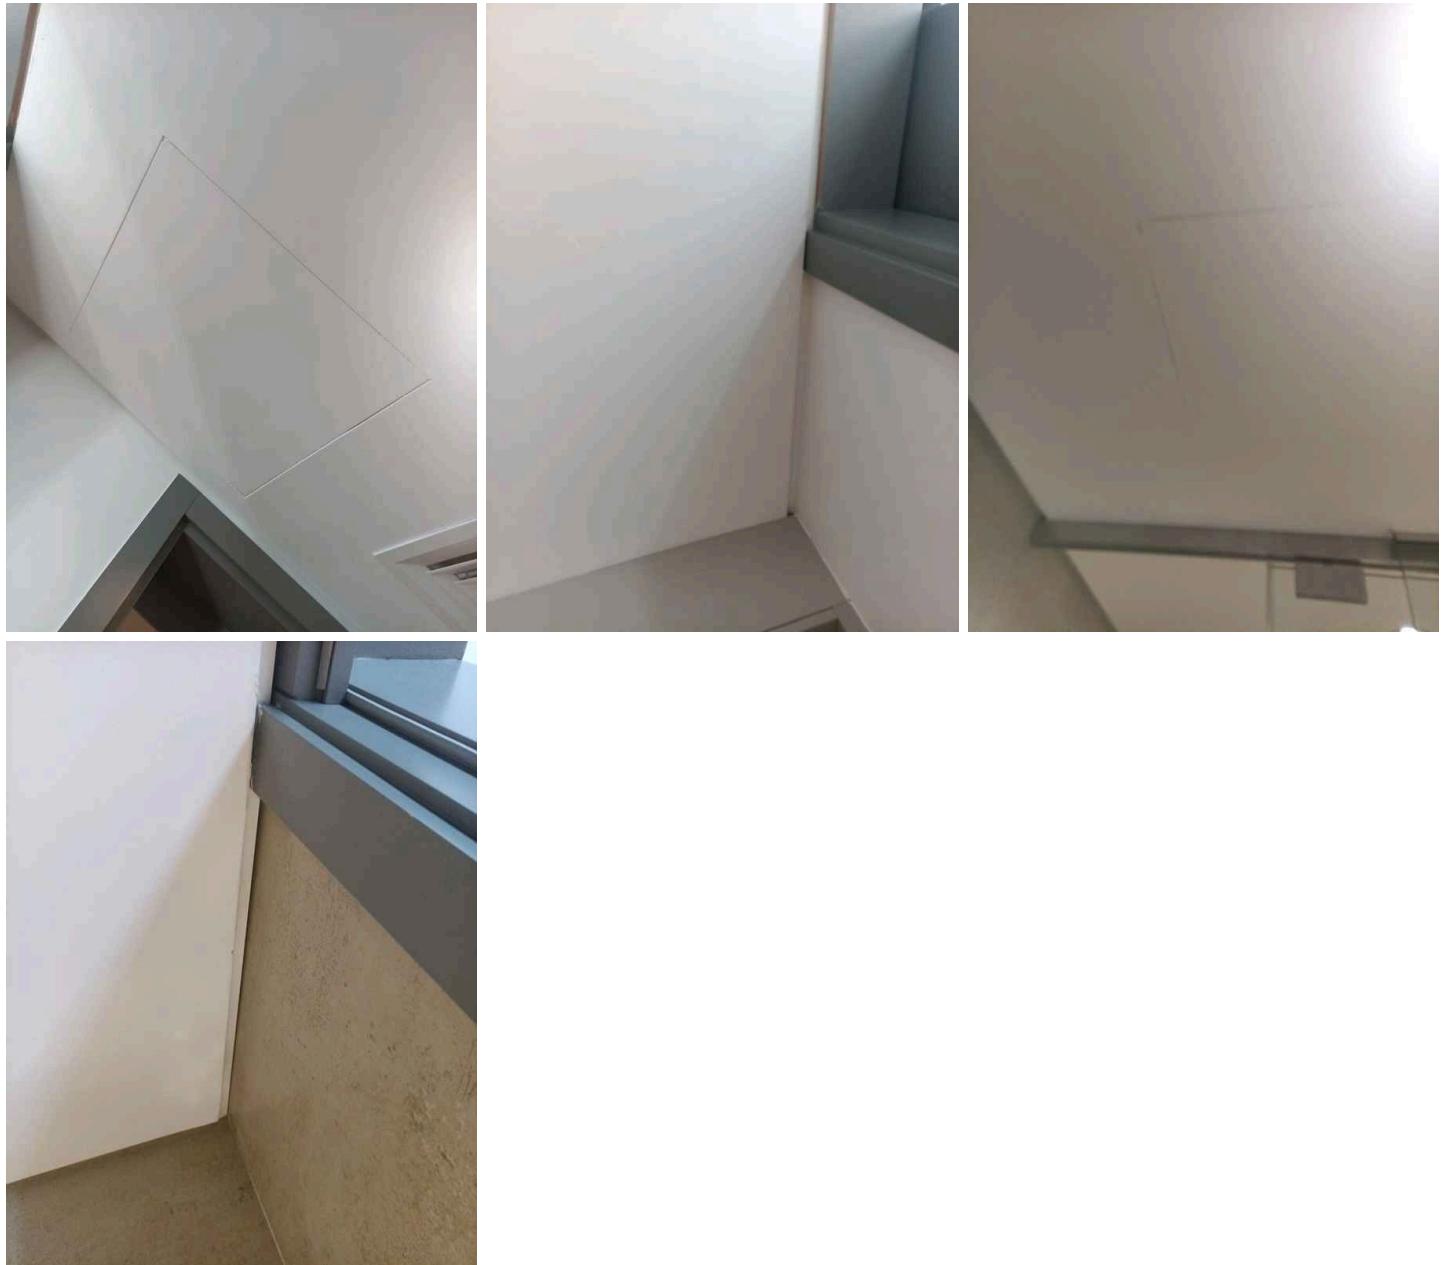
## 13.3.1 Ceiling

**PAINT TOUCH-UP AND FINISHING ISSUE**

The ceiling has visible touch-up marks and uneven paint application, leading to a patchy and inconsistent finish. This can affect the overall aesthetic of the room. Proper surface preparation, touch-up, and even repainting are required for a smooth and uniform ceiling finish.

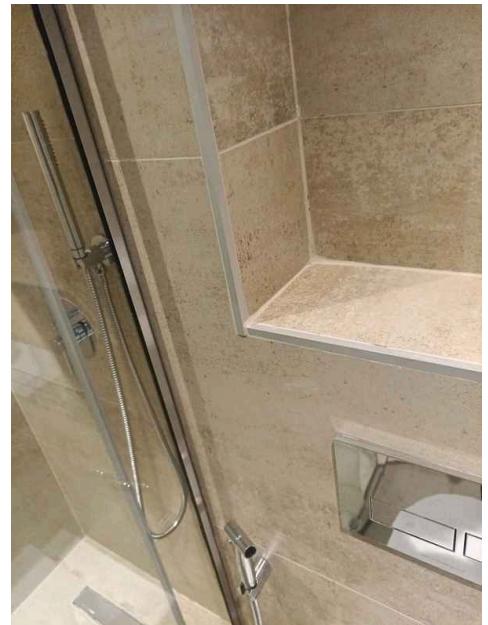
#### 13.4.1 Walls

#### **UNEVEN TILE LEVEL ISSUE**

Wall tiles are not uniformly leveled, resulting in height variations that create tripping hazards and a poor visual finish. This is often due to improper installation and wall irregularities. Reinstallation or leveling correction is needed for a smooth and safe surface.

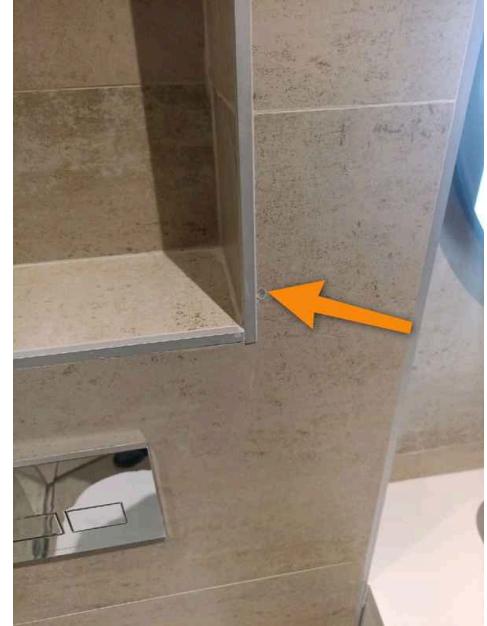
## 13.4.2 Walls

**TILE CRACKS**

Cracks observed on tiles due to poor installation. Affects aesthetics and may worsen over time. Requires replacement or proper repair.

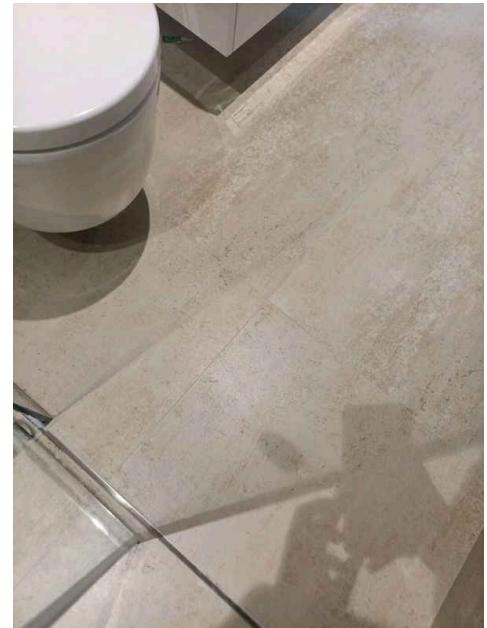
## 13.5.1 Floor

**UNEVEN TILE LEVEL ISSUE**

Floor tiles are not uniformly leveled, resulting in height variations that create tripping hazards and a poor visual finish. This is often due to improper installation and subfloor irregularities. Reinstallation or leveling correction is needed for a smooth and safe surface.

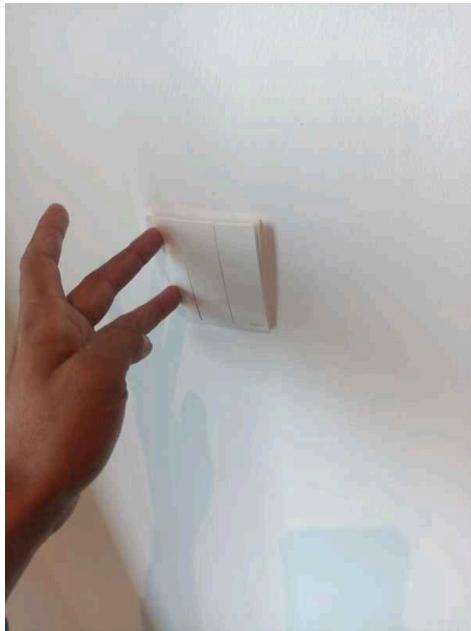
## 13.6.1 Lighting Fixtures, Switches &amp; Receptacles

**CONNECTION ISSUE**

The socket switch are not functioning properly, Due to loose connections, faulty wiring, damaged components. Immediate repair are required to restore proper operation and ensure safety.

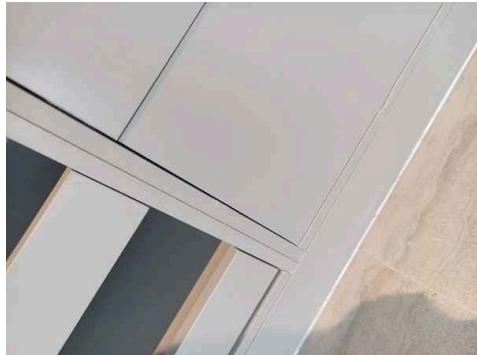
## 13.7.1 Cabinets

**CHIPPING ISSUE**

Cabinet surfaces show visible chips and damage. Affects appearance and finish quality. Requires repair or replacement of affected areas.

Repair Needed

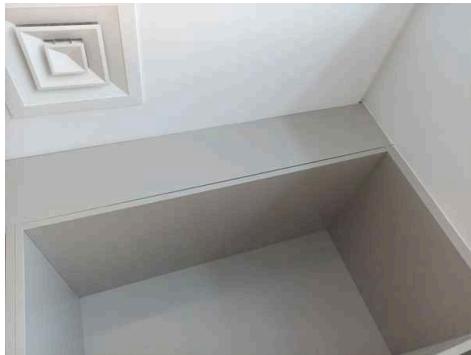
## 13.7.2 Cabinets

**GAPS ISSUE**

Gaps observed in cabinet installation; gaps to be properly filled, aligned, and finished to achieve a neat and acceptable appearance.

Repair Needed

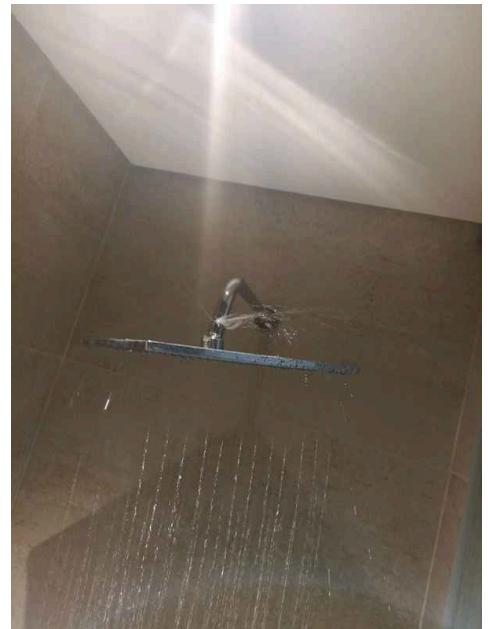
## 13.9.1 Shower

**WATER LEAKAGE FROM  
SHOWER HEAD**

Water leaks continuously from the joint of shower head when the valve is open, indicating faulty internal seals.

Immediate Action Needed

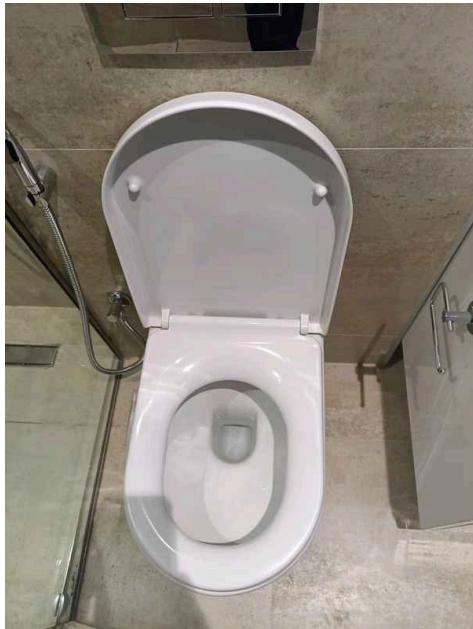
## 13.10.1 WC

**FLUSH NOT FUNCTIONING PROPERLY**

Flush mechanism is weak, incomplete, or not operating, requiring adjustment or replacement.

Repair Needed

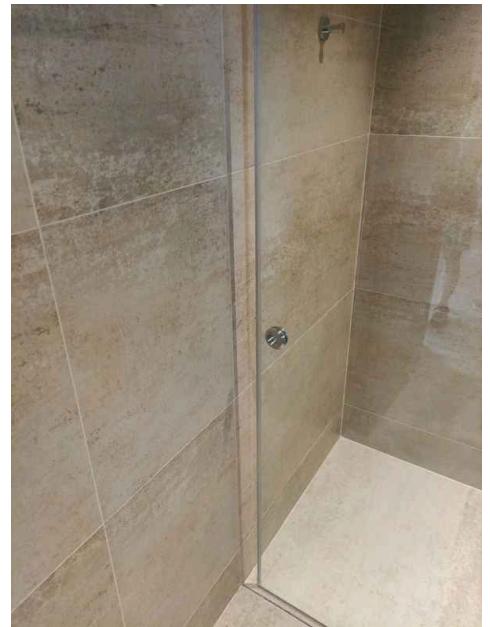
## 13.13.1 Glass Separation

**GAP ISSUES**

Gaps observed at glass partition joints; proper sealing and alignment to be carried out to ensure safety and neat finish.

✖ Repair Needed

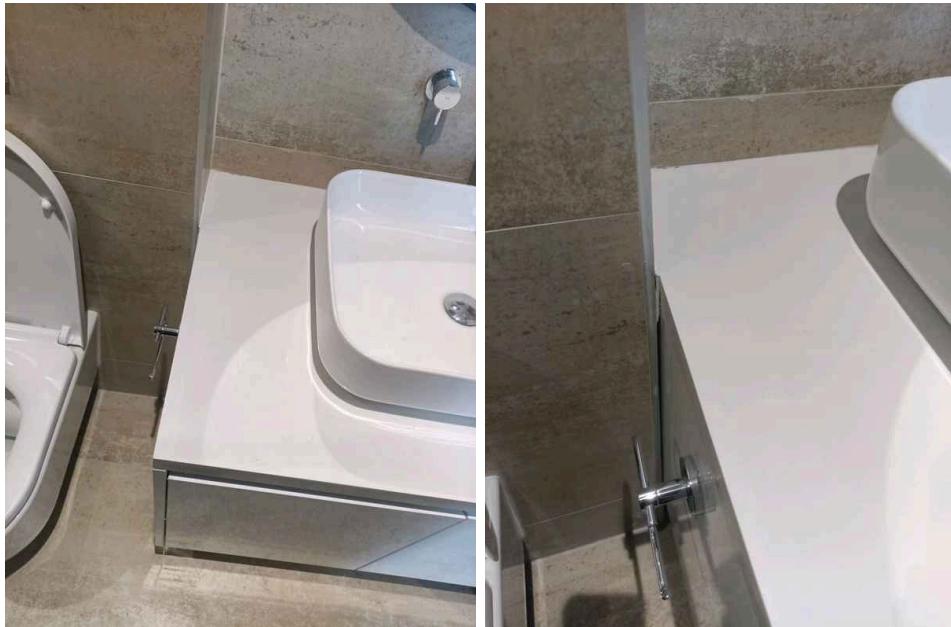
## 13.14.1 Vanity

**POOR FINISHING**

Vanity surfaces show uneven finishing, rough edges and visible defects. Affects appearance and quality. Requires proper sanding, filling, and finishing.

✖ Repair Needed

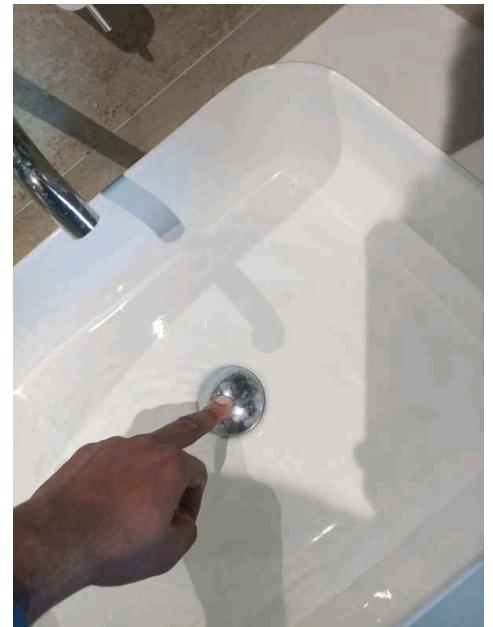
13.14.2 Vanity

### **DRAINAGE BOBBING ISSUE**

Hand wash basin drainage bobbing is improper. Affects functionality and safety. Requires proper fixing and support.

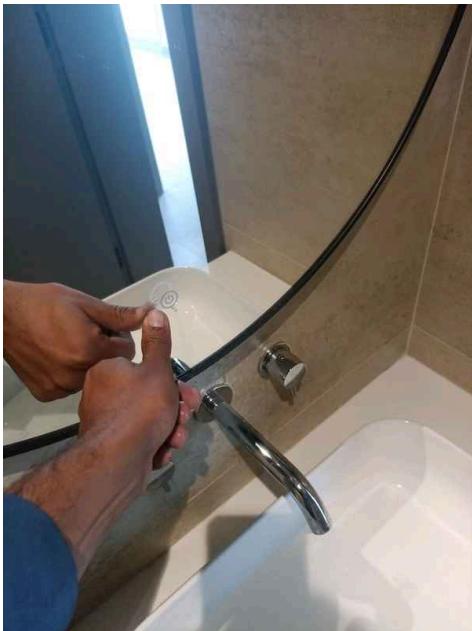
13.14.3 Vanity

### **ALIGNMENT ISSUE**

Cabinet alignment is improper; adjustment and refixing required to ensure proper fit, smooth operation, and uniform appearance.

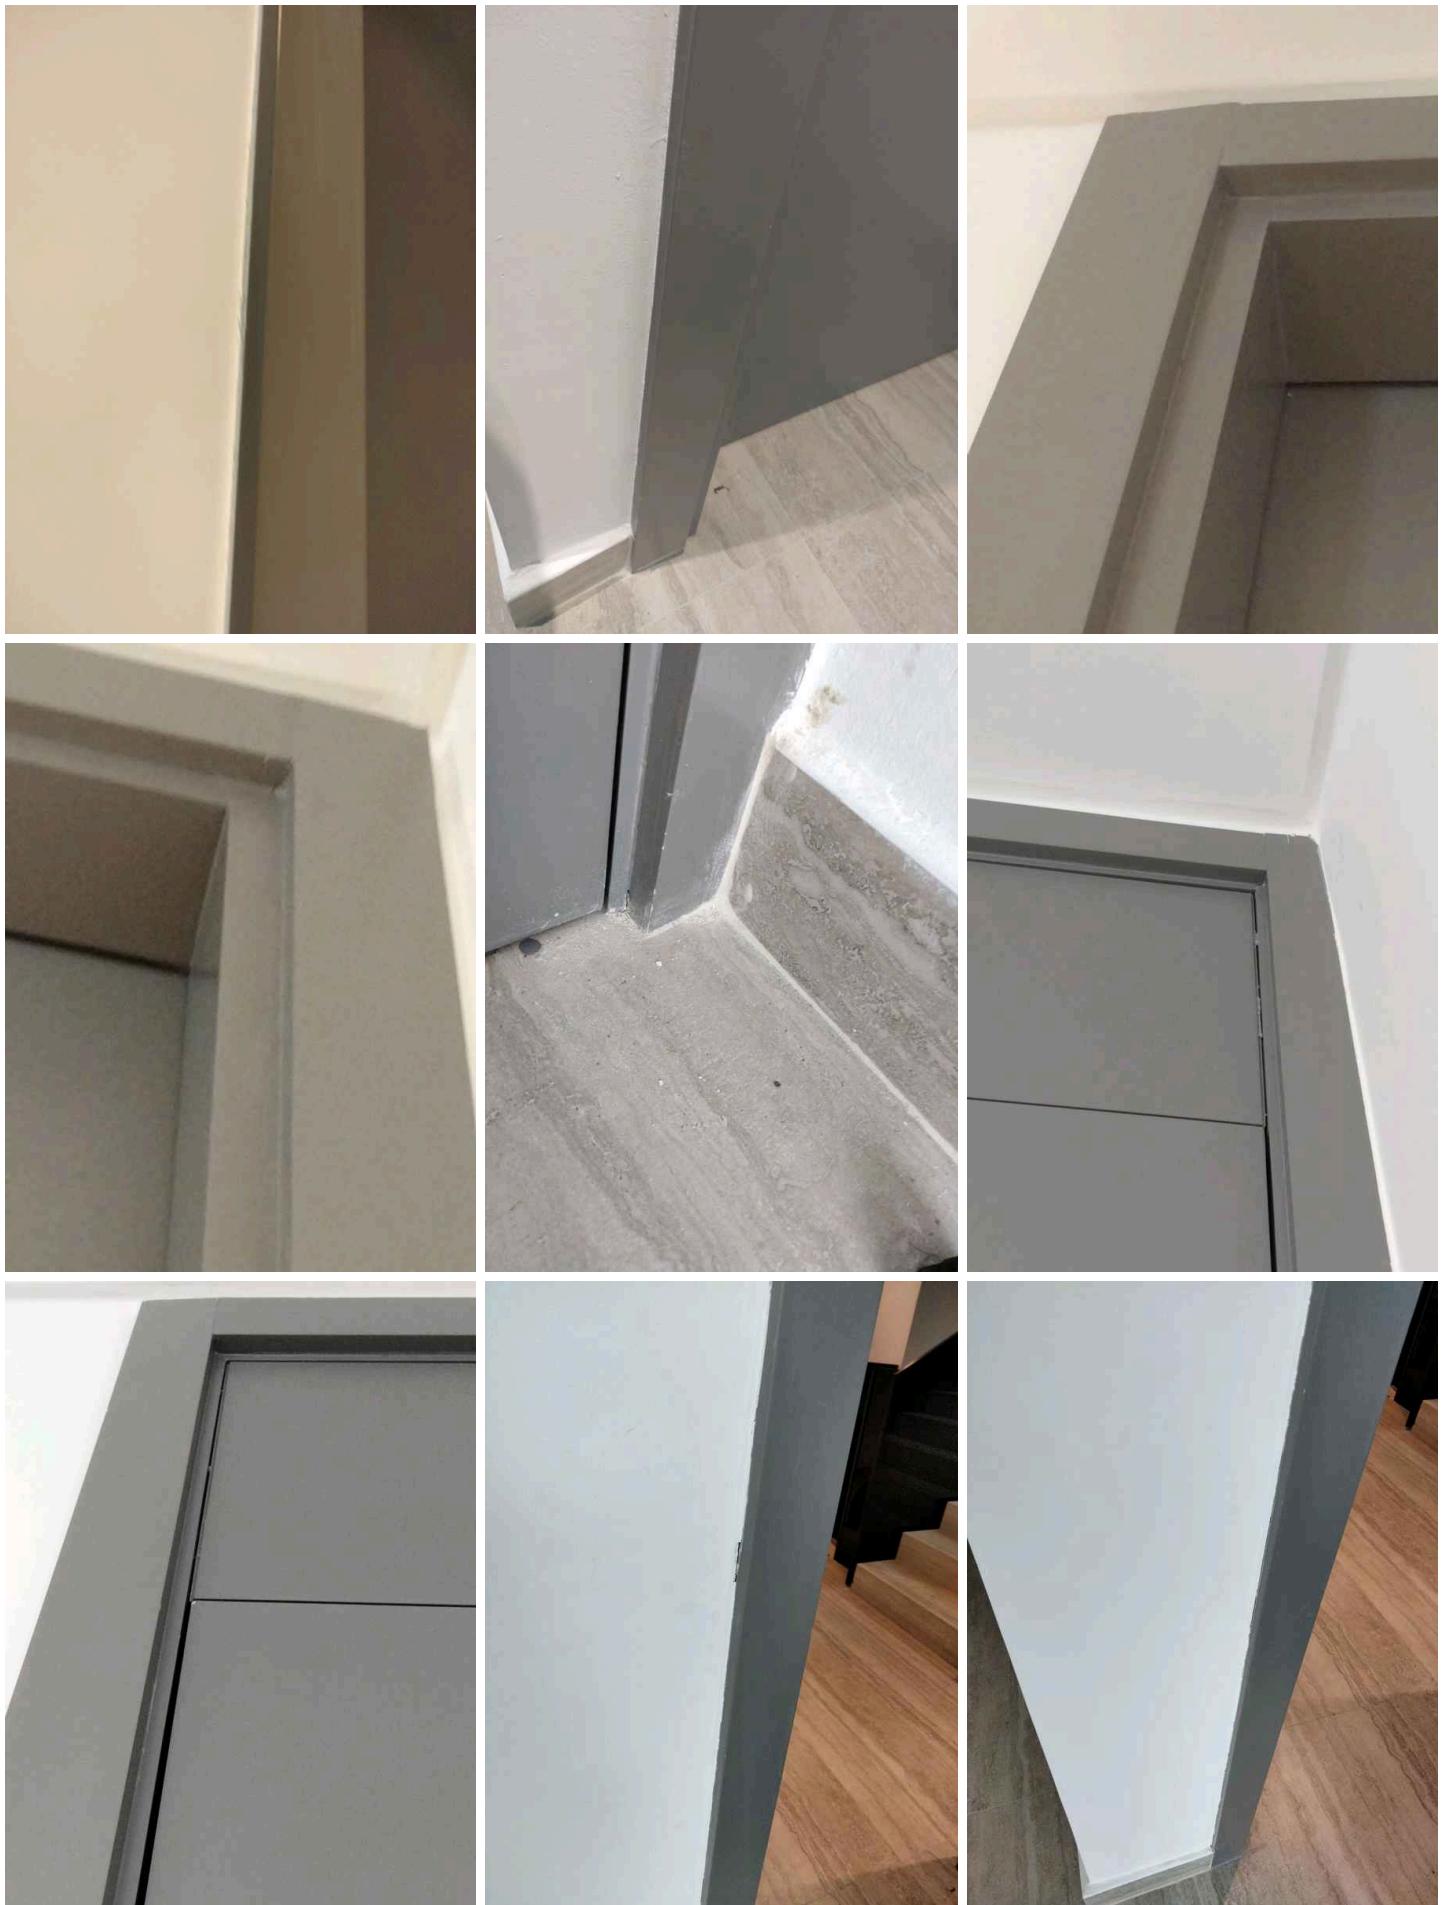
#### 14.2.2 Door

#### FRAME GAP ISSUE

There is a visible gap between the frame and adjacent surface, indicating poor installation. This may lead to air and dust infiltration and affects the overall finish. Proper sealing or realignment is required to correct the defect.

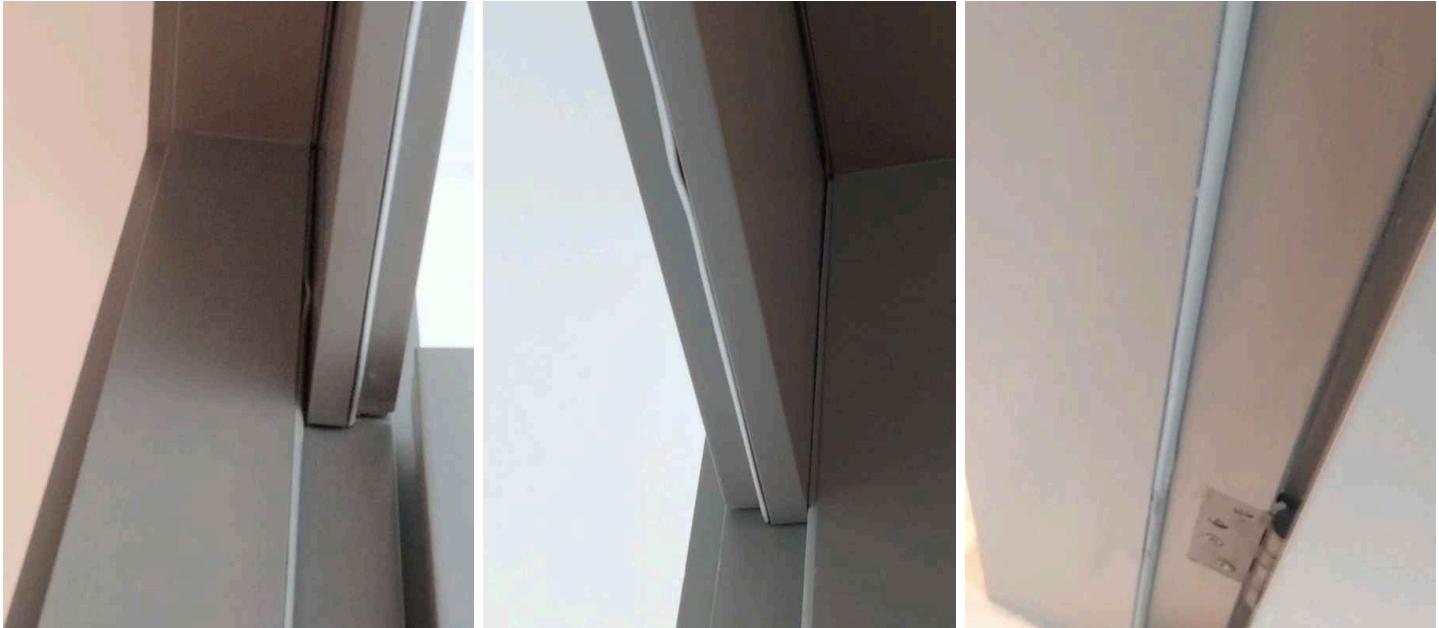
## 14.2.3 Door

The rubber seal is improperly installed, compromising its ability to provide an effective seal. This may result in air, water, or dust infiltration.

Repair Needed

Replacement or proper adjustment is needed to restore full functionality.

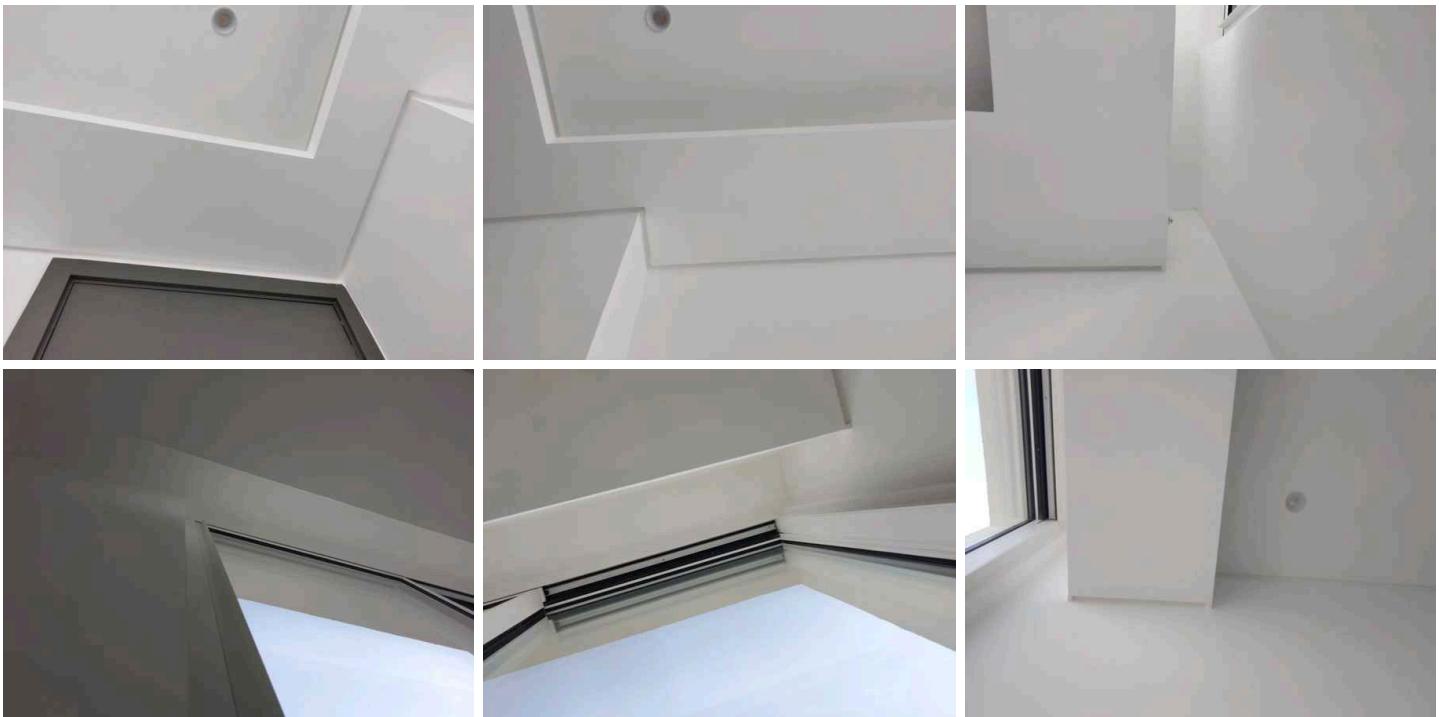
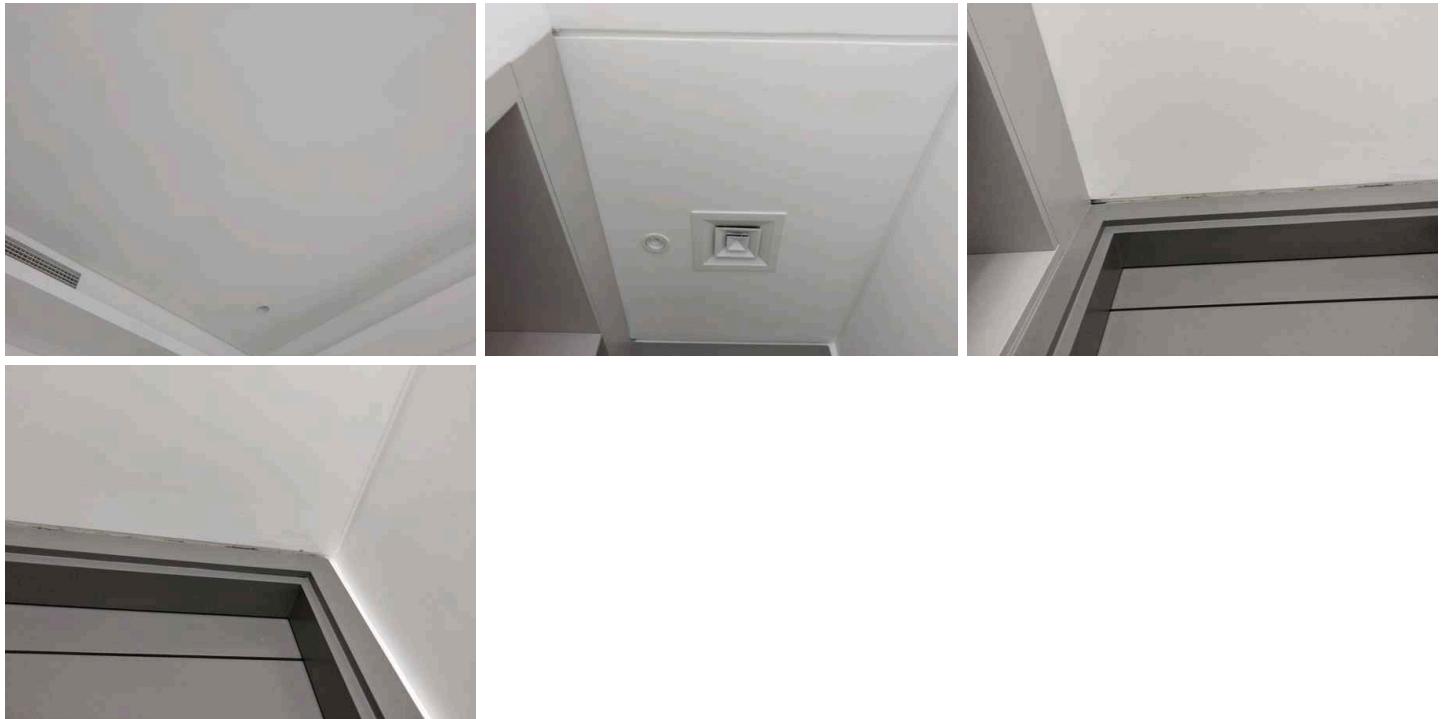
## 14.3.1 Ceiling

**PAINT TOUCH-UP AND FINISHING ISSUE**

The ceiling has visible touch-up marks and uneven paint application, leading to a patchy and inconsistent finish. This can affect the overall aesthetic of the room. Proper surface preparation, touch-up, and even repainting are required for a smooth and uniform ceiling finish.

Repair Needed

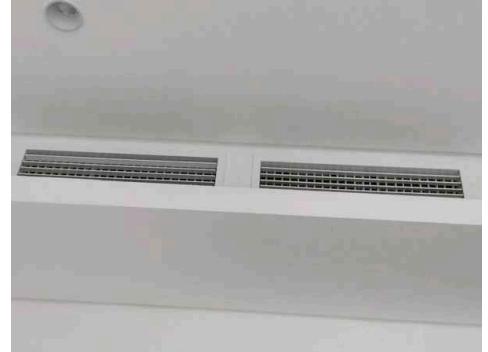
**AC GRILL CLEANING REQUIRED**

AC grille is dirty and requires thorough cleaning to ensure proper airflow and neat appearance.

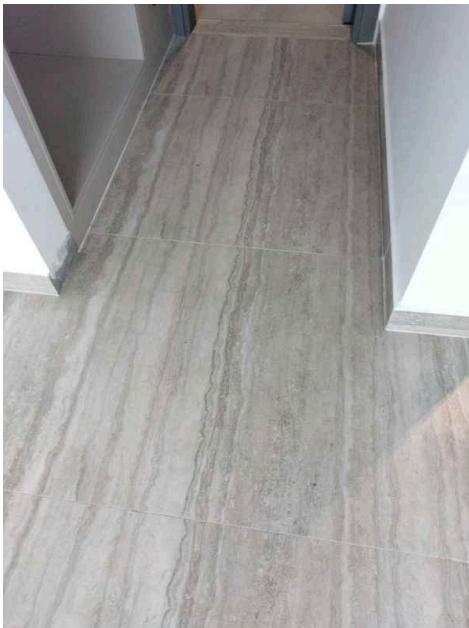
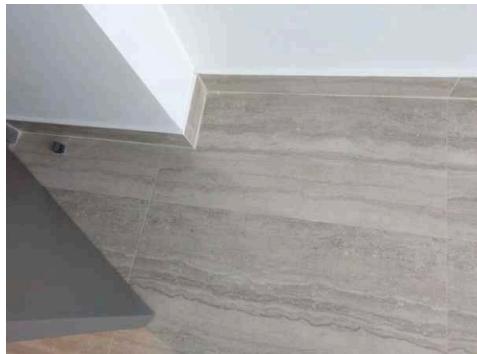
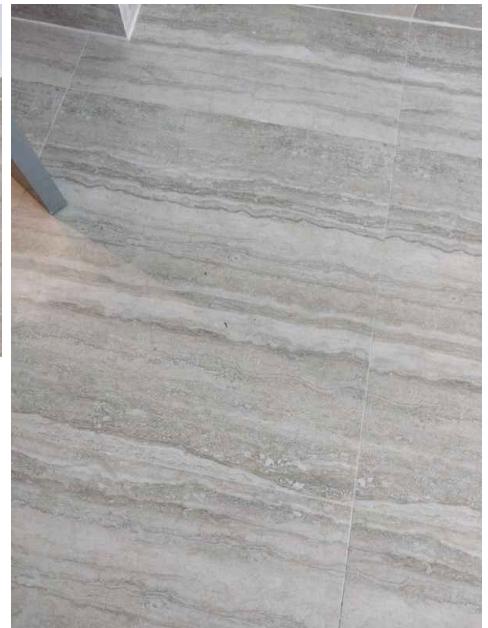
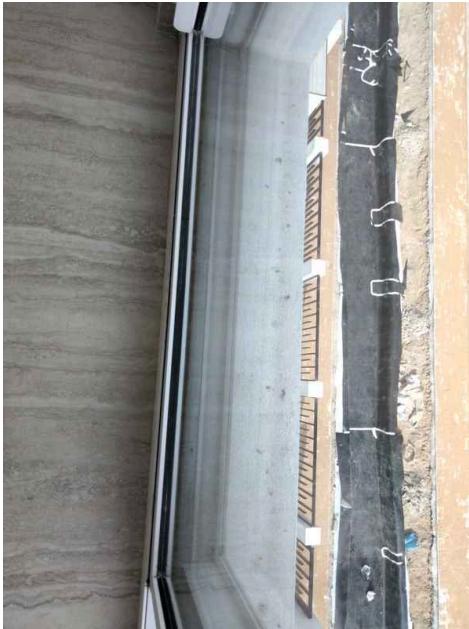
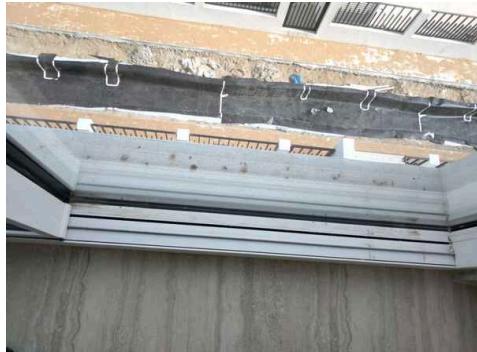
**STAINING ISSUE**

Floor shows visible stains affecting appearance and finish. Caused by spills, construction residue and improper cleaning. Requires proper cleaning or treatment to restore uniform look.

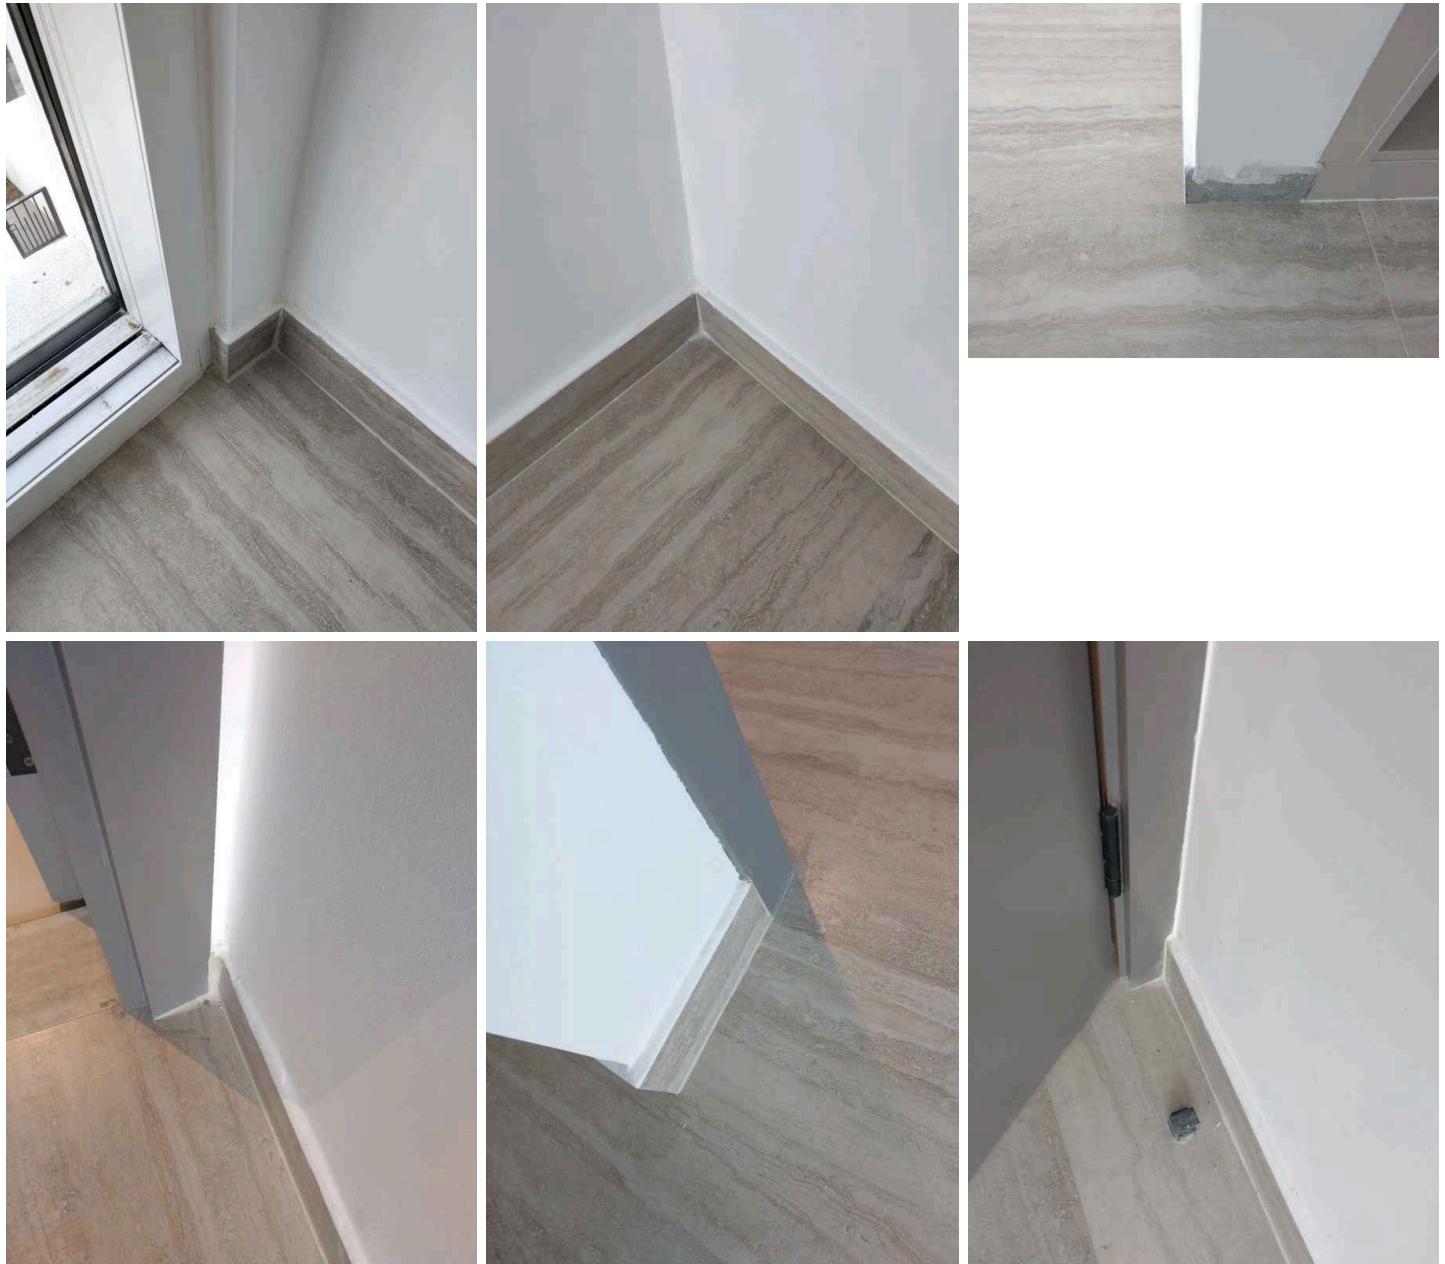
## 14.5.2 Floor

**SKIRTING GAP ISSUES**

Gaps observed between skirting and wall floor due to poor filling. Affects finish and visual appearance. Requires proper fixing and sealing.

Immediate Action Needed

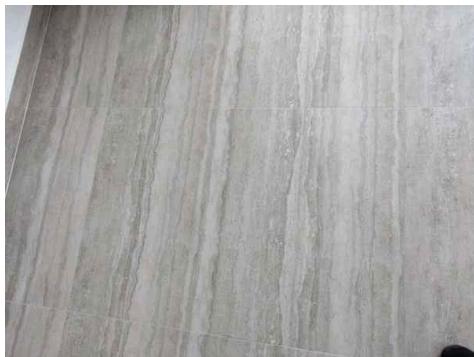
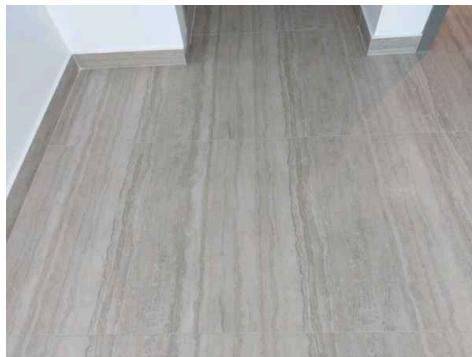
## 14.5.3 Floor

**GROUTING COLOR VARIATION**

Grout color is inconsistent across the floor, affecting uniformity and appearance. Indicates poor workmanship and improper material mixing. Requires cleaning, correction, or re-grouting for a consistent finish.

Repair Needed

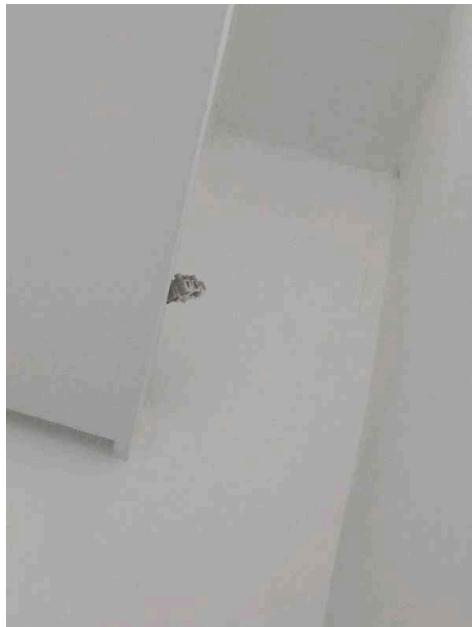
## 14.6.1 Lighting Fixtures, Switches &amp; Receptacles

**EXPOSED WIRES ISSUES**

Exposed electrical wiring observed; wiring to be properly insulated, secured, and concealed to comply with safety standards.

Immediate Action Needed

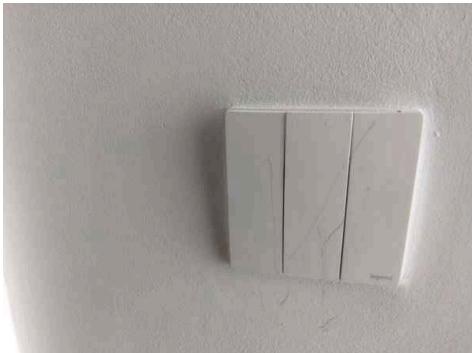
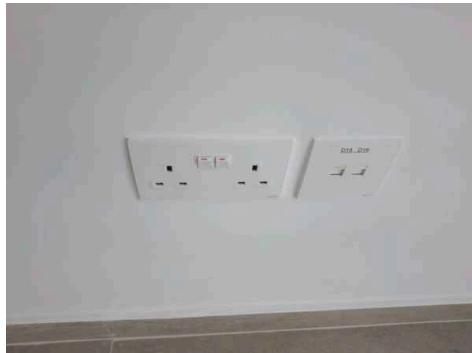
## 14.6.2 Lighting Fixtures, Switches &amp; Receptacles

**CLEANING REQUIRED SOCKET SWITCHES**

Sockets and switches are dirty or stained; proper cleaning to be carried out to restore neat appearance and safe operation.

Repair Needed

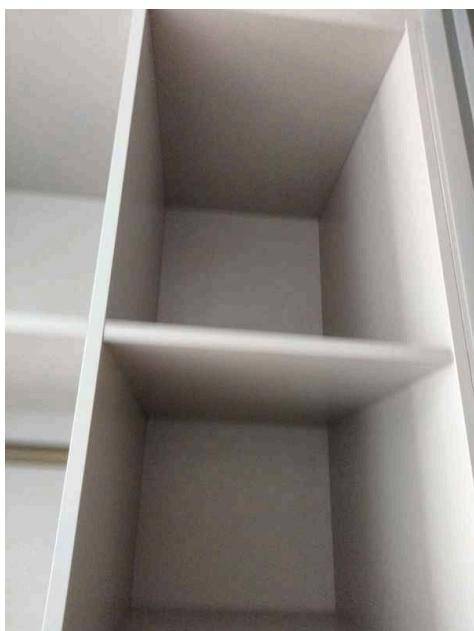
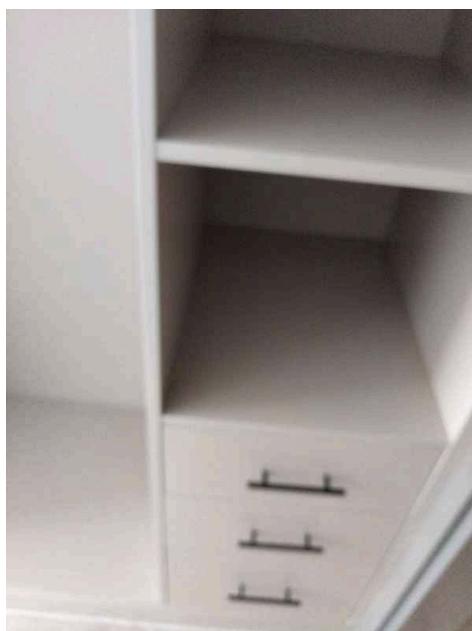
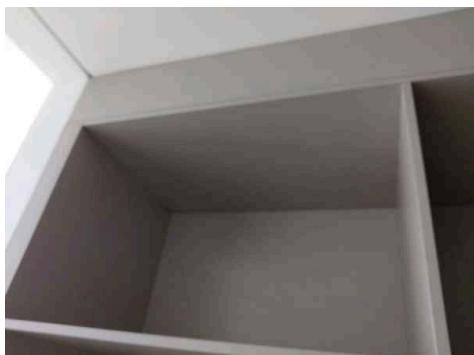
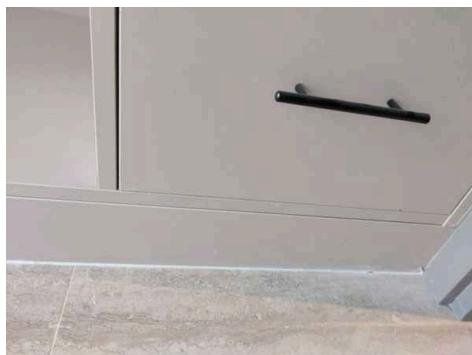
## 14.7.1 Cabinets

**CLEANING REQUIRED**

Cabinet surfaces are dirty or stained; thorough cleaning to be carried out to achieve acceptable finish and appearance.

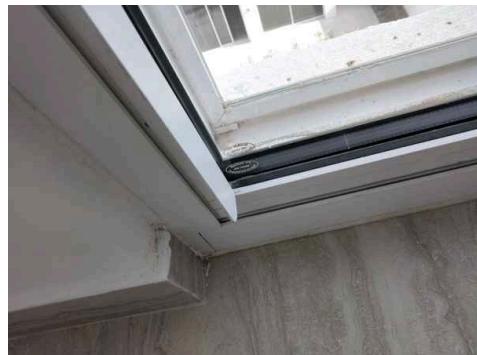
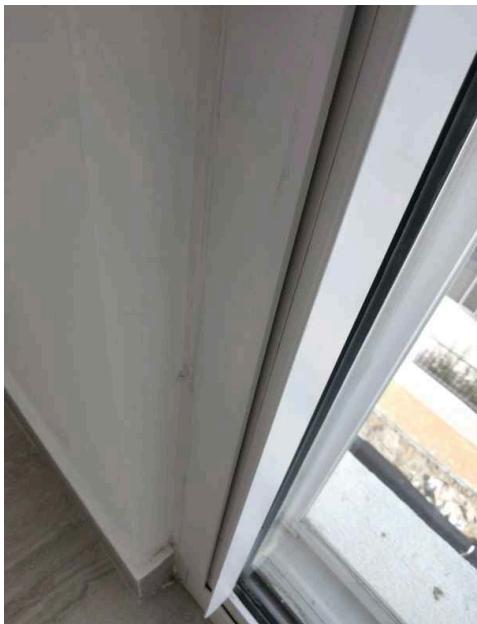
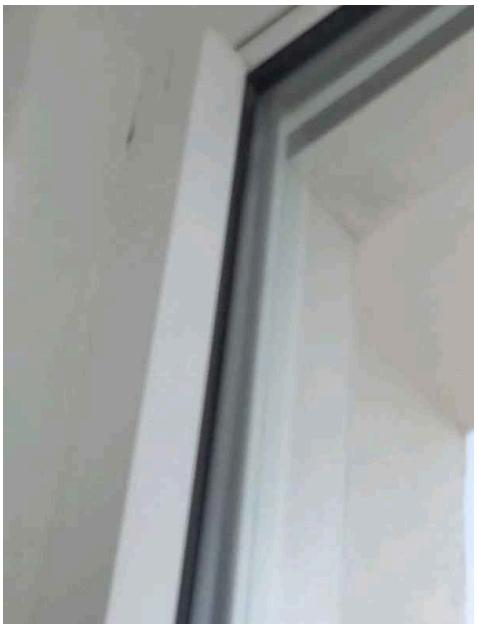
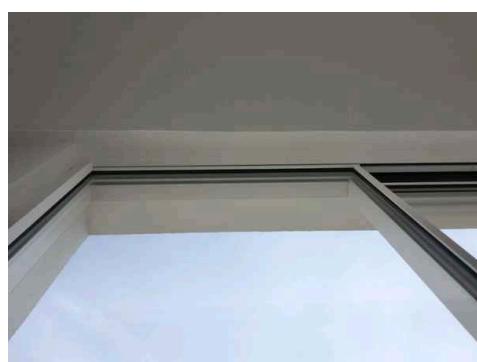
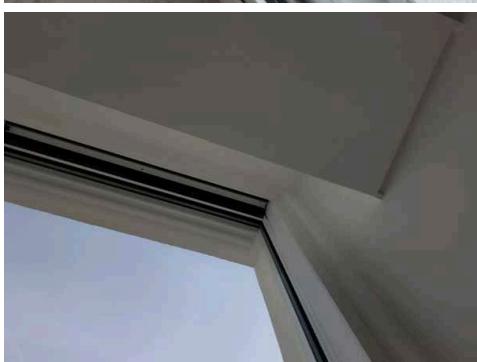
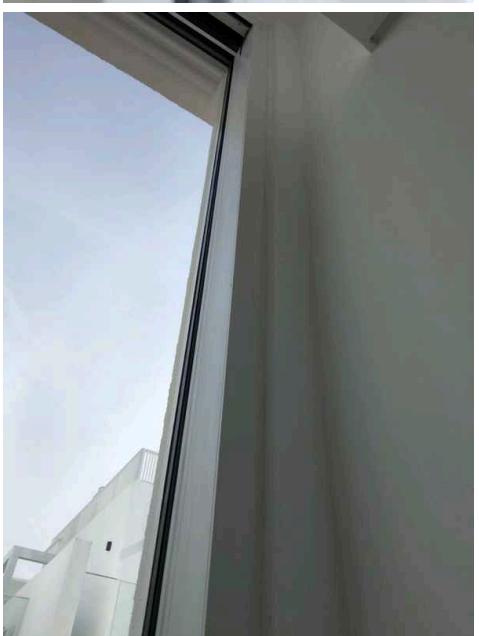
## 14.8.1 Window

**RUBBER SEALANT ISSUE**

Window rubber sealant is damaged and improperly applied. Causes air and heat penetration, affecting performance. Requires replacement or proper sealing.

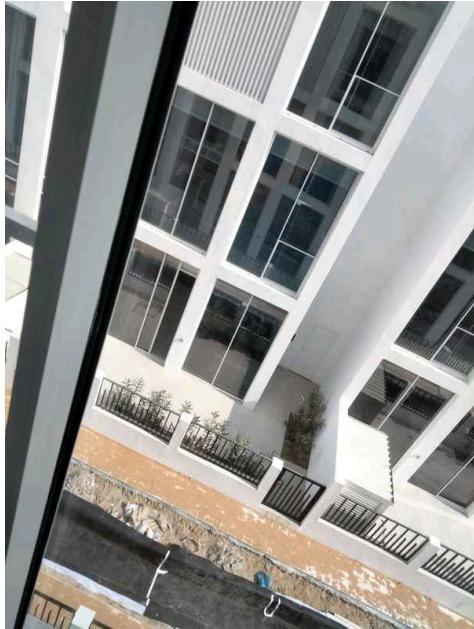
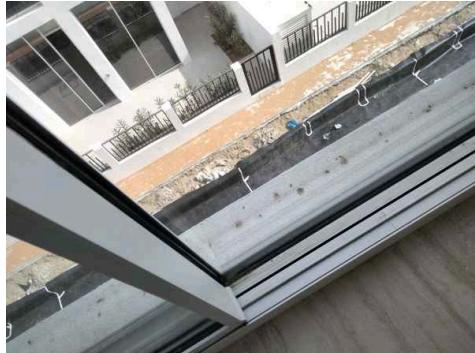
## 14.8.2 Window

**GLASS SCRATCHES ISSUE**

Window glass shows visible scratches affecting appearance. May compromise clarity and finish quality. Requires polishing or glass replacement.

Repair Needed

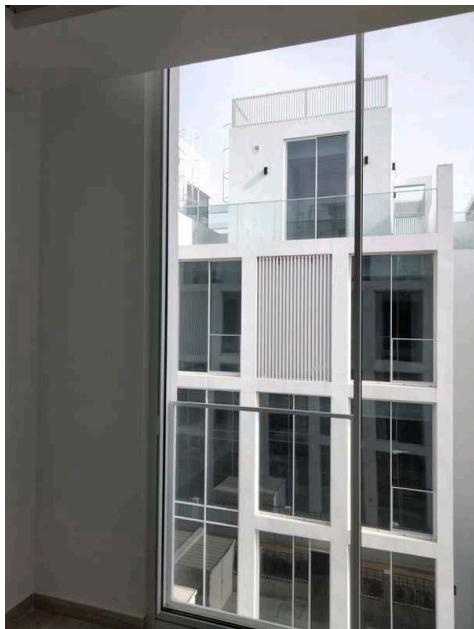
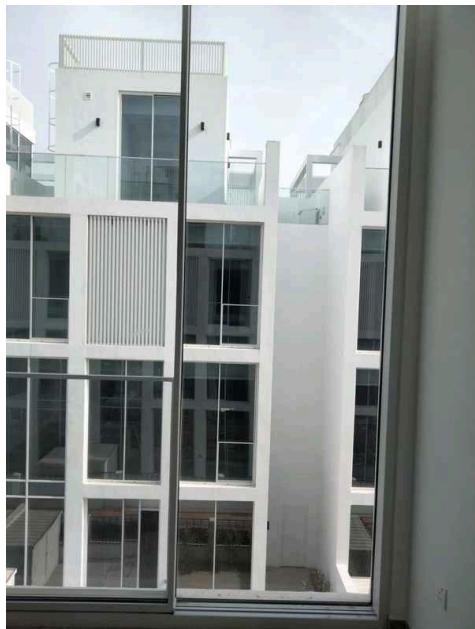
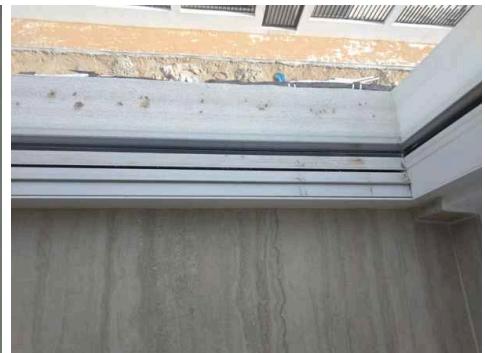
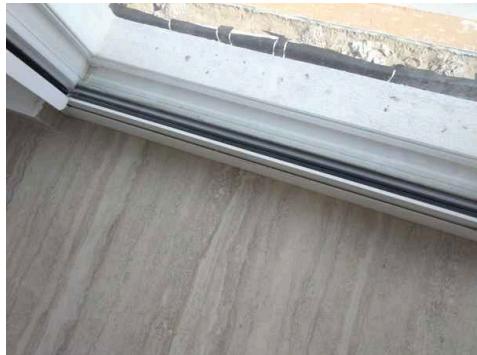
## 14.8.3 Window

**DEEP CLEANING REQUIRED**

Repair Needed

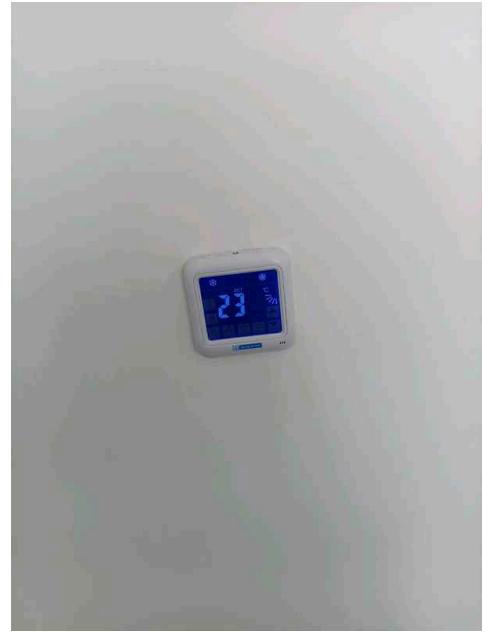
14.9.1 Ac thermostat iss

### **TOUCH SENSOR IS LOOSE**

Thermostat touch sensor is loose; fixing to be secured and functionality to be checked to ensure proper operation.

Repair Needed
