## Sample Property Snagging Report in Dubai – Professional Inspection PDF

This PDF is issued by Dubai Property Snagging, a professional property inspection company in Dubai, providing snagging reports, pre-handover inspections, and defect reports for villas and apartments across the UAE.

Client  
06/02/2026

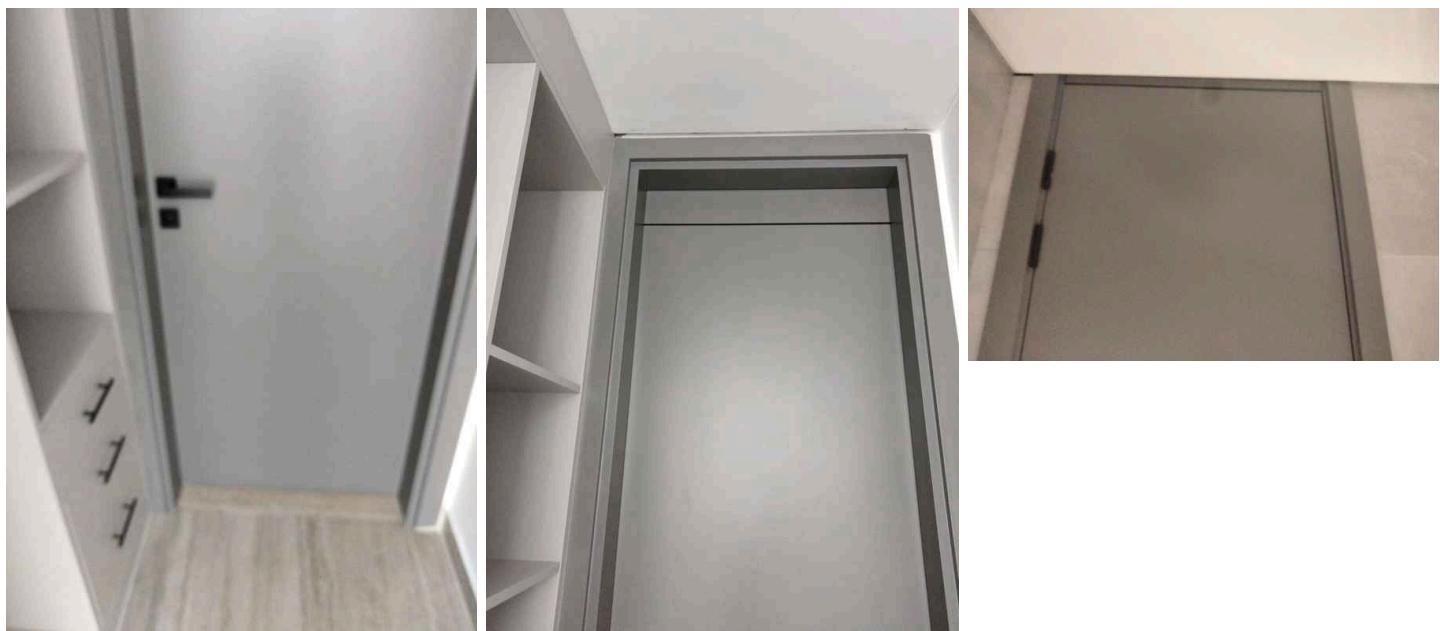
Repair Needed
**PAINT FINISHING ISSUE**

Paint finishing is unsatisfactory at the affected area. Carry out surface preparation and apply final paint coats to achieve uniform color and proper finish.

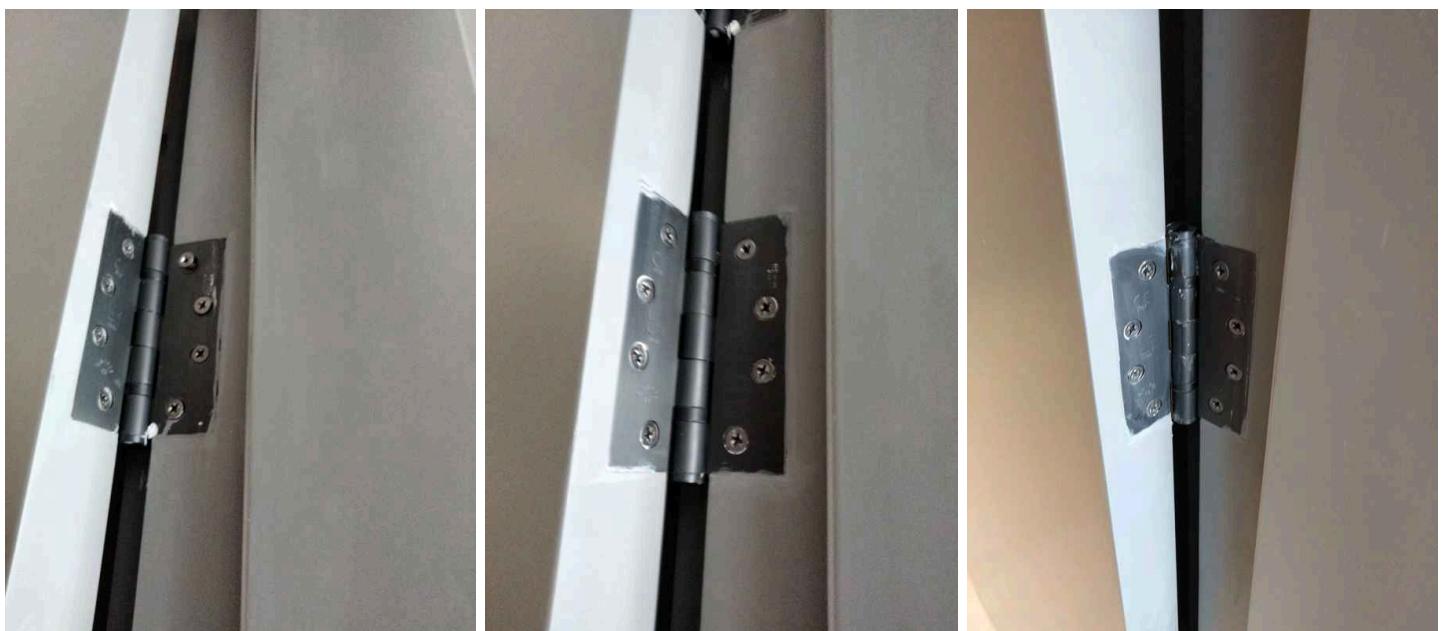
## 15.2.2 Door

Door hinges issues. Excessive lubrication is present, leading to visible stains and attracting dust. Adjustment and proper cleaning are required for smooth and clean operation.

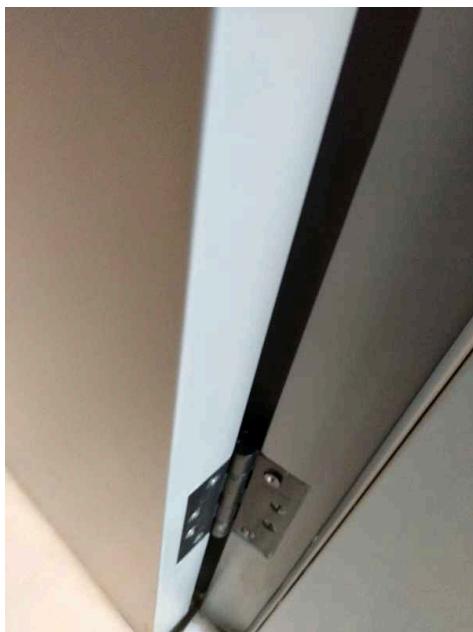
**HINGES AND EXCESS LUBRICATION ISSUE**

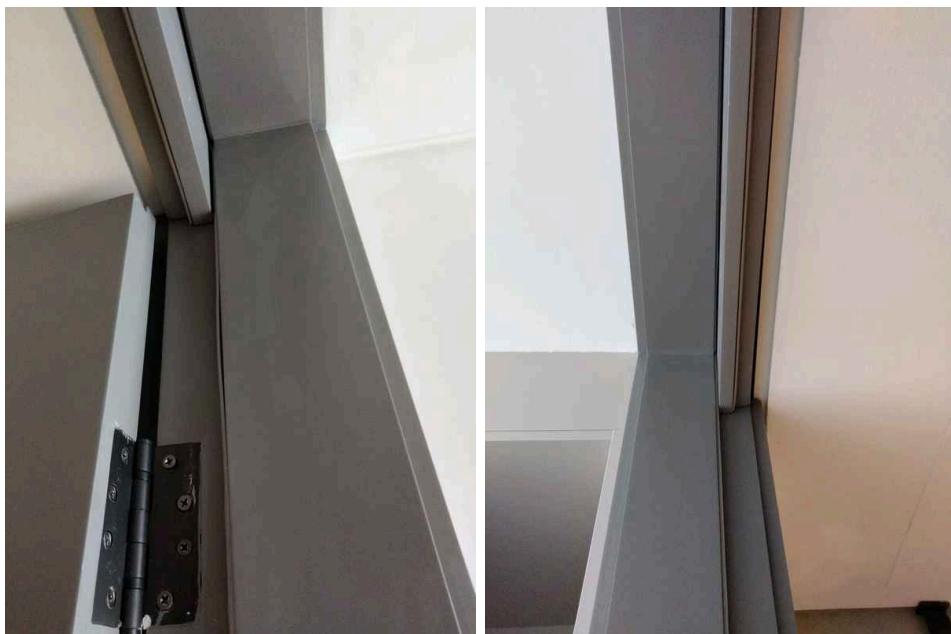
## 15.2.3 Door

**RUBBER SEAL ISSUE**

The rubber seal is improperly installed, compromising its ability to provide an effective seal. This may result in air, water, or dust infiltration.

Replacement or proper adjustment is needed to restore full functionality.

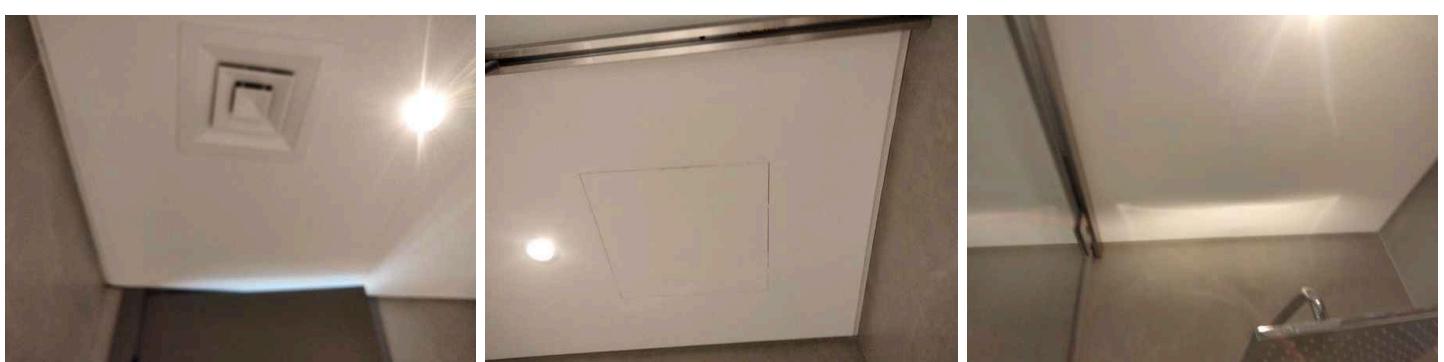
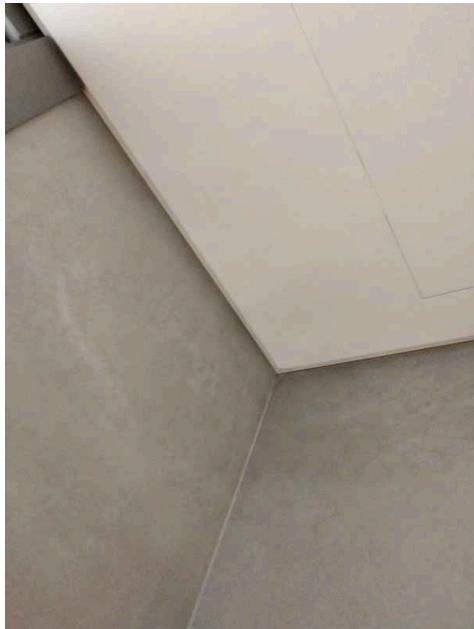
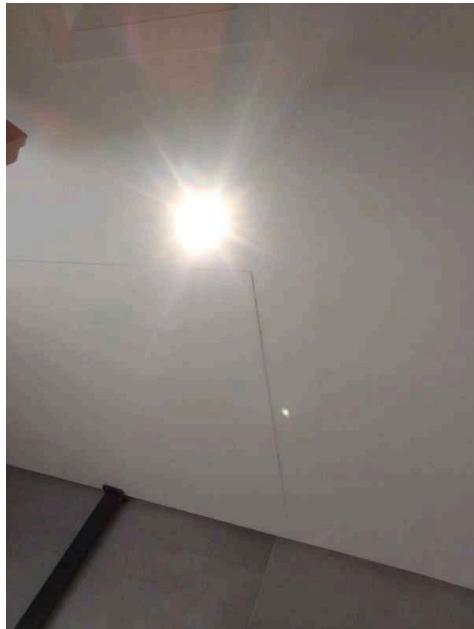
## 15.3.1 Ceiling

**PAINT TOUCH-UP AND FINISHING ISSUE**

The ceiling has visible touch-up marks and uneven paint application, leading to a patchy and inconsistent finish. This can affect the overall aesthetic of the room. Proper surface preparation, touch-up, and even repainting are required for a smooth and uniform ceiling finish.

Repair Needed

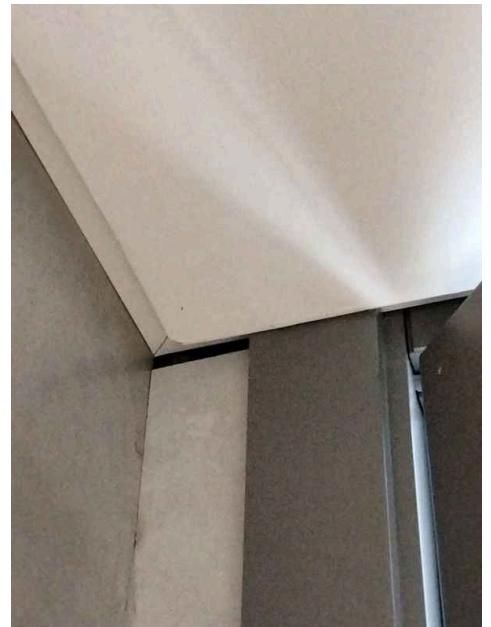
#### 15.4.1 Walls

#### **PAINT TOUCH-UP AND FINISHING ISSUE**

The wall shows visible touch-up spots and uneven paint application, resulting in an inconsistent and patchy appearance. Edges and blending are poorly executed. Proper surface preparation and repainting are required for a seamless finish.

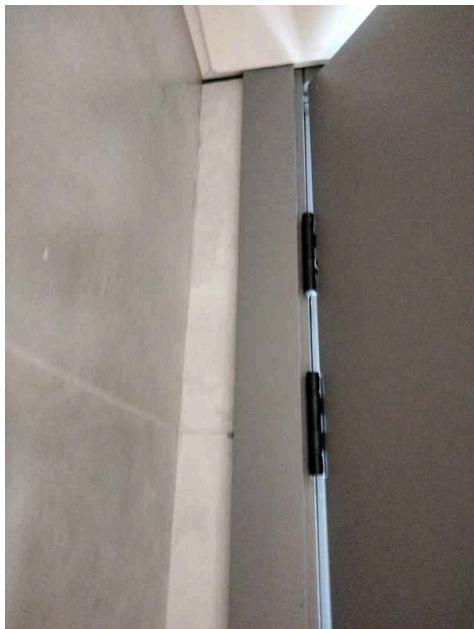
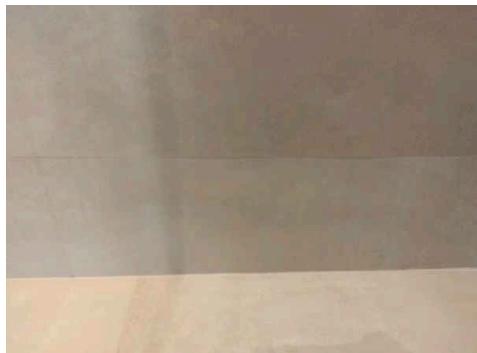
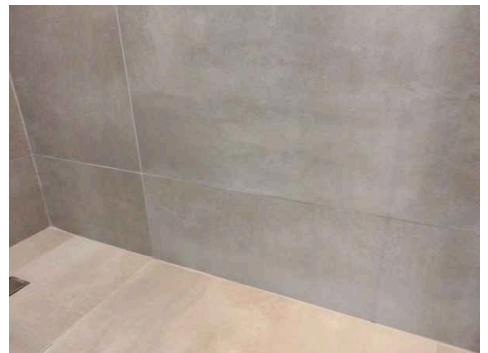
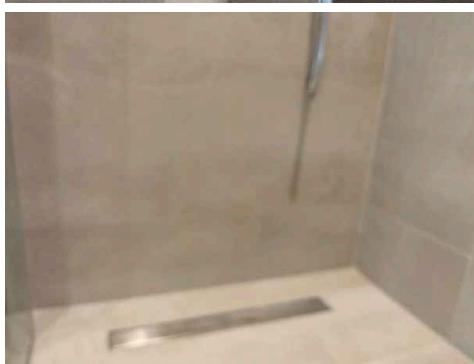
Wall tiles are not uniformly leveled, resulting in height variations that create tripping hazards and a poor visual finish. This is often due to improper installation and wall irregularities. Reinstallation or leveling correction is needed for a smooth and safe surface.

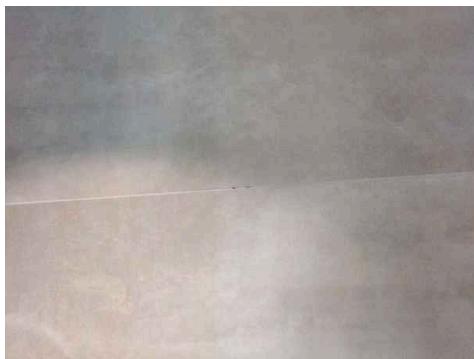
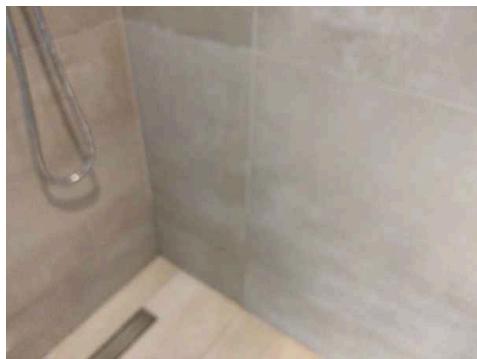
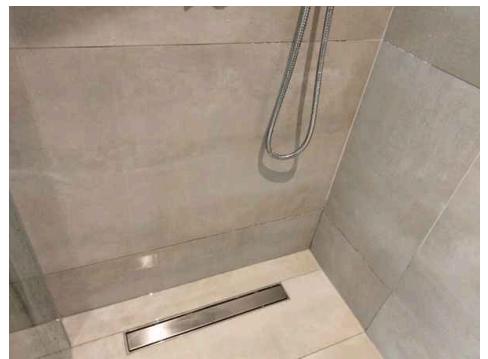
#### 15.4.3 Walls

#### **GROUT MISSING**

wall areas have missing and incomplete grout between tiles. Creates gaps that affect appearance and may cause water ingress. Requires proper grouting to finish the surface.

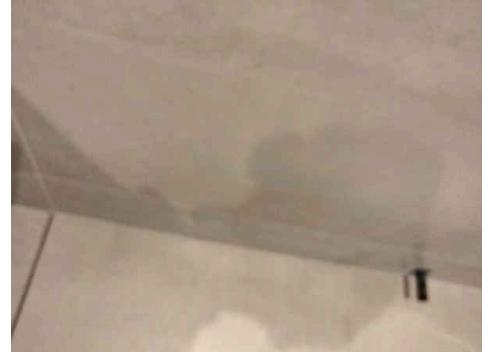
#### 15.4.4 Walls

#### **STAIN ISSUES**

Stains observed on surfaces; affected areas to be properly cleaned or treated to restore acceptable appearance.

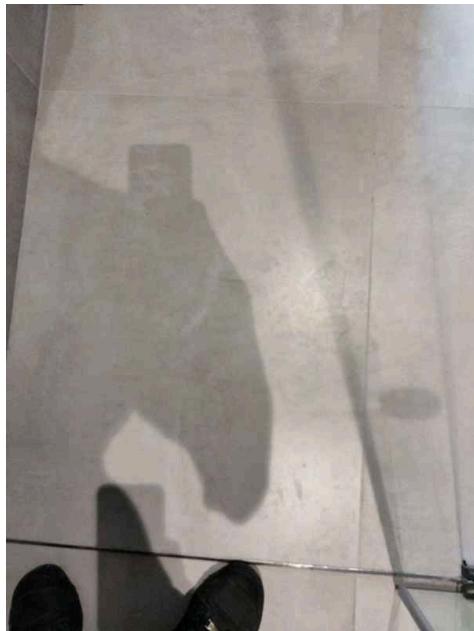
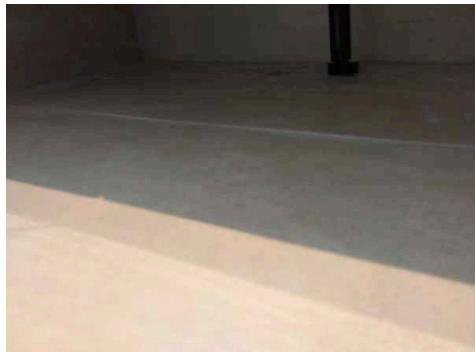
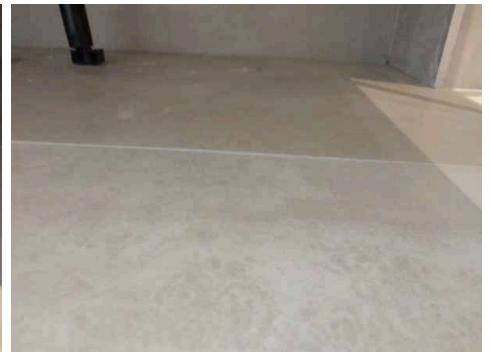
#### 15.5.1 Floor

#### **STAINING ISSUE**

Floor shows visible stains affecting appearance and finish. Caused by spills, construction residue and improper cleaning. Requires proper cleaning or treatment to restore uniform look.

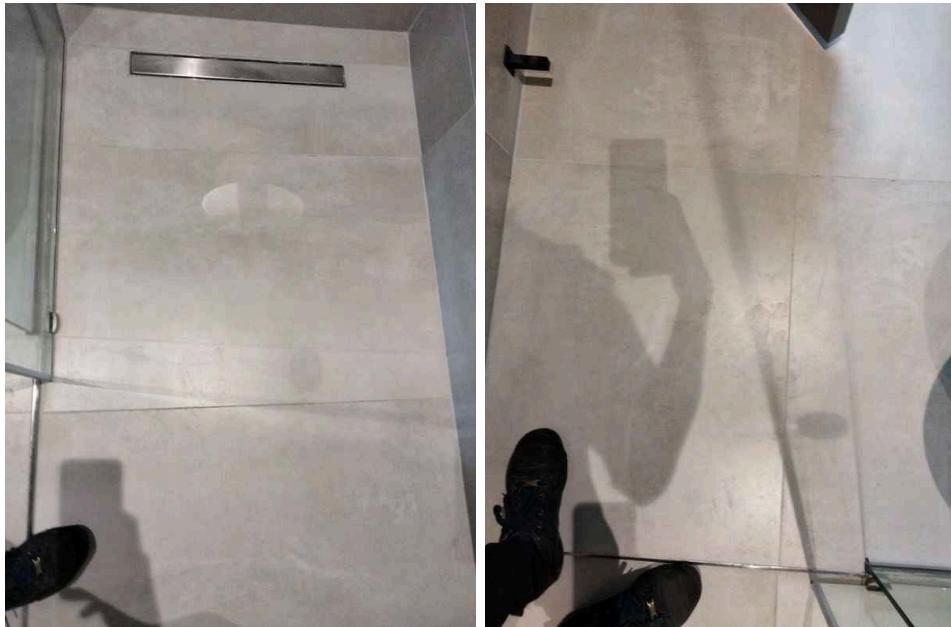
#### 15.5.2 Floor

#### **GROUTING COLOR VARIATION**

Grout color is inconsistent across the floor, affecting uniformity and appearance. Indicates poor workmanship and improper material mixing. Requires cleaning, correction, or re-grouting for a consistent finish.

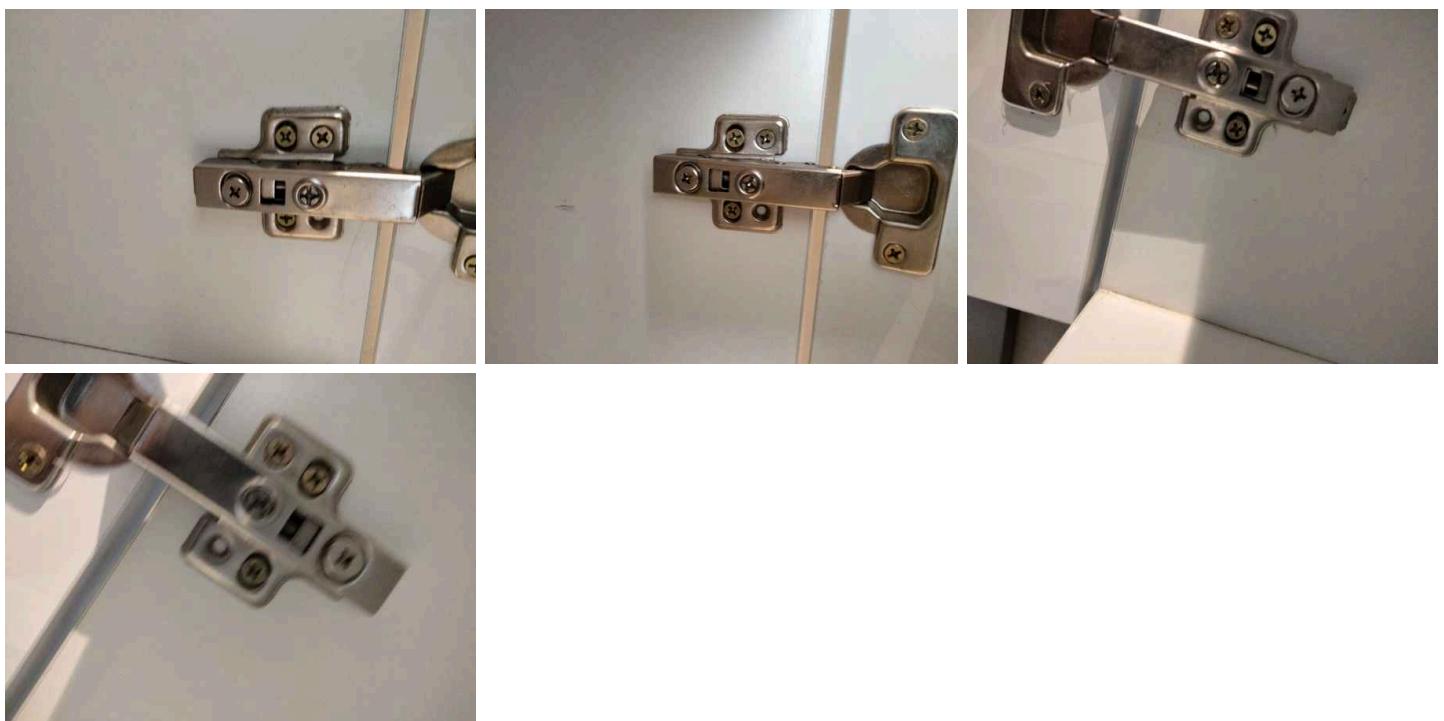
Cabinet hinges have missing screws, causing instability and poor functionality. Affects durability and safe operation. Requires proper replacement and tightening of screws.

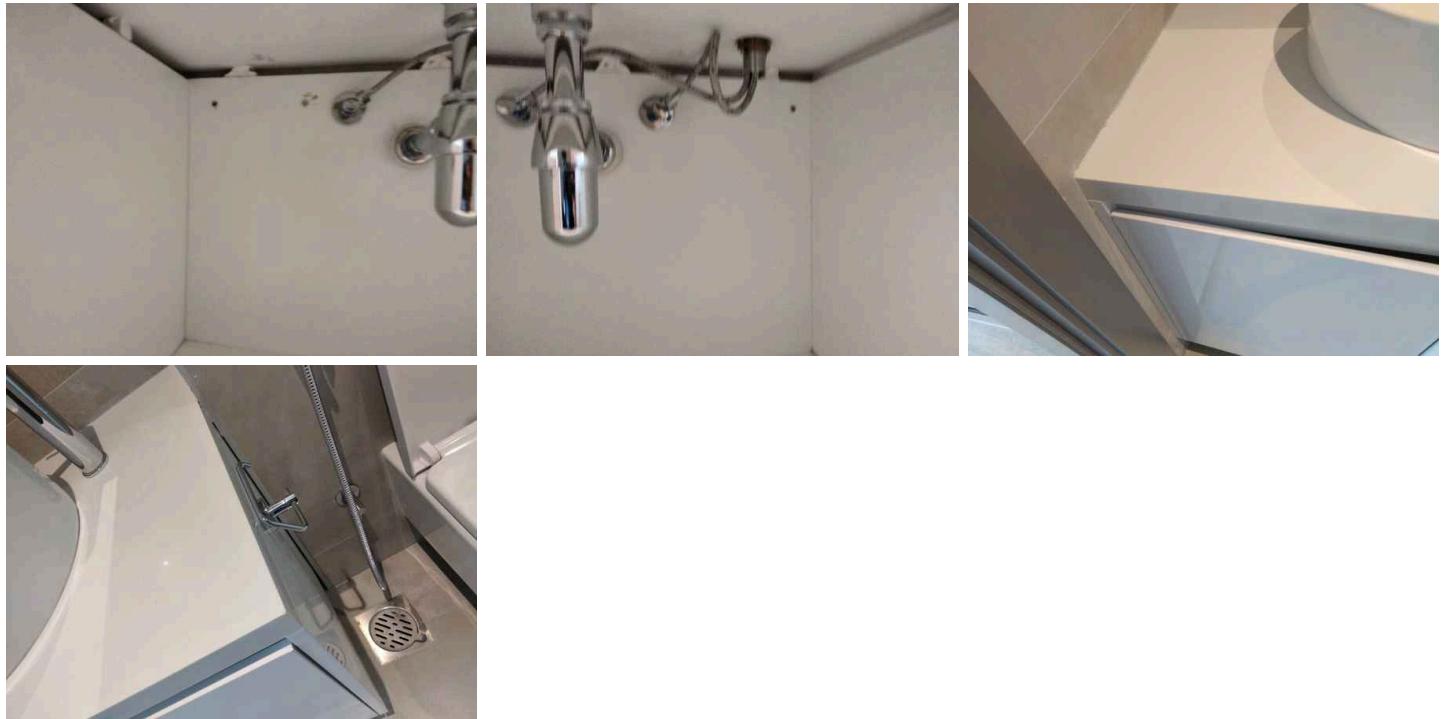
## 15.7.2 Cabinets

Cabinet shows cleaning and finishing defects; thorough cleaning and finishing rectification to be carried out to achieve acceptable workmanship.

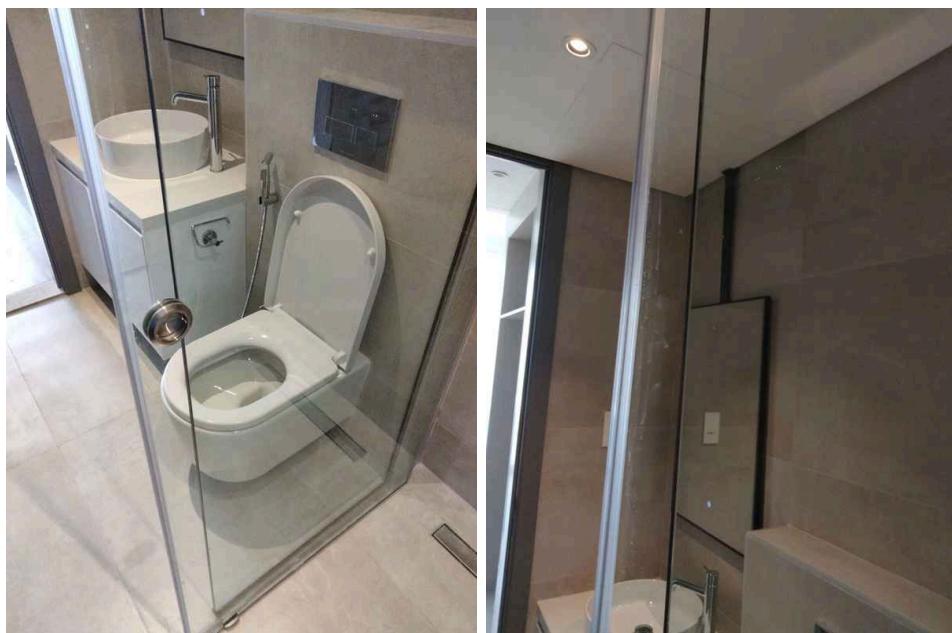
## 15.13.1 Glass Separation

Excessive gaps observed at glass separation joints; alignment and sealing to be corrected to ensure safety and proper finish.

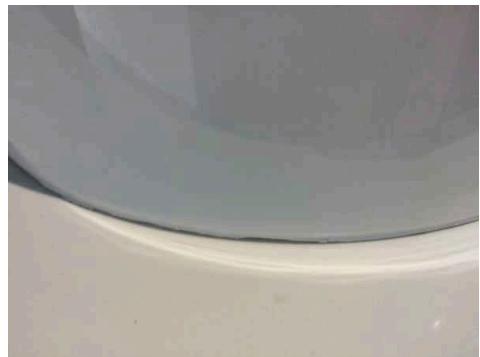
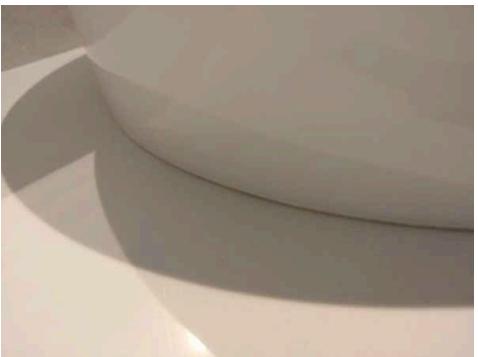
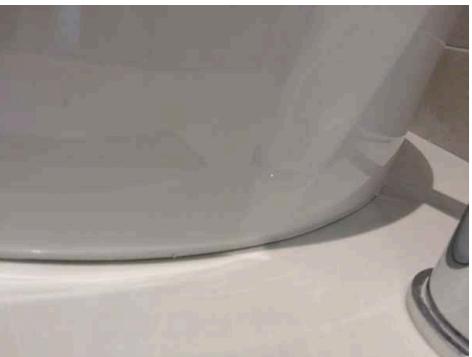
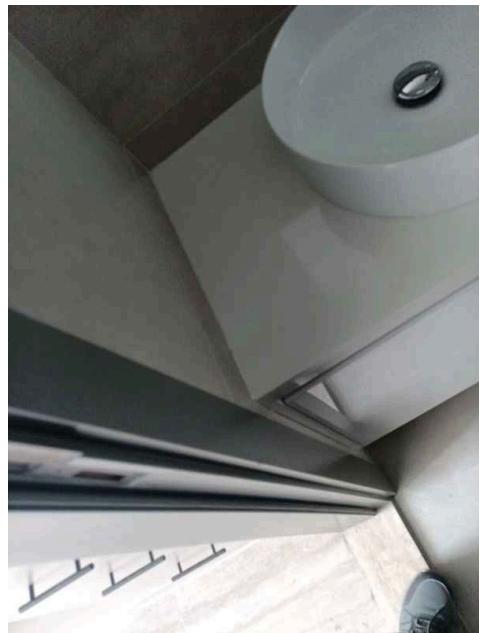
Vanity surfaces show uneven finishing, rough edges and visible defects. Affects appearance and quality. Requires proper sanding, filling, and finishing.

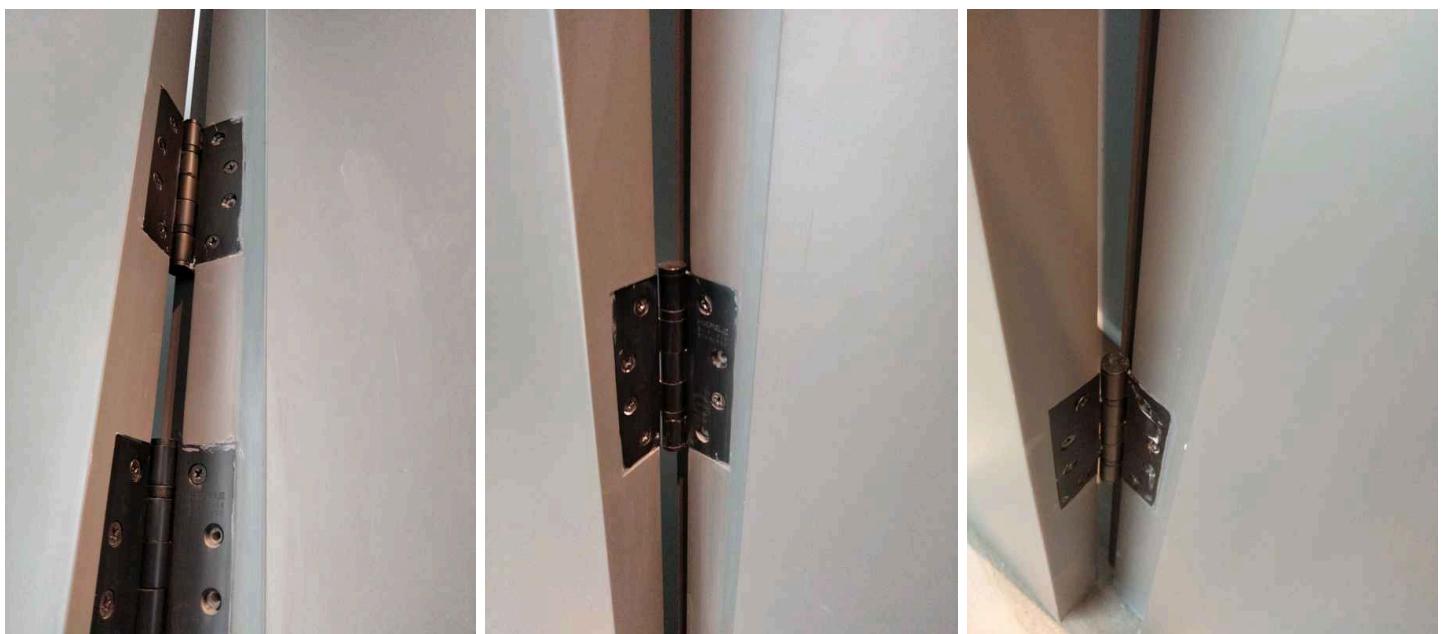
#### 16.2.2 Door

Door hinges issues. Excessive lubrication is present, leading to visible stains and attracting dust. Adjustment and proper cleaning are required for smooth and clean operation.

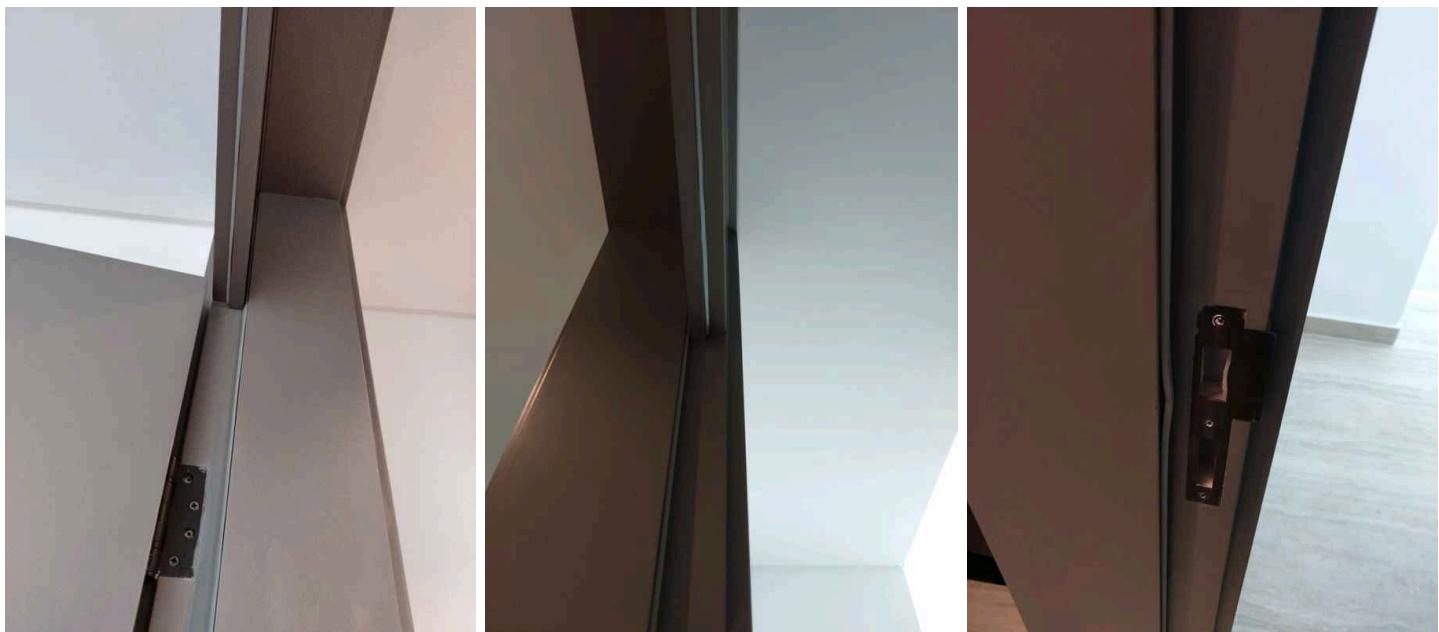
The rubber seal is improperly installed, compromising its ability to provide an effective seal. This may result in air, water, or dust infiltration.

Replacement or proper adjustment is needed to restore full functionality.

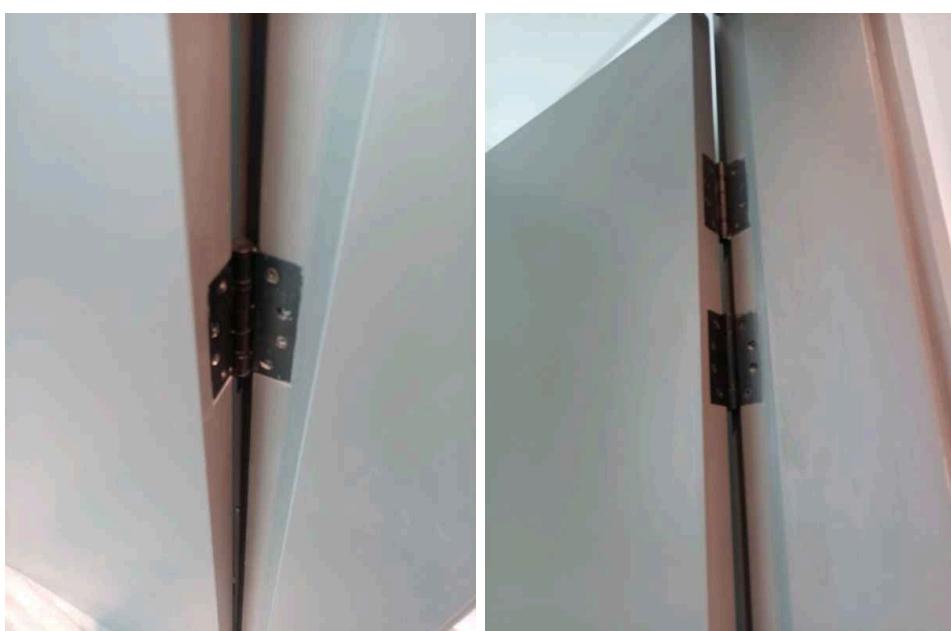
## 16.2.4 Door

Screws are missing from the door hinges, which reduces stability and may cause the door to sag and become difficult to operate. If left unattended, this could lead to further hinge damage or compromise safety. Replacement and secure tightening of all hinge screws are required to ensure proper functionality.

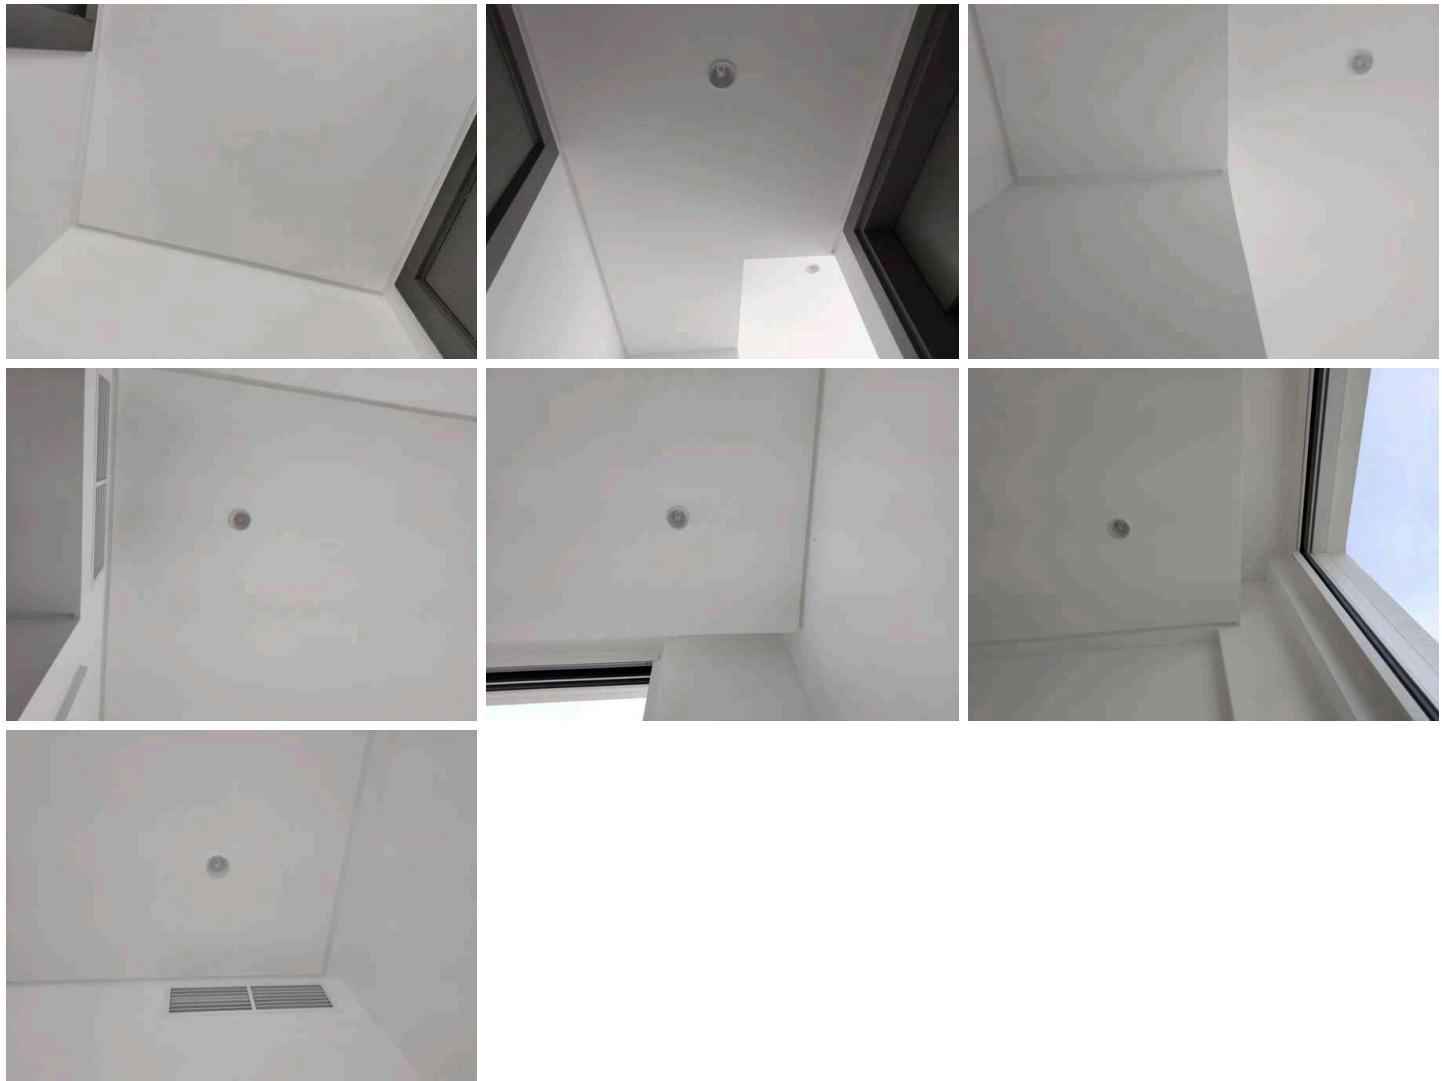
**PAINT TOUCH-UP AND FINISHING ISSUE**

The ceiling has visible touch-up marks and uneven paint application, leading to a patchy and inconsistent finish. This can affect the overall aesthetic of the room. Proper surface preparation, touch-up, and even repainting are required for a smooth and uniform ceiling finish.

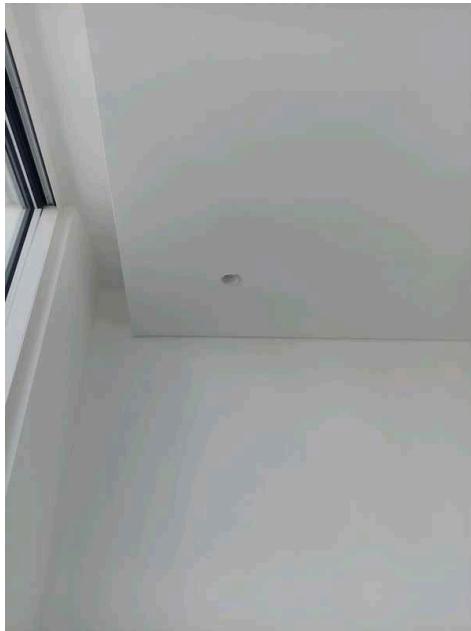
## 16.3.2 Ceiling

**LIGHT LEVEL ISSUE**

Light fixture level is uneven; alignment to be corrected to ensure proper installation and uniform appearance.

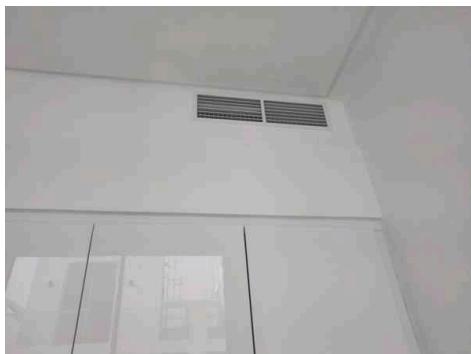
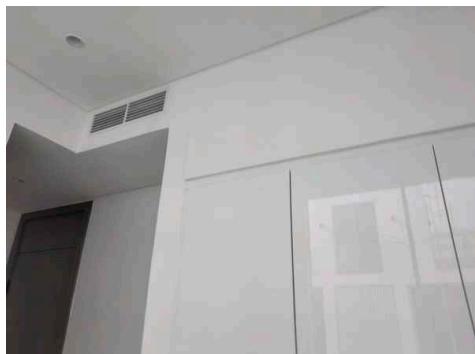
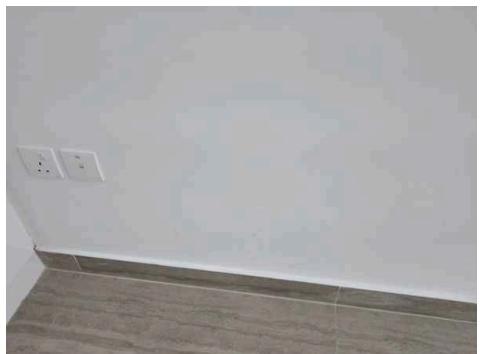
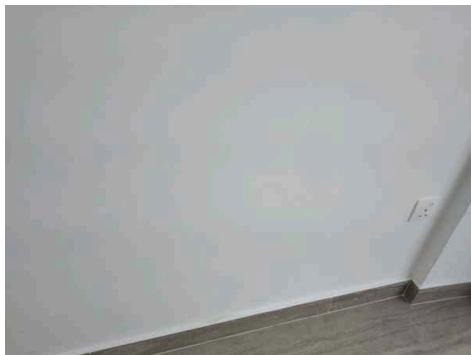
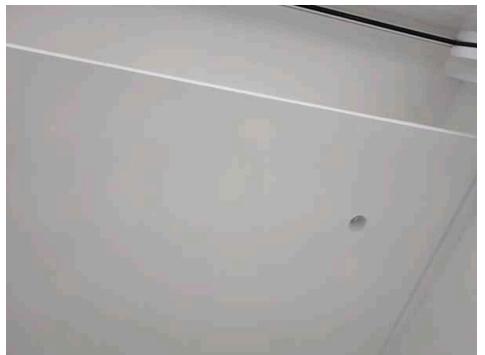
## 16.4.1 Walls

**PAINT TOUCH-UP AND FINISHING ISSUE**

The wall shows visible touch-up spots and uneven paint application, resulting in an inconsistent and patchy appearance. Edges and blending are poorly executed. Proper surface preparation and repainting are required for a seamless finish.

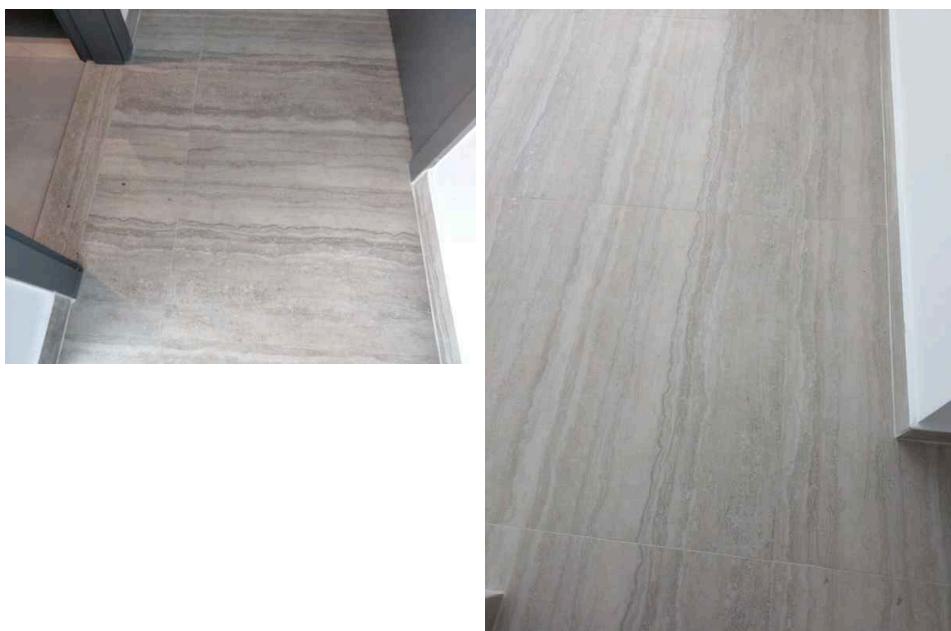
## 16.5.1 Floor

**STAINING ISSUE**

Floor shows visible stains affecting appearance and finish. Caused by spills, construction residue and improper cleaning. Requires proper cleaning or treatment to restore uniform look.

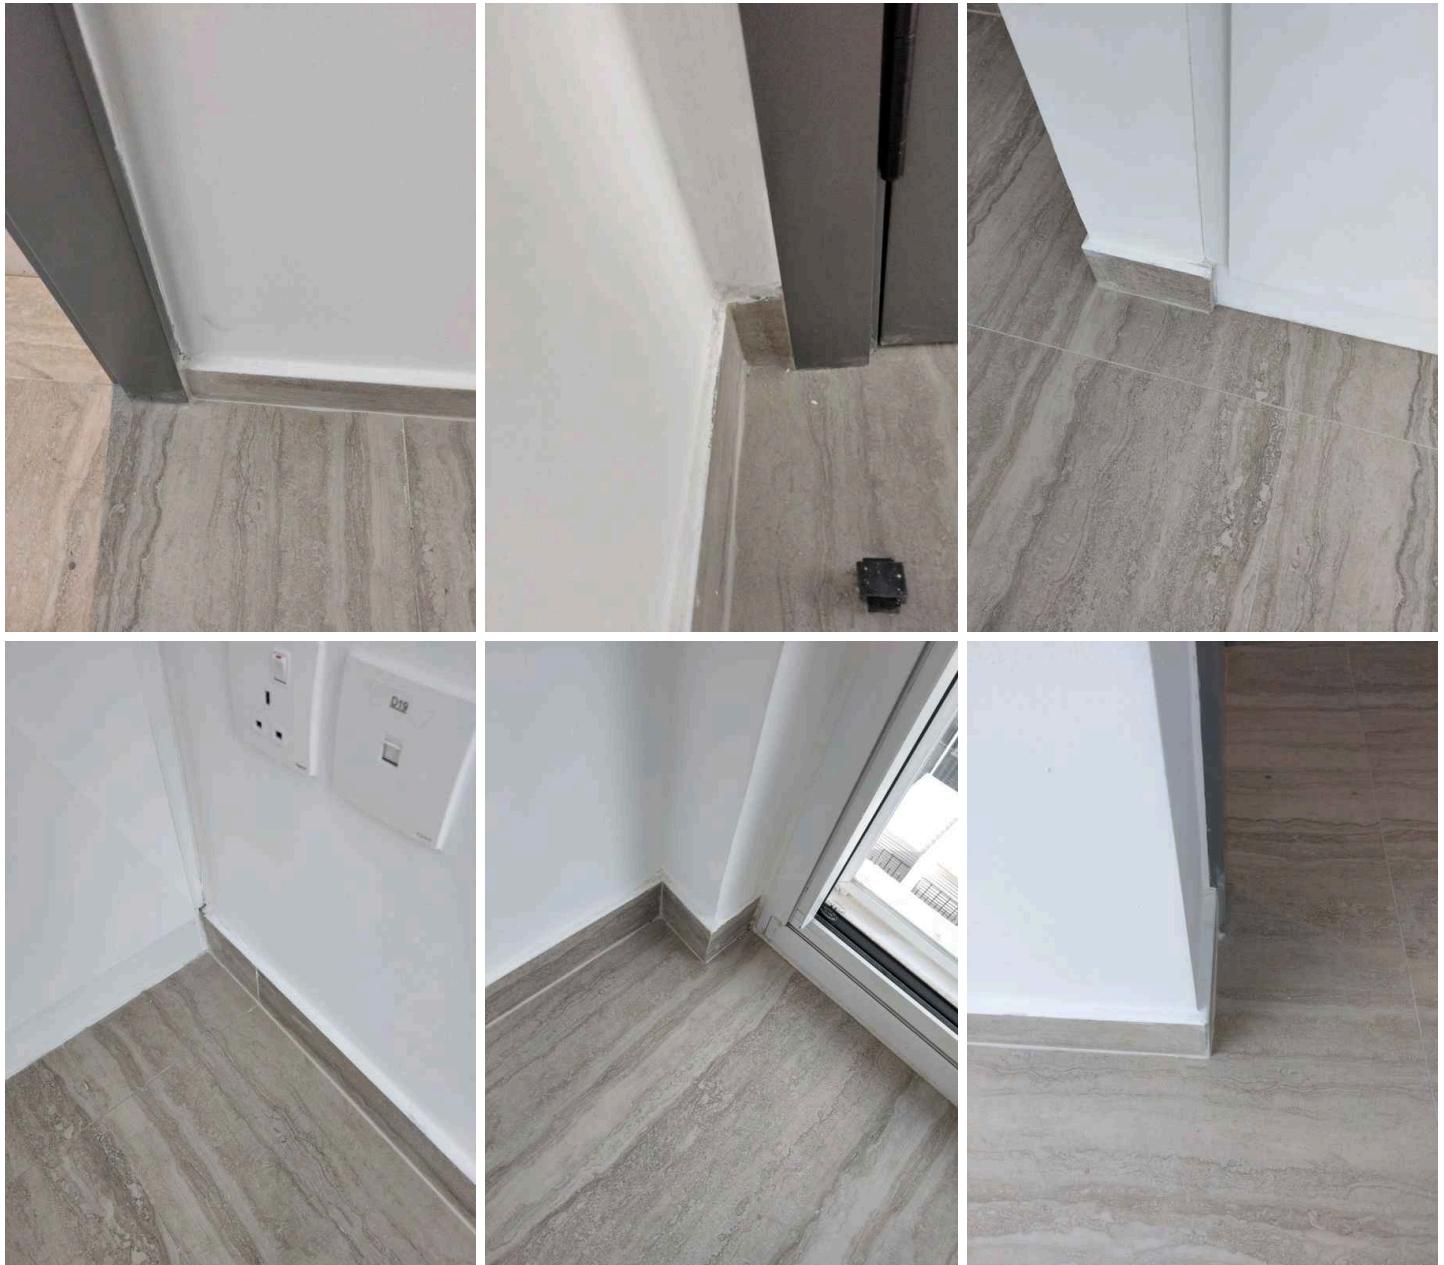
Gaps observed between skirting and wall floor due to poor filling. Affects finish and visual appearance. Requires proper fixing and sealing.

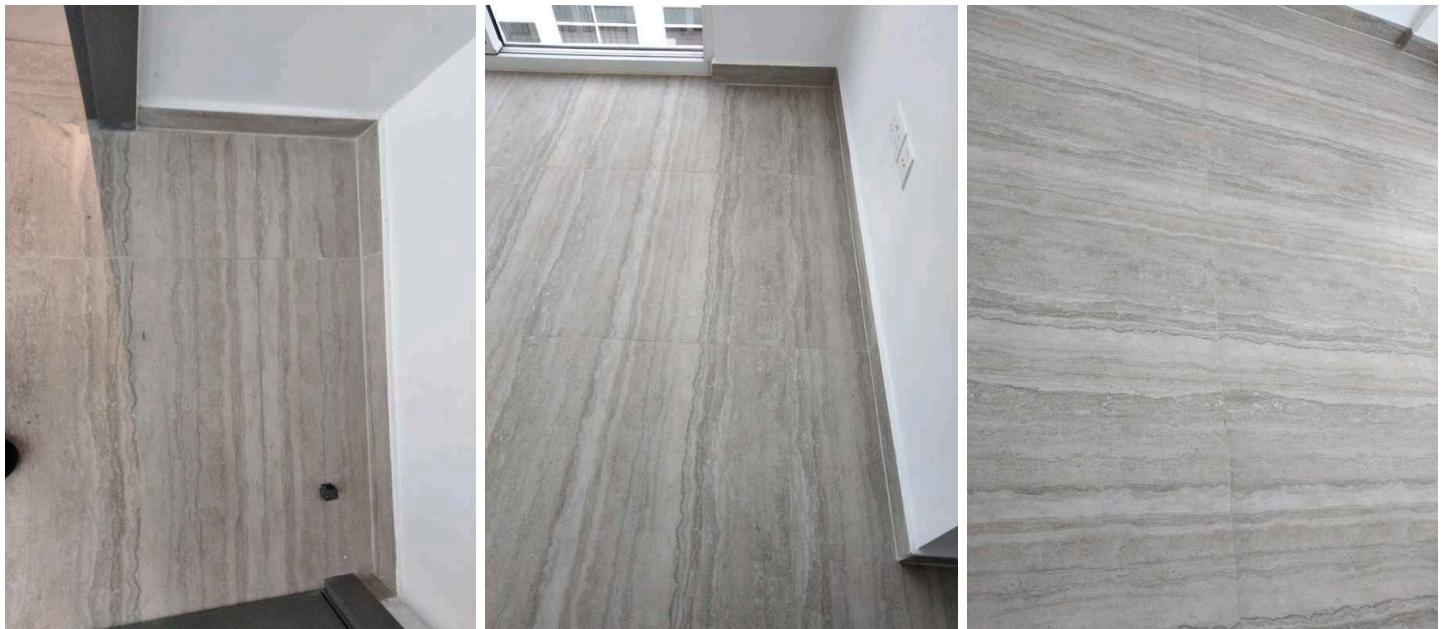
Grout color is inconsistent across the floor, affecting uniformity and appearance. Indicates poor workmanship and improper material mixing. Requires cleaning, correction, or re-grouting for a consistent finish.

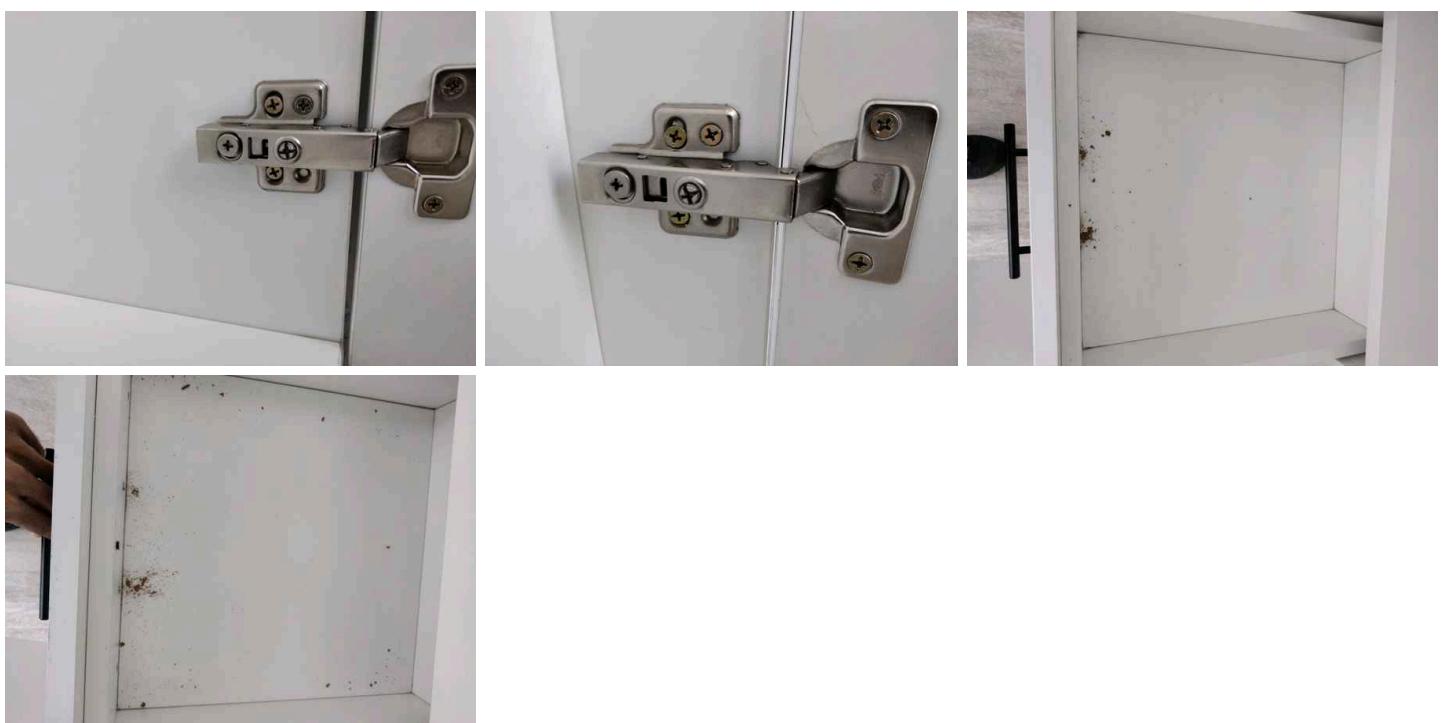
## 16.7.1 Cabinets

Cabinet hinges have missing screws, causing instability and poor functionality. Affects durability and safe operation. Requires proper replacement and tightening of screws.
