## Sample Property Snagging Report in Dubai – Professional Inspection PDF

This PDF is issued by Dubai Property Snagging, a professional property inspection company in Dubai, providing snagging reports, pre-handover inspections, and defect reports for villas and apartments across the UAE.

Client  
06/02/2026

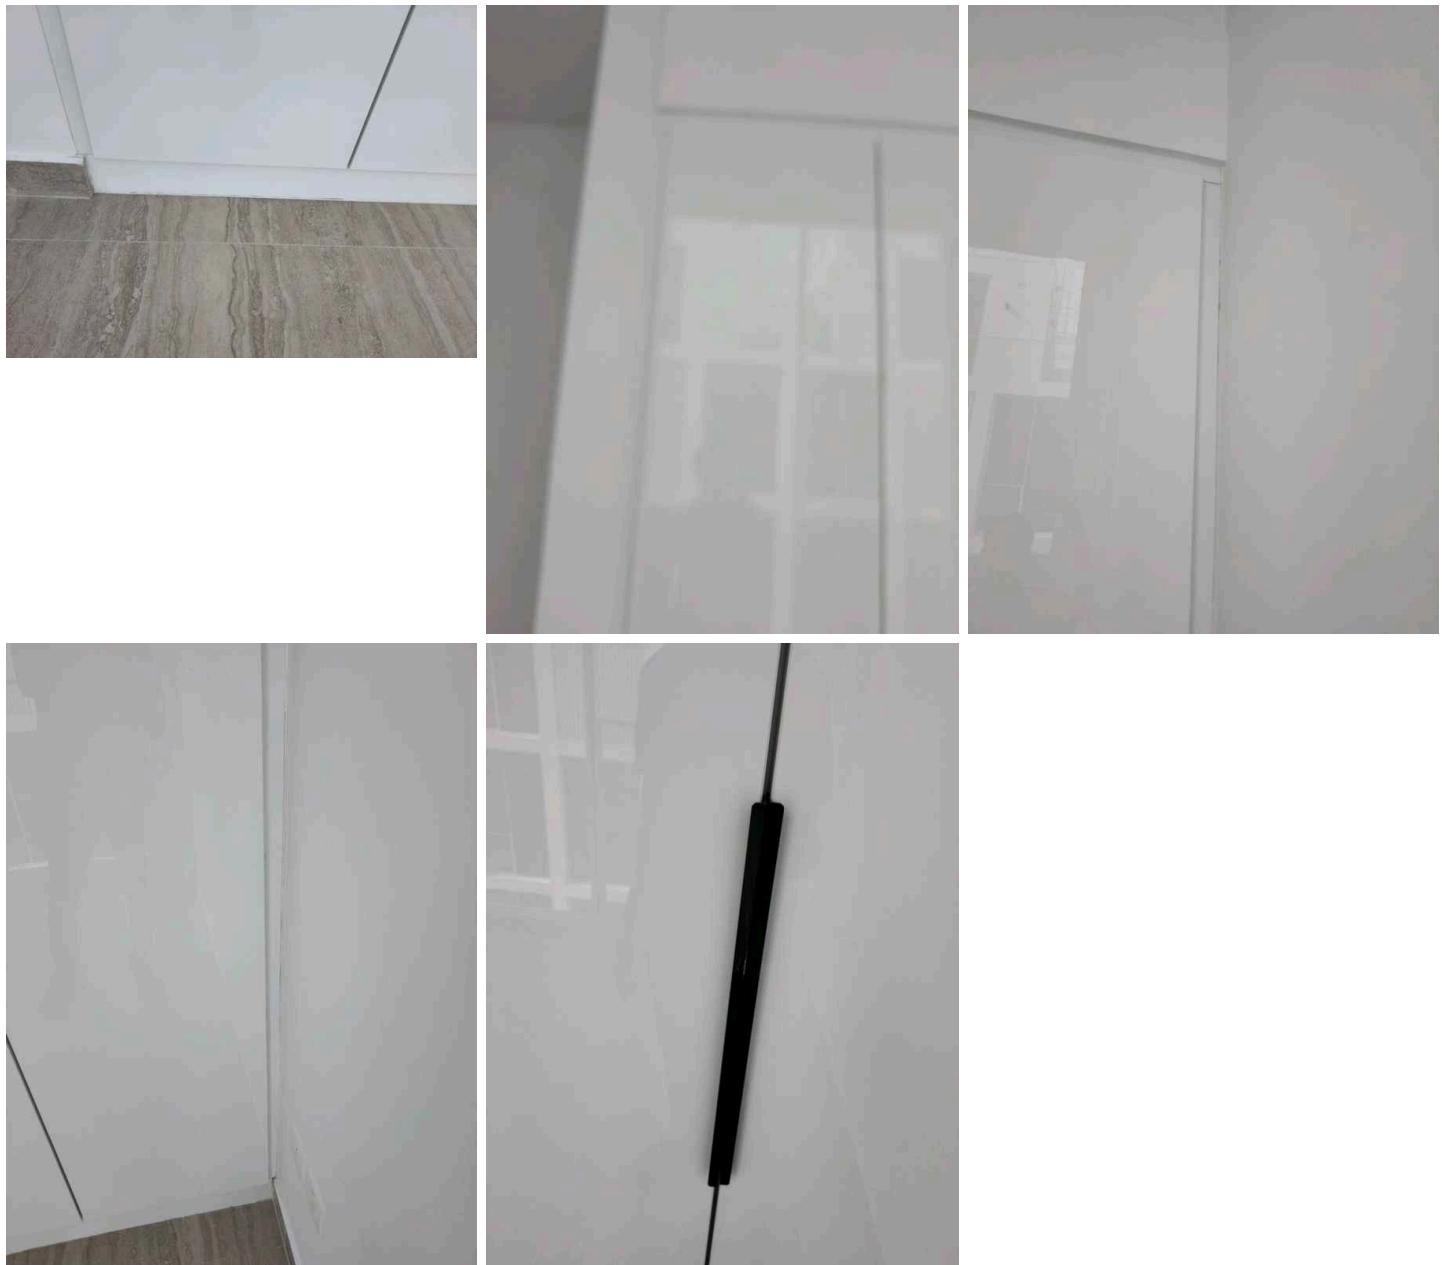
## 16.7.2 Cabinets

Cabinet paint shows uneven coverage, streaks and peeling. Affects appearance and finish quality. Requires sanding and proper repainting.

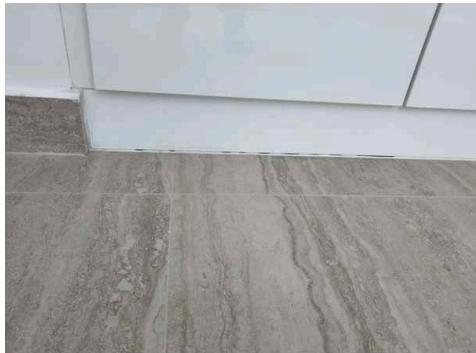
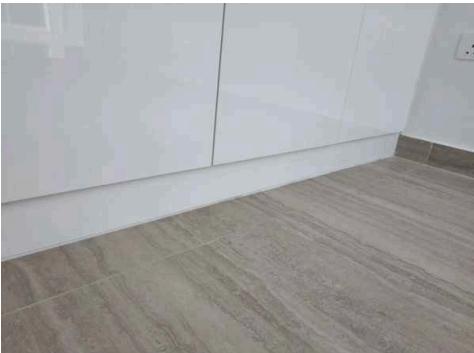
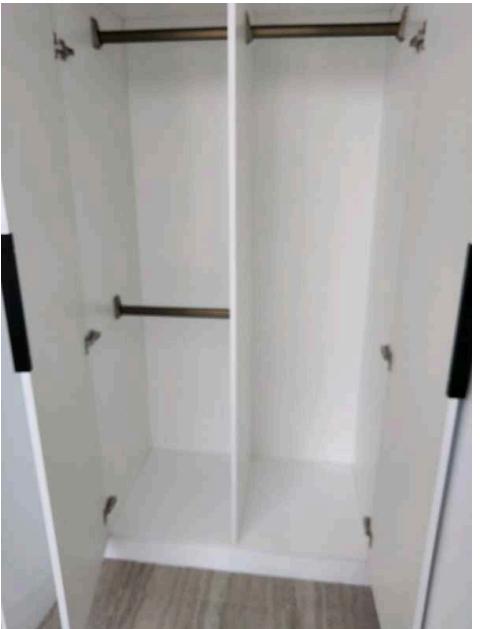
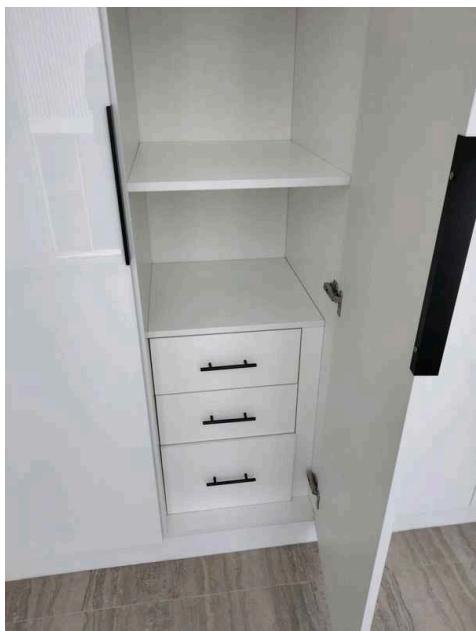
Cabinet requires cleaning and proper silicone finishing; sealing to be applied neatly to achieve a clean and finished appearance.

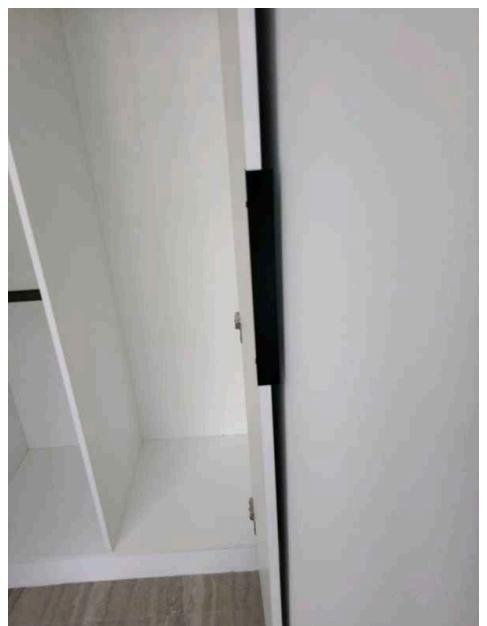
#### 16.7.4 Cabinets

#### **STOPPER MISSING**

Cabinet door stopper is missing; suitable stopper to be supplied and installed to prevent impact damage and ensure controlled operation.

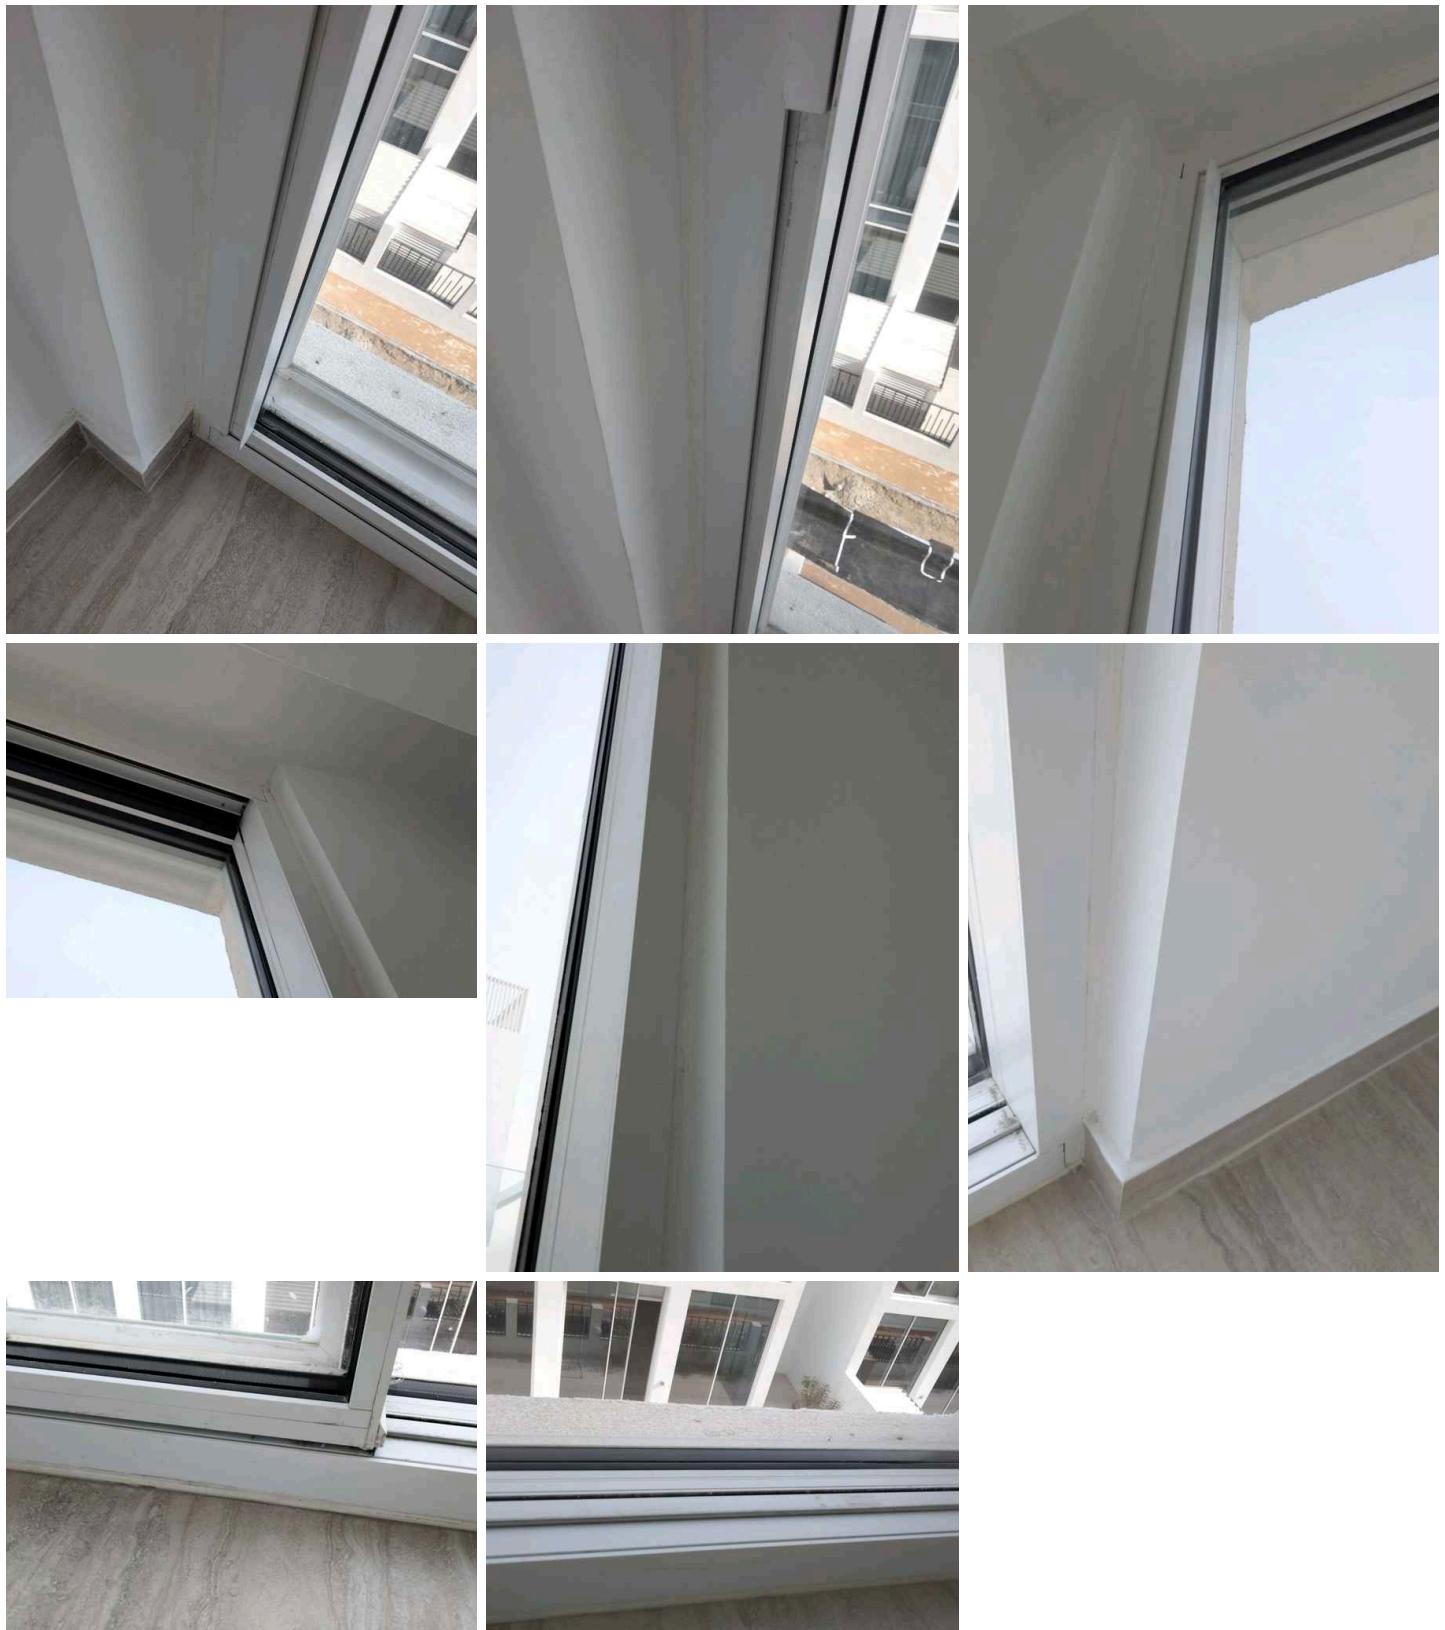
Window rubber sealant is damaged and improperly applied. Causes air and heat penetration, affecting performance. Requires replacement or proper sealing.

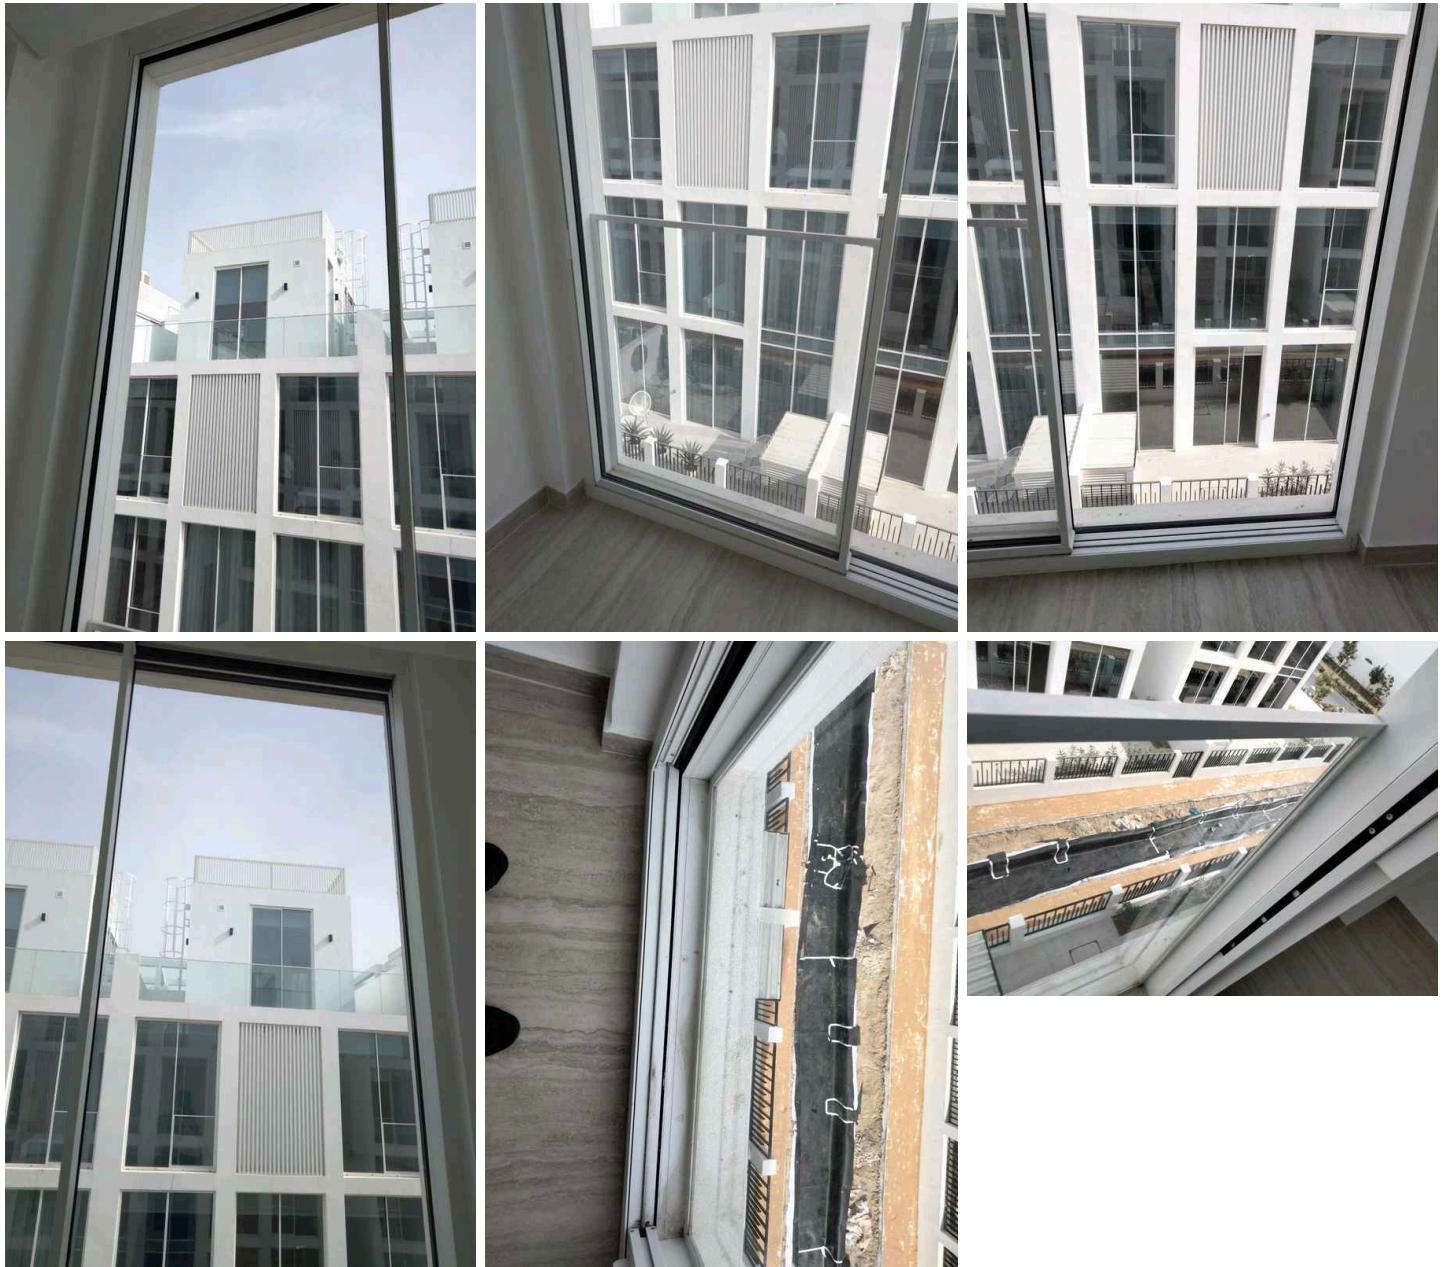
## 16.8.2 Window

Windows have accumulated dirt, dust and construction residue. Affects appearance and clarity. Requires thorough cleaning to restore proper finish.

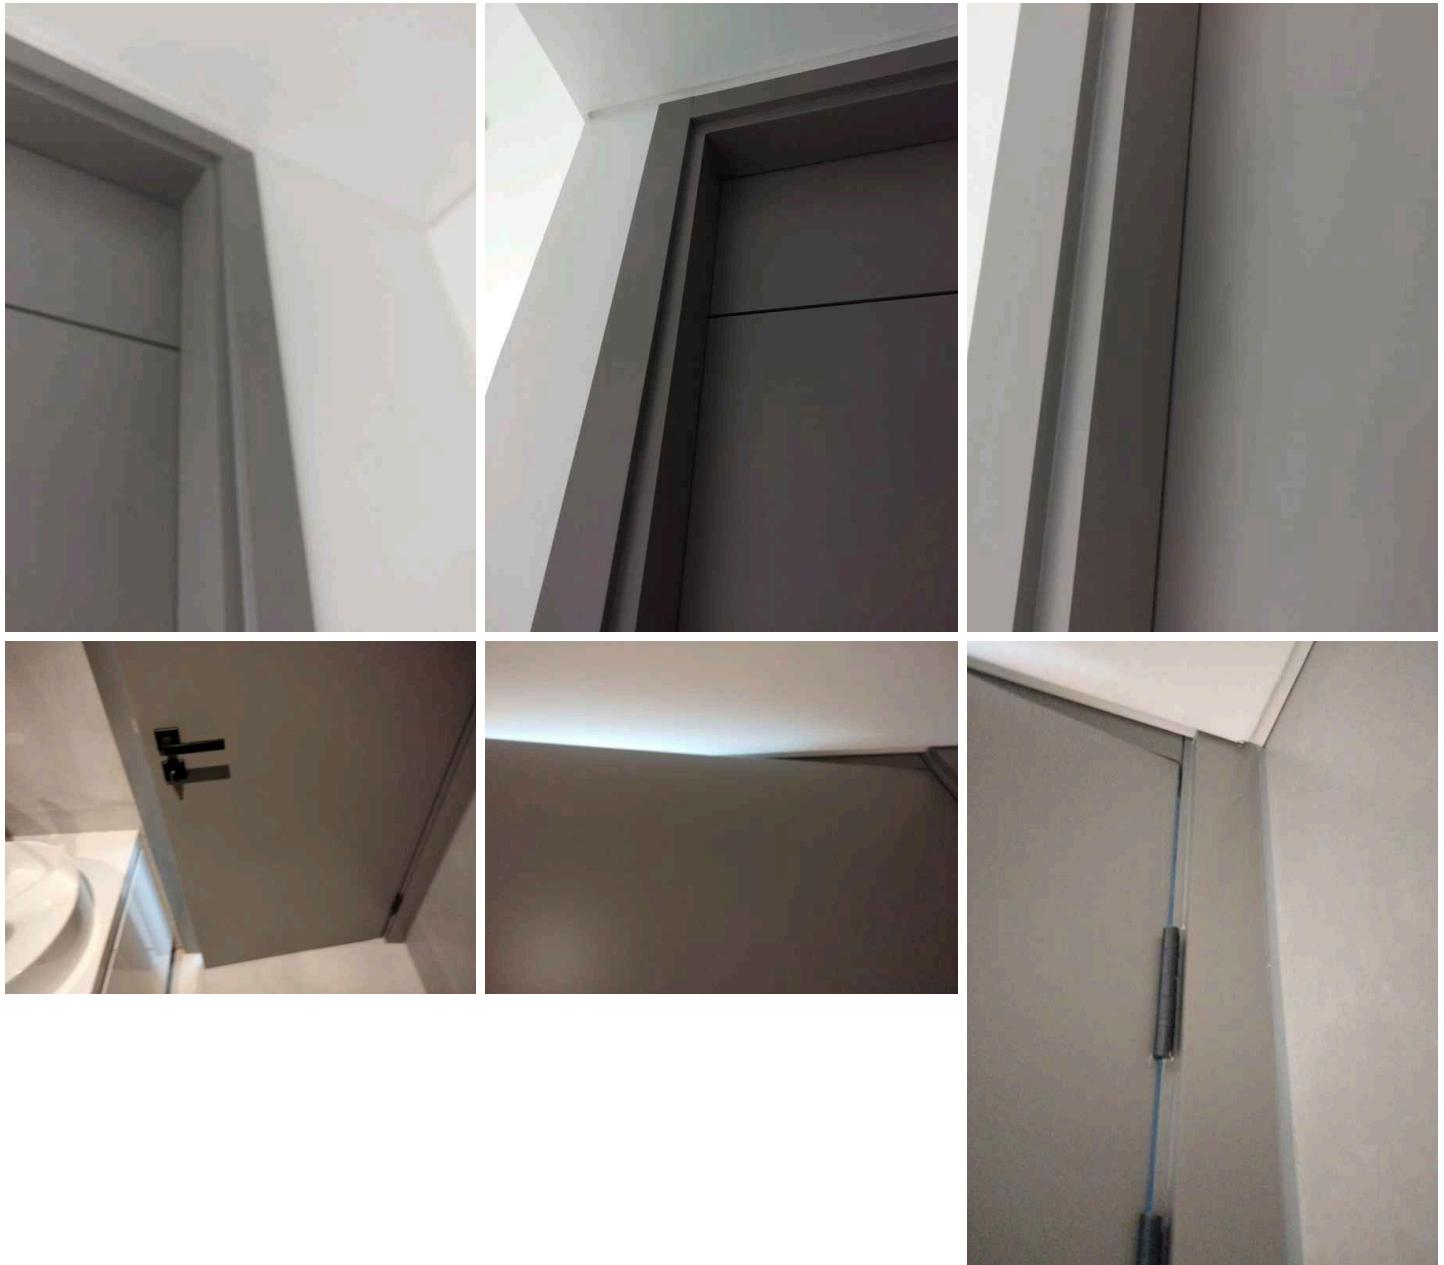
Repair Needed
**PAINT FINISHING ISSUE**

Paint finishing is unsatisfactory at the affected area. Carry out surface preparation and apply final paint coats to achieve uniform color and proper finish.

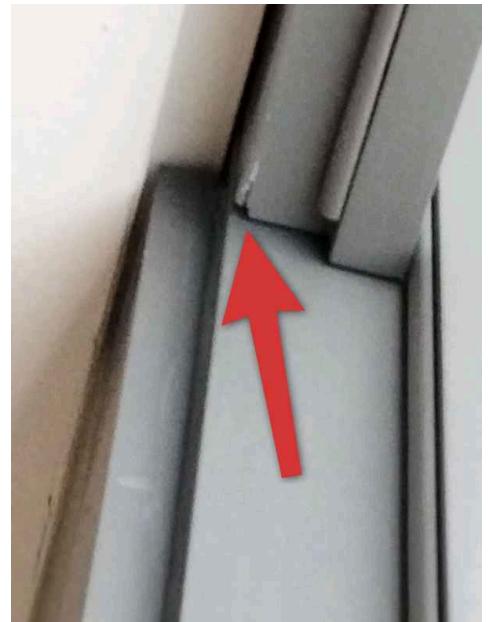
#### 17.2.2 Door **CHIPPING ISSUE**

Chipping observed on the affected surface finish. Repair or replace the damaged area and ensure proper finishing to restore acceptable appearance.

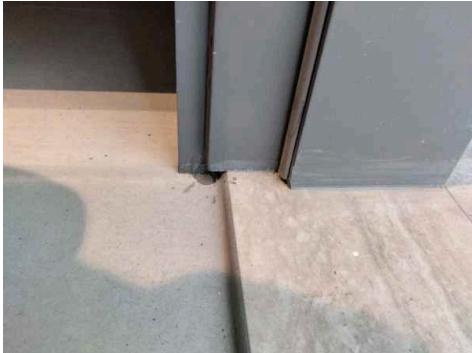
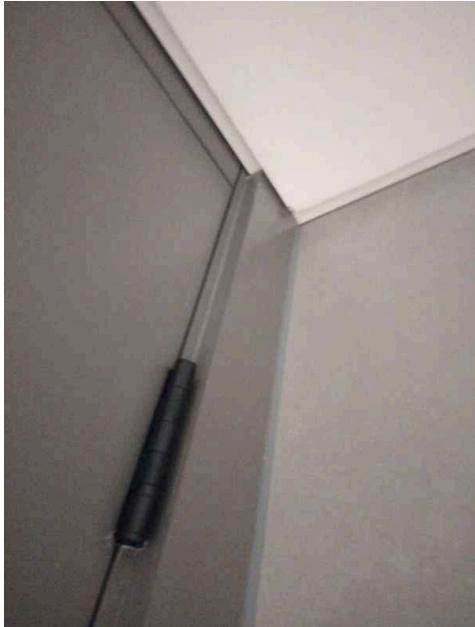
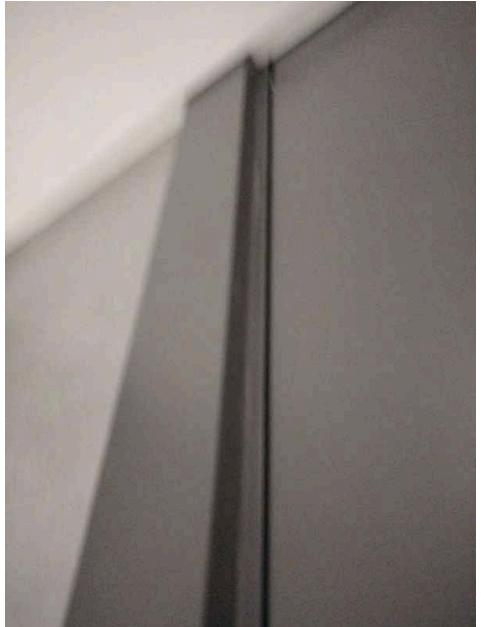
## 17.2.3 Door

**FRAME GAP ISSUE**

There is a visible gap between the frame and adjacent surface, indicating poor installation. This may lead to air and dust infiltration and affects the overall finish. Proper sealing or realignment is required to correct the defect.

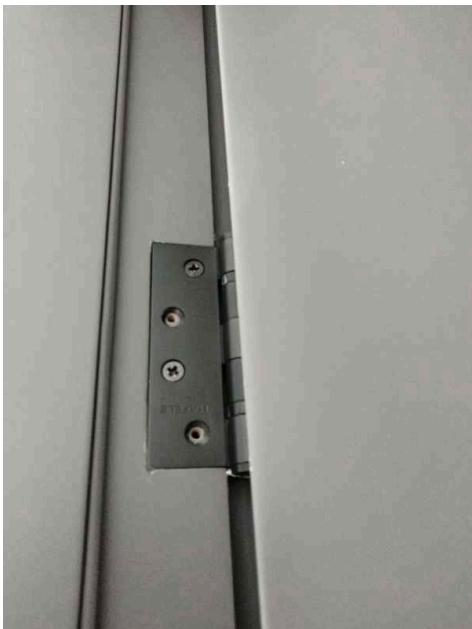
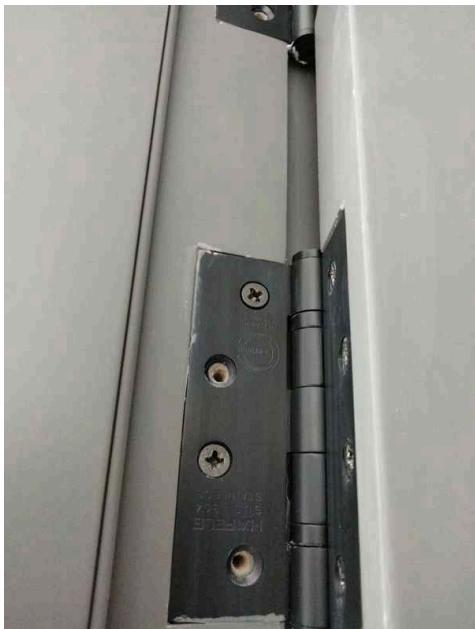
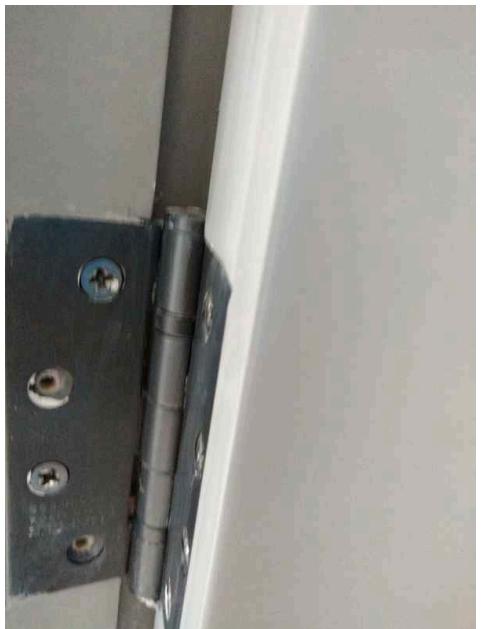
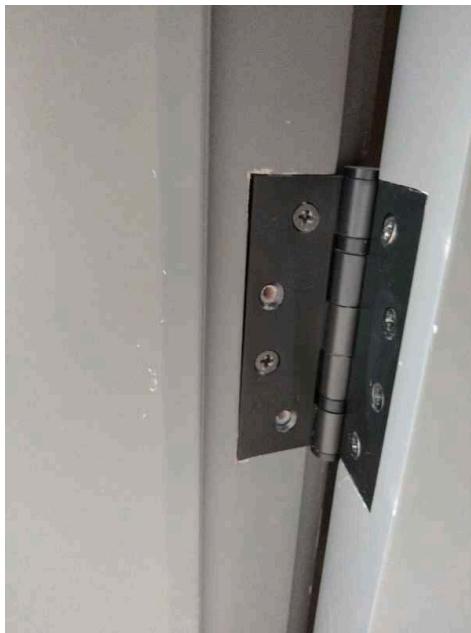
Door hinges issues. Excessive lubrication is present, leading to visible stains and attracting dust. Adjustment and proper cleaning are required for smooth and clean operation.

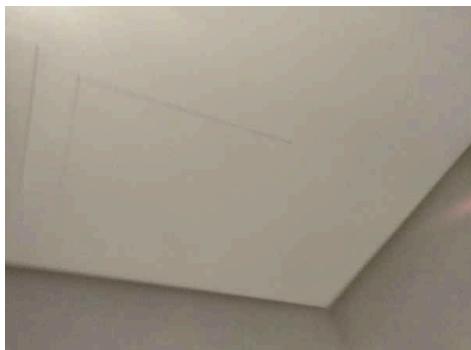
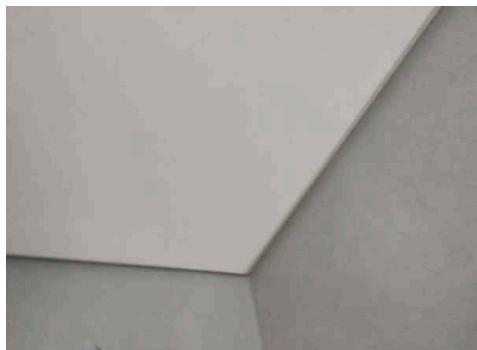
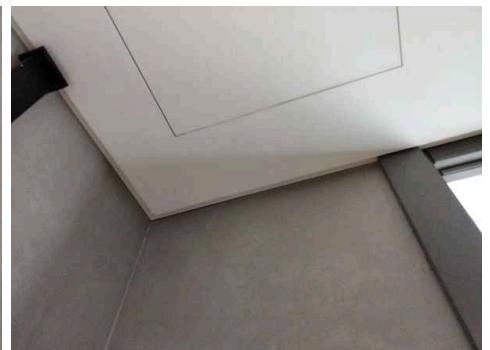
17.3.1 Ceiling

### PAINT TOUCH-UP AND FINISHING ISSUE

The ceiling has visible touch-up marks and uneven paint application, leading to a patchy and inconsistent finish. This can affect the overall aesthetic of the room. Proper surface preparation, touch-up, and even repainting are required for a smooth and uniform ceiling finish.

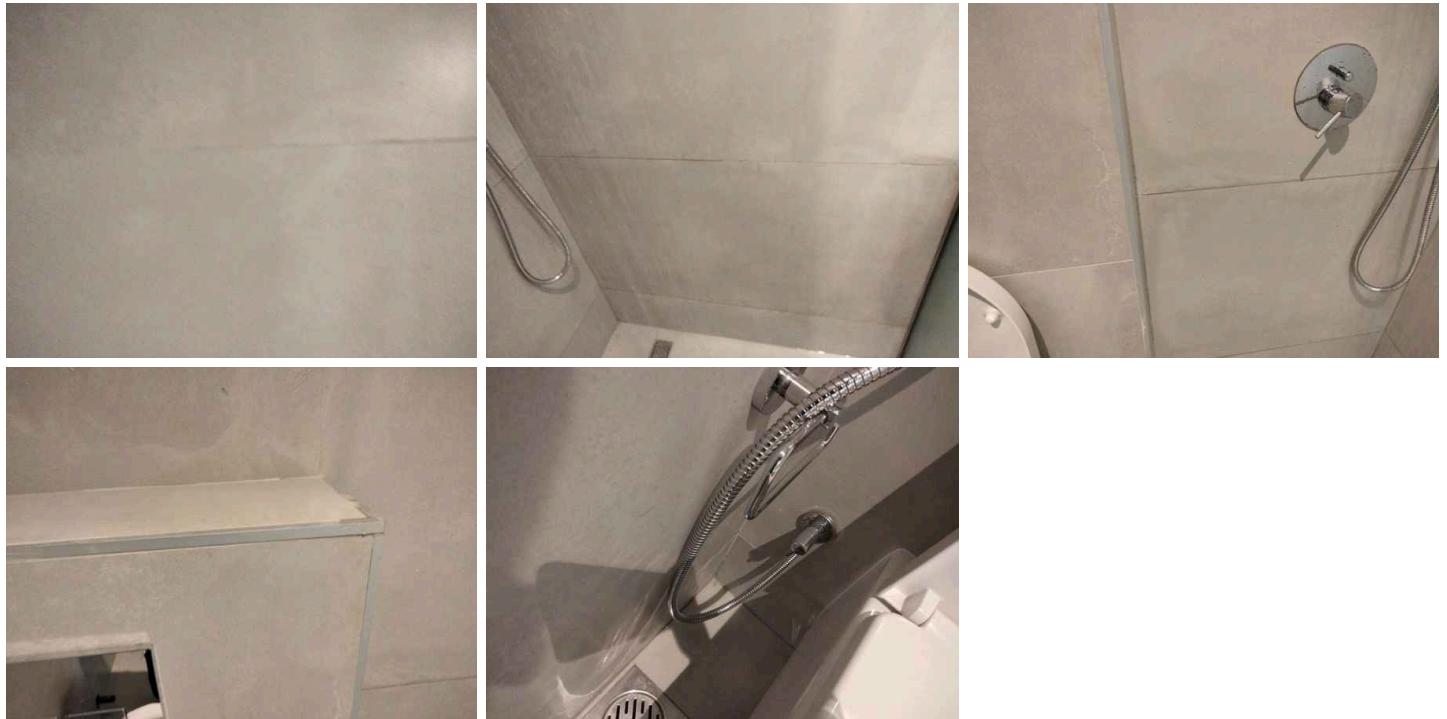
wall areas have missing and incomplete grout between tiles. Creates gaps that affect appearance and may cause water ingress. Requires proper grouting to finish the surface.

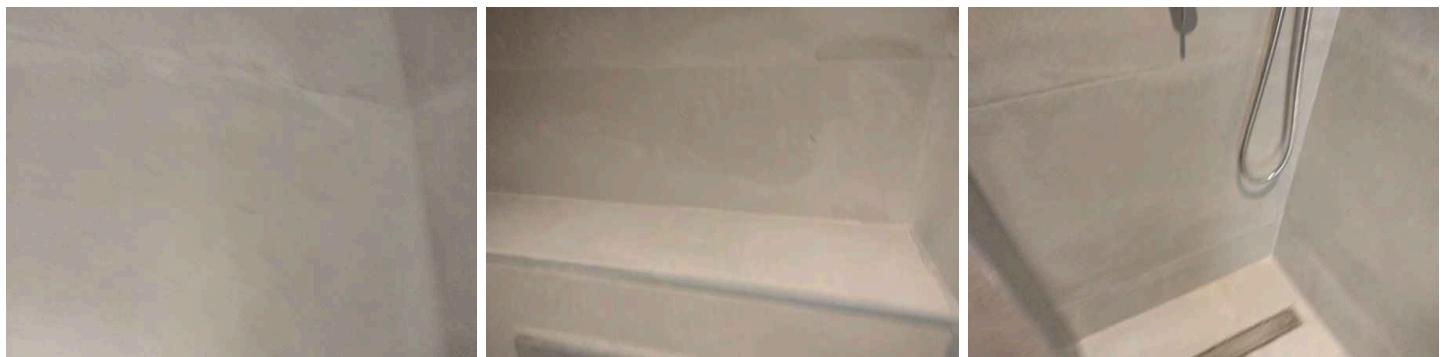
17.4.1 Walls

### GROUT MISSING

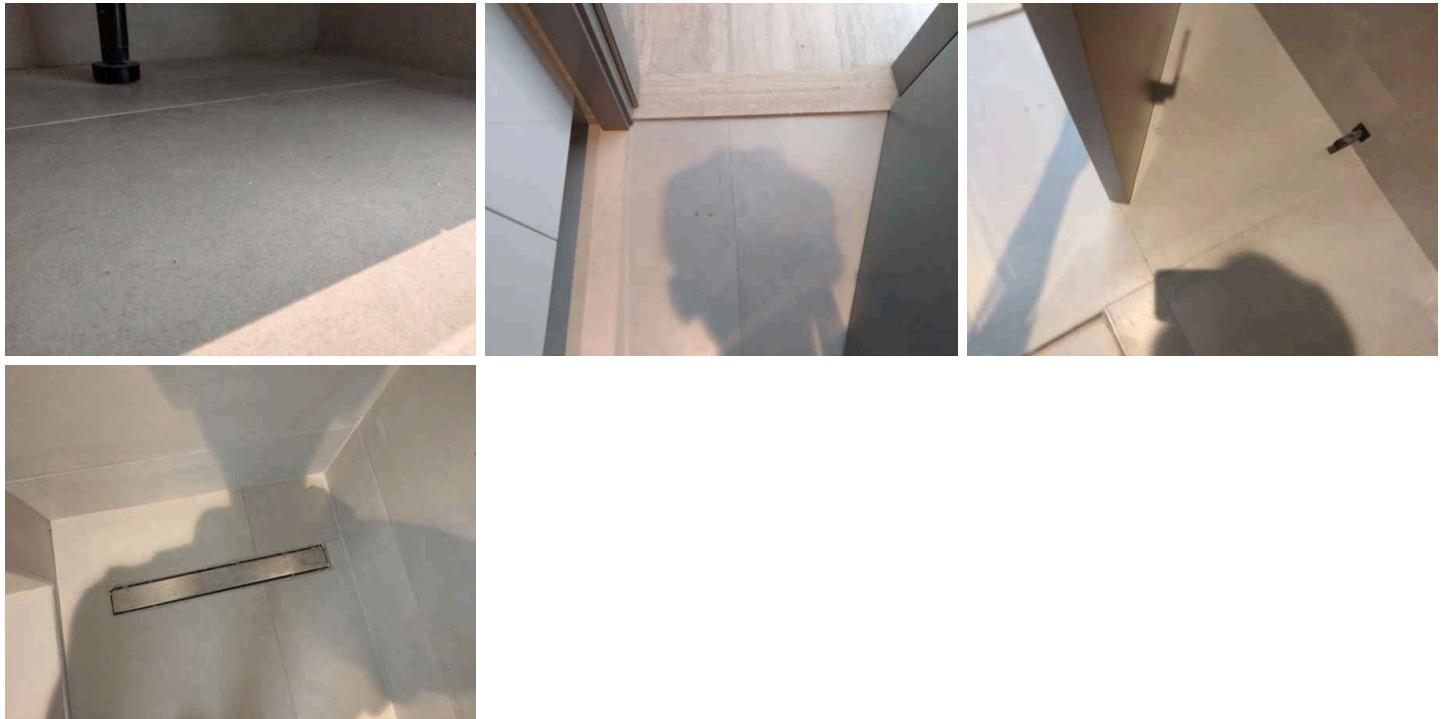
#### 17.5.1 Floor

#### **STAINING ISSUE**

Floor shows visible stains affecting appearance and finish. Caused by spills, construction residue and improper cleaning. Requires proper cleaning or treatment to restore uniform look.

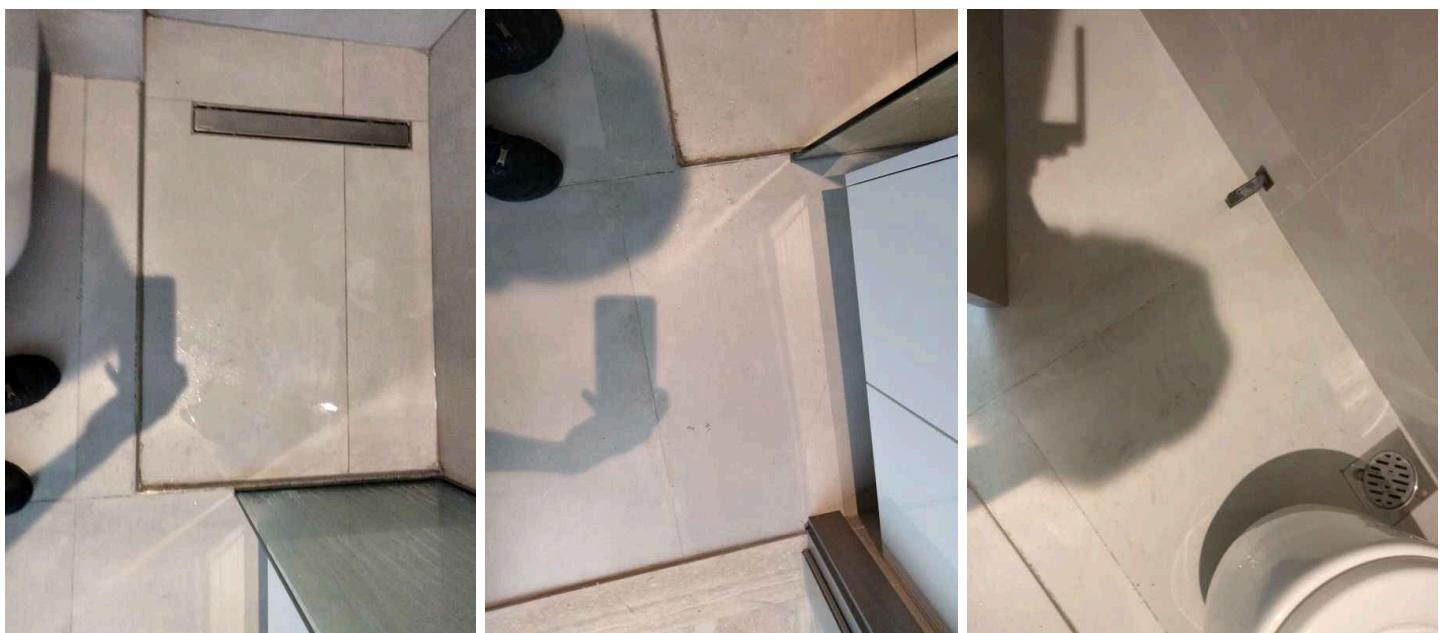
## 17.5.2 Floor

Grout color is inconsistent across the floor, affecting uniformity and appearance. Indicates poor workmanship and improper material mixing. Requires cleaning, correction, or re-grouting for a consistent finish.

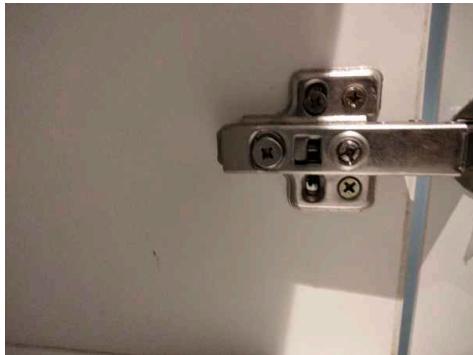
**HINGES SCREW MISSING**

Cabinet hinges have missing screws, causing instability and poor functionality. Affects durability and safe operation. Requires proper replacement and tightening of screws.

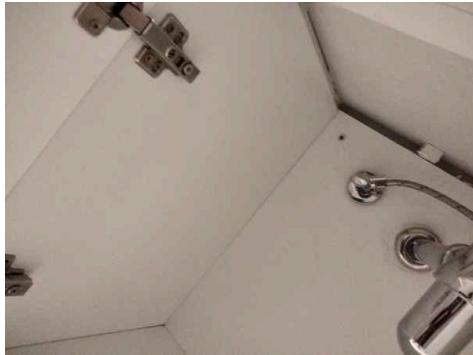
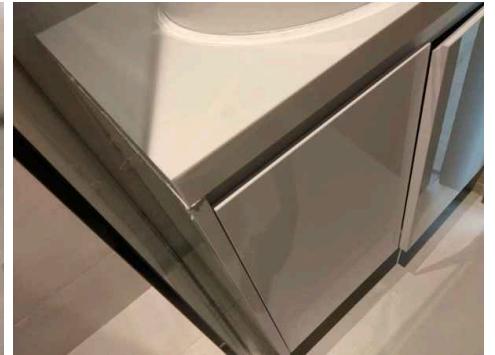
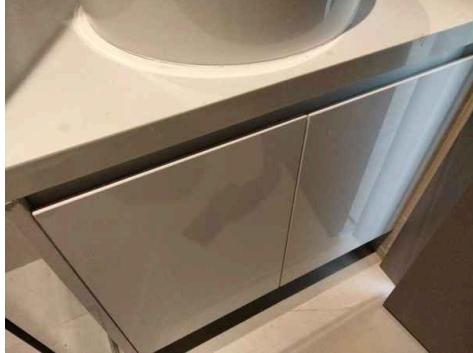
## 17.7.2 Cabinets

**CLEANING AND FINISHING ISSUES**

Cleaning and finishing defects observed; affected areas to be properly cleaned and finishing works rectified to achieve acceptable workmanship.

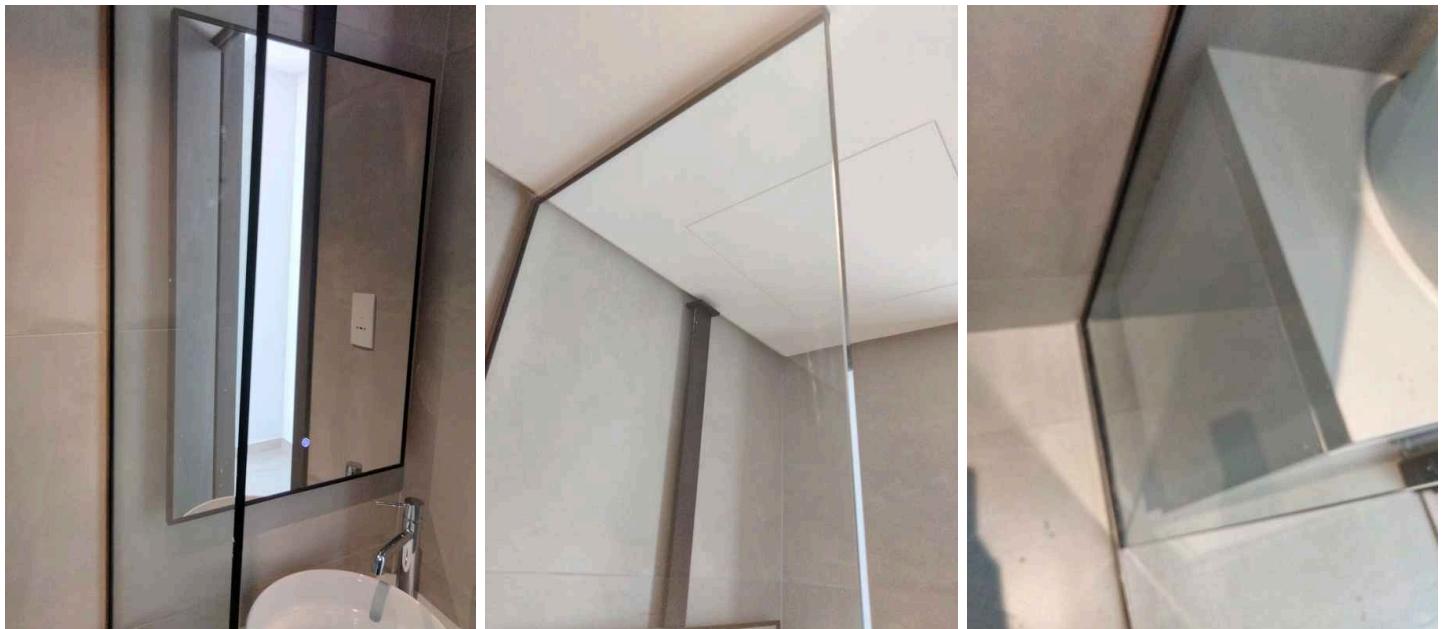
Cleaning and finishing defects observed; affected areas to be properly cleaned and finishing works rectified to achieve acceptable workmanship.

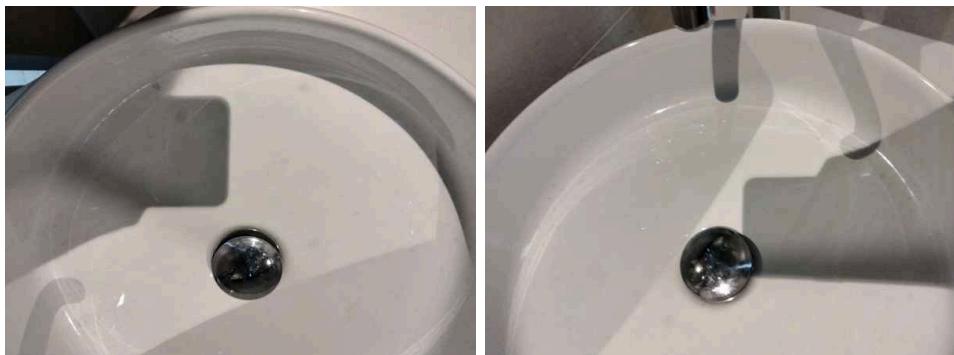
**WATER STAINS**

Water stains visible on the vanity surface due to poor sealing and leaks around the sink area.

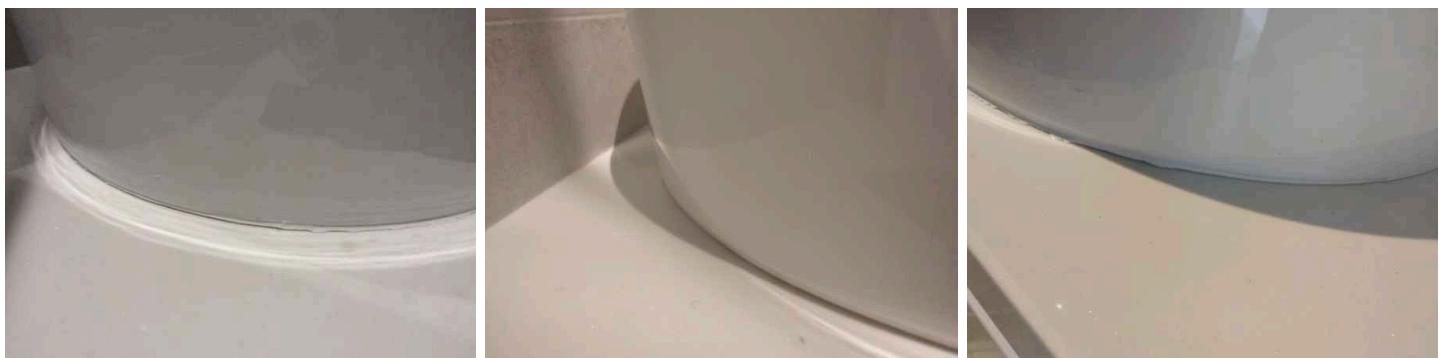
## 17.14.2 Vanity

**POOR FINISHING**

Vanity surfaces show uneven finishing, rough edges and visible defects. Affects appearance and quality. Requires proper sanding, filling, and finishing.

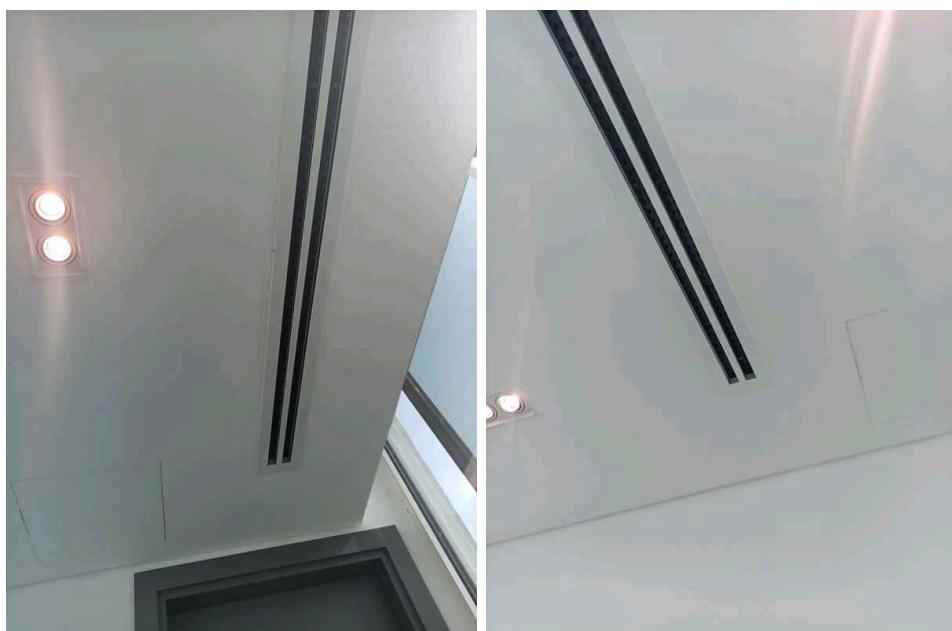
#### PAINT TOUCH-UP AND FINISHING ISSUE

The ceiling has visible touch-up marks and uneven paint application, leading to a patchy and inconsistent finish. This can affect the overall aesthetic of the room. Proper surface preparation, touch-up, and even repainting are required for a smooth and uniform ceiling finish.

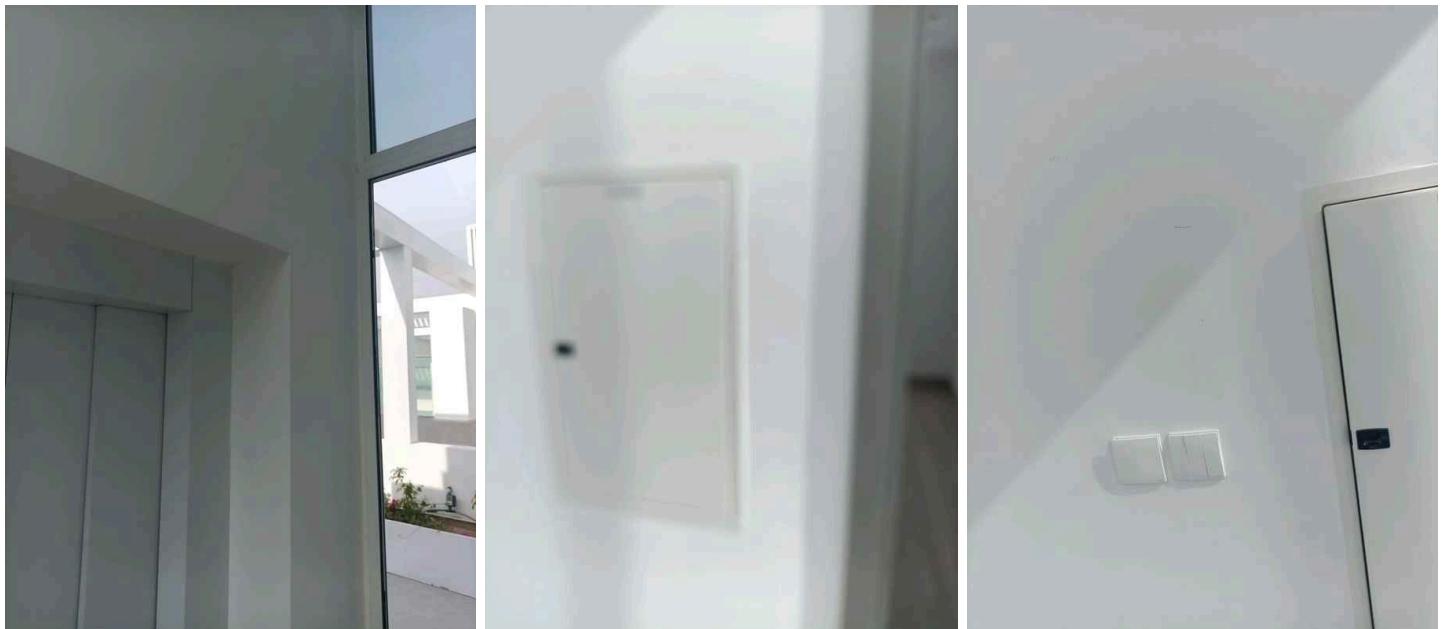
18.4.1 Walls

#### PAINT TOUCH-UP AND FINISHING ISSUE

The wall shows visible touch-up spots and uneven paint application, resulting in an inconsistent and patchy appearance. Edges and blending are poorly executed. Proper surface preparation and repainting are required for a seamless finish.

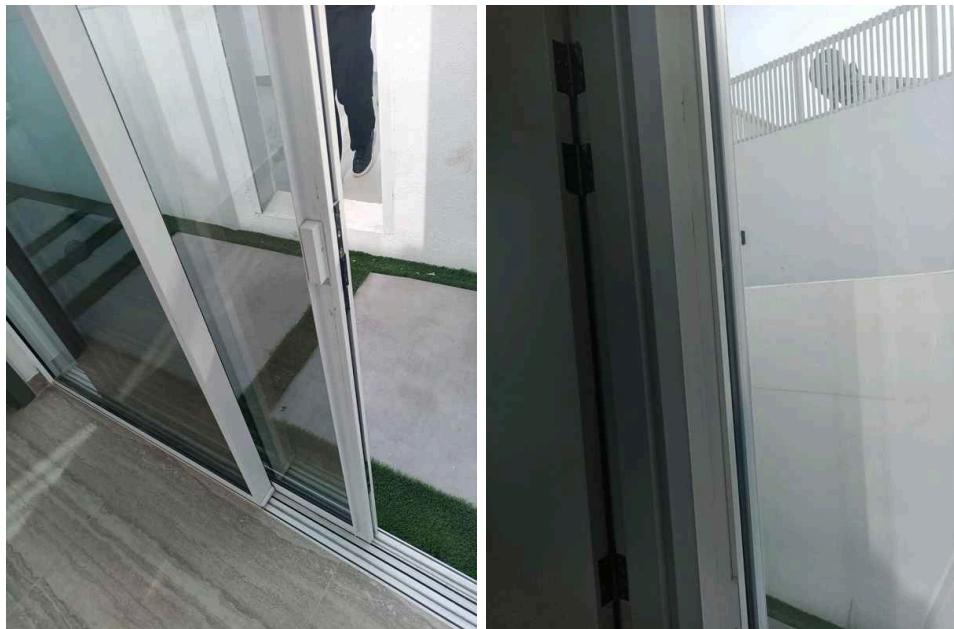
Window powder coating is uneven, chipped and peeling. Affects appearance and surface protection. Requires re-coating and touch-up for proper finish.

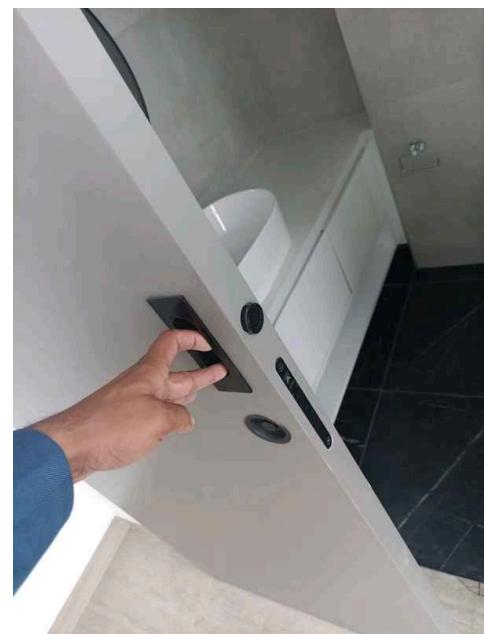
### PAINT FINISHING ISSUE

Paint finishing is unsatisfactory at the affected area. Carry out surface preparation and apply final paint coats to achieve uniform color and proper finish.

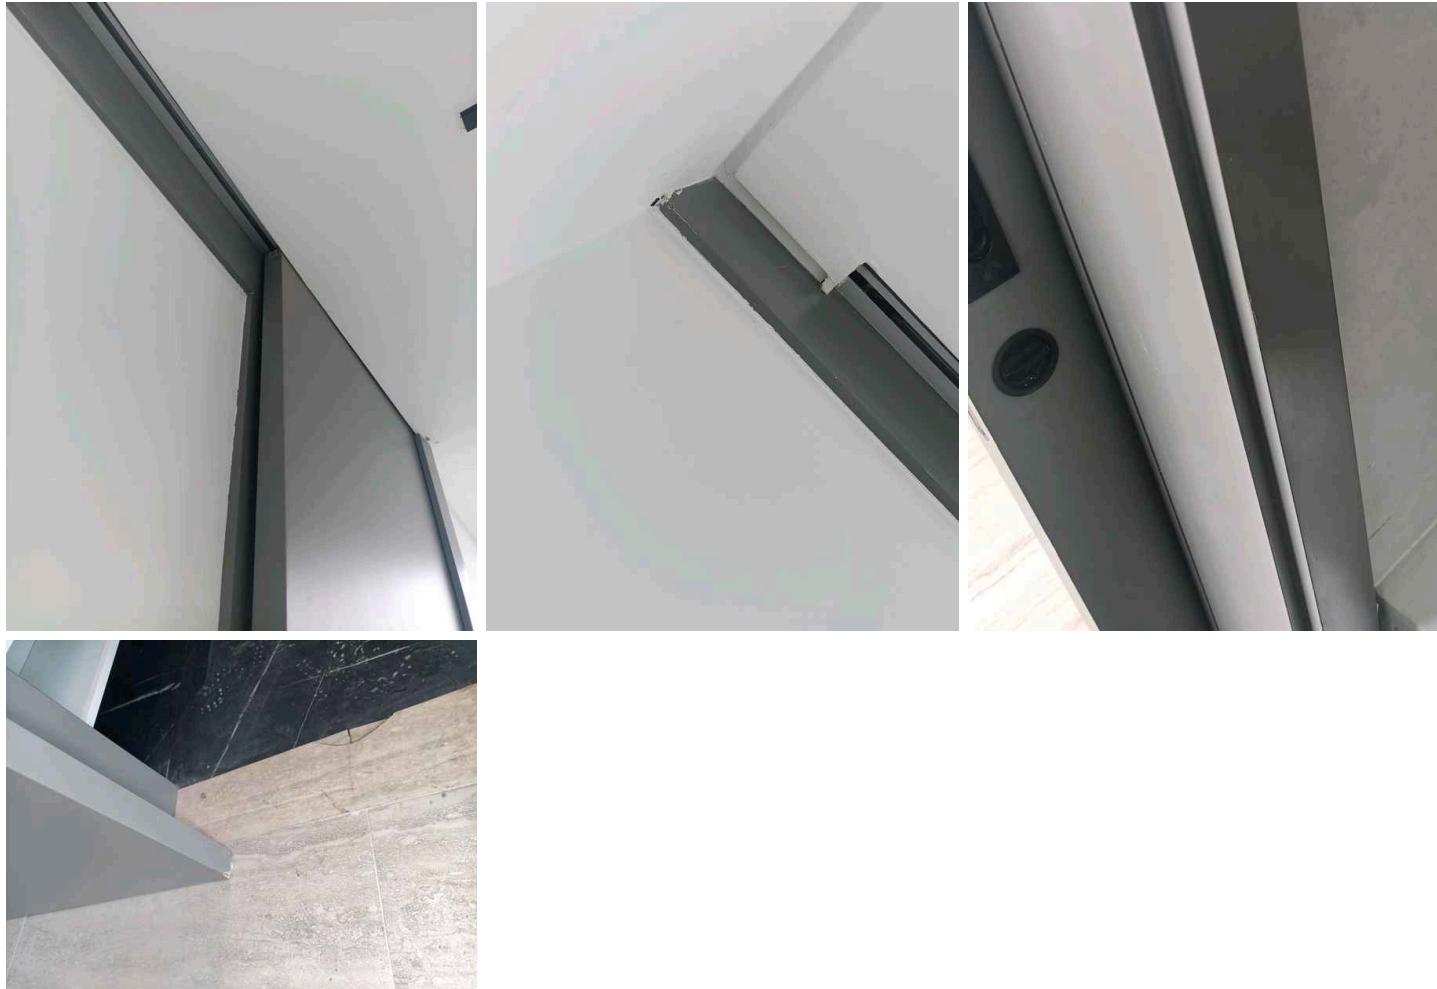
19.2.2 Door

### CHIPPING ISSUE

Chipping observed on the affected surface finish. Repair or replace the damaged area and ensure proper finishing to restore acceptable appearance.
