## Sample Property Snagging Report in Dubai – Professional Inspection PDF

This PDF is issued by Dubai Property Snagging, a professional property inspection company in Dubai, providing snagging reports, pre-handover inspections, and defect reports for villas and apartments across the UAE.

Client  
06/02/2026

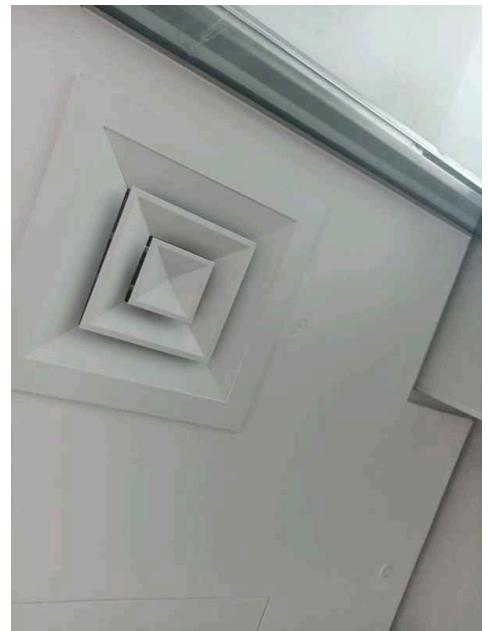
**PAINT TOUCH-UP AND FINISHING ISSUE**

The ceiling has visible touch-up marks and uneven paint application, leading to a patchy and inconsistent finish. This can affect the overall aesthetic of the room. Proper surface preparation, touch-up, and even repainting are required for a smooth and uniform ceiling finish.

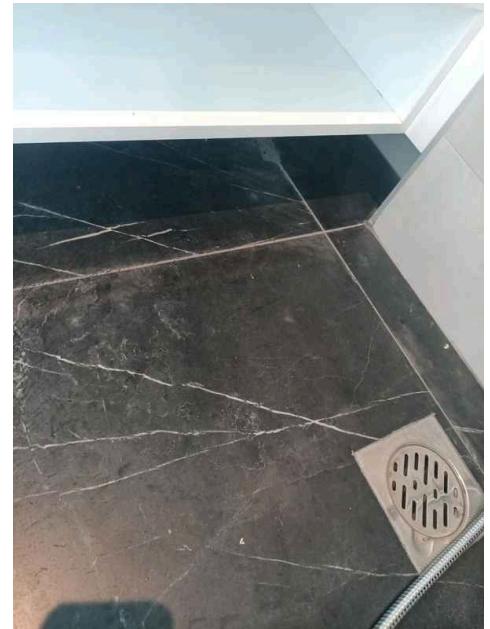
#### 19.5.2 Floor

### **TILE CRACKS**

Cracks observed on tiles due to poor installation. Affects aesthetics and may worsen over time. Requires replacement or proper repair.

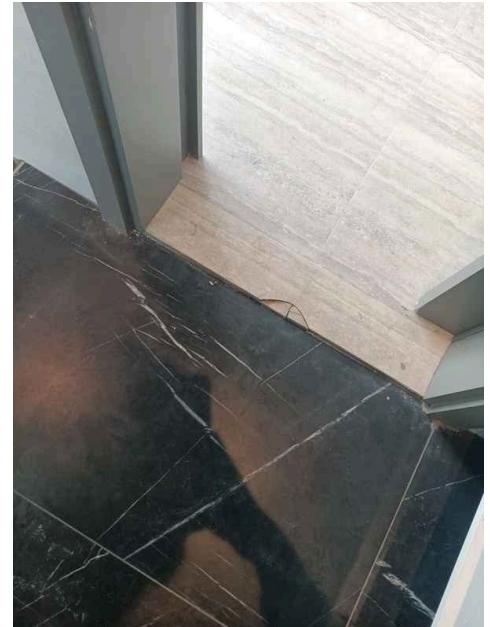
#### 19.5.3 Floor

### **CHIPPING ISSUE**

Surfaces show signs of chipping and cracking, typically due to impact damage, material weakness, improper installation. These defects compromise both the appearance and structural integrity. Repair or replacement is needed to restore the surface to acceptable standards.

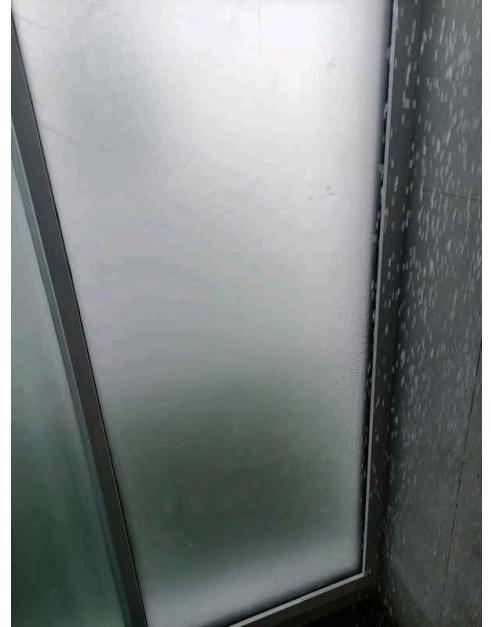
## 19.14.1 Vanity

**POOR FINISHING**

Vanity surfaces show uneven finishing, rough edges and visible defects. Affects appearance and quality. Requires proper sanding, filling, and finishing.

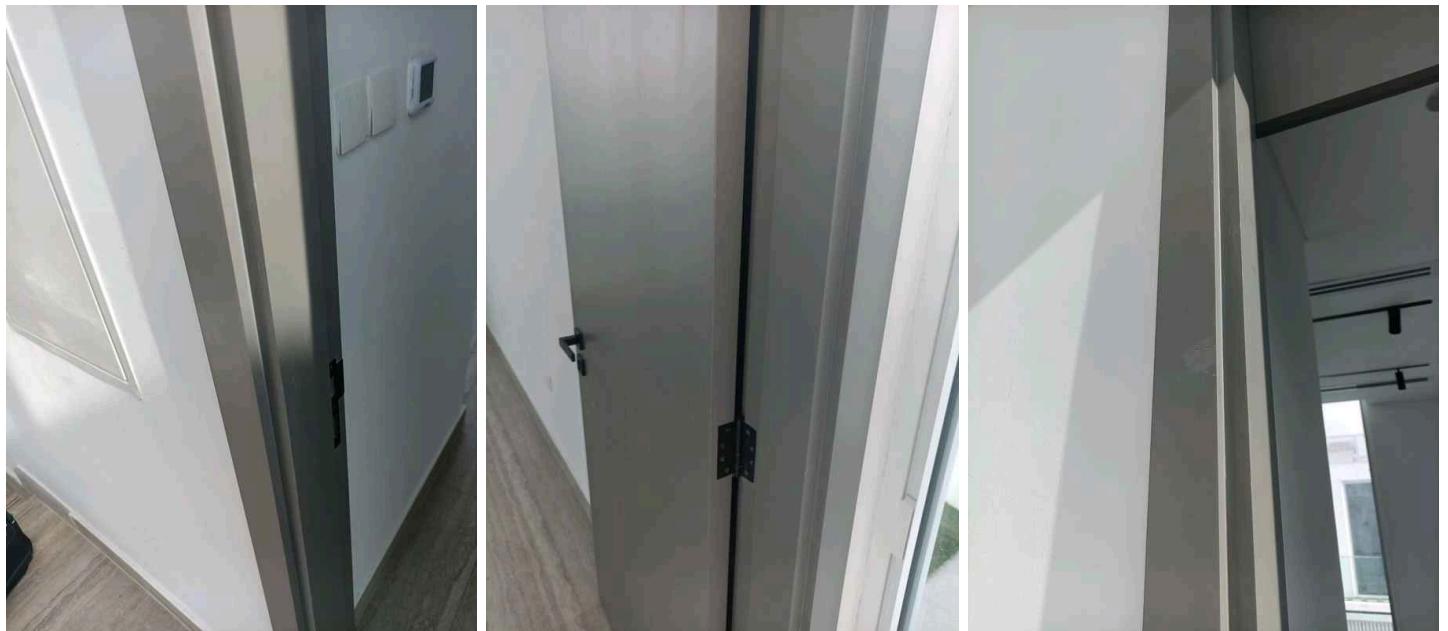
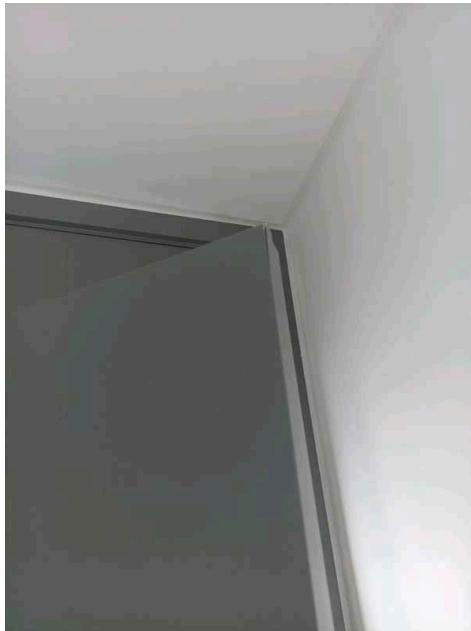
#### PAINT FINISHING ISSUE

Paint finishing is unsatisfactory at the affected area. Carry out surface preparation and apply final paint coats to achieve uniform color and proper finish.

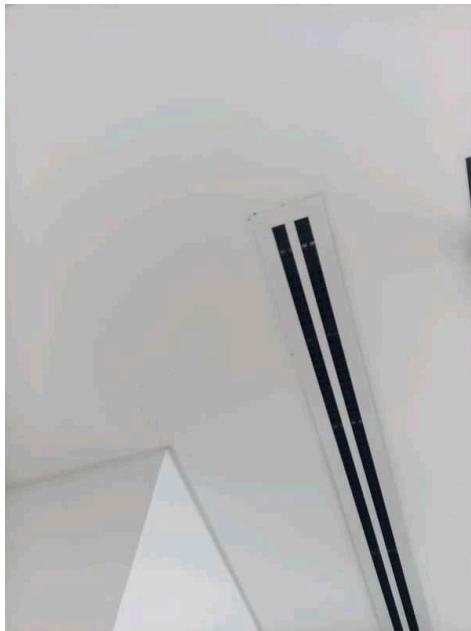
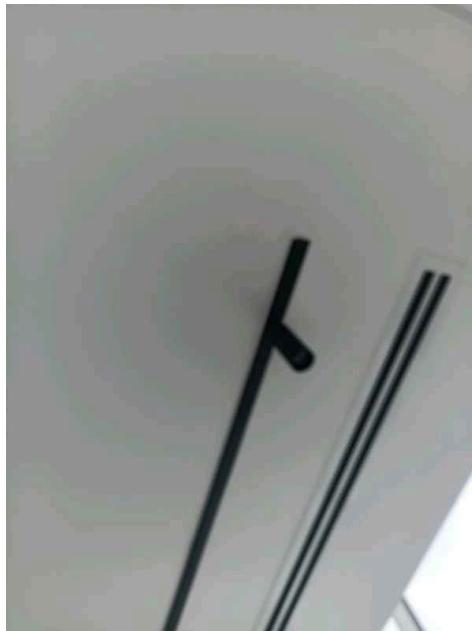
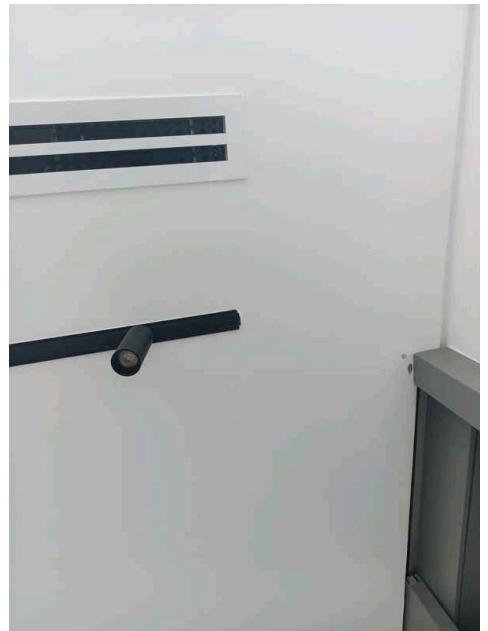
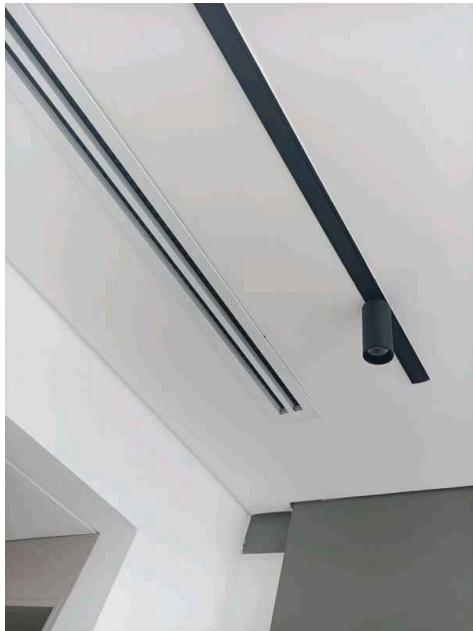
## 20.3.1 Ceiling

**PAINT TOUCH-UP AND FINISHING ISSUE**- Repair Needed

The ceiling has visible touch-up marks and uneven paint application, leading to a patchy and inconsistent finish. This can affect the overall aesthetic of the room. Proper surface preparation, touch-up, and even repainting are required for a smooth and uniform ceiling finish.

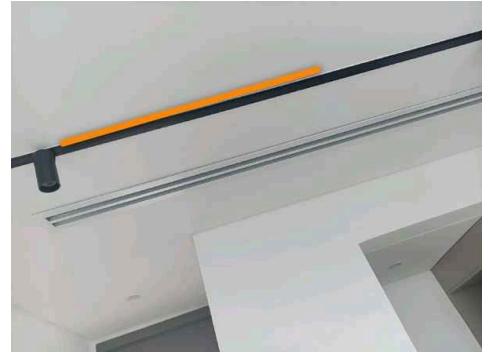
Gaps observed around the grill installation; sealing and alignment to be corrected to ensure proper fit and finished appearance.

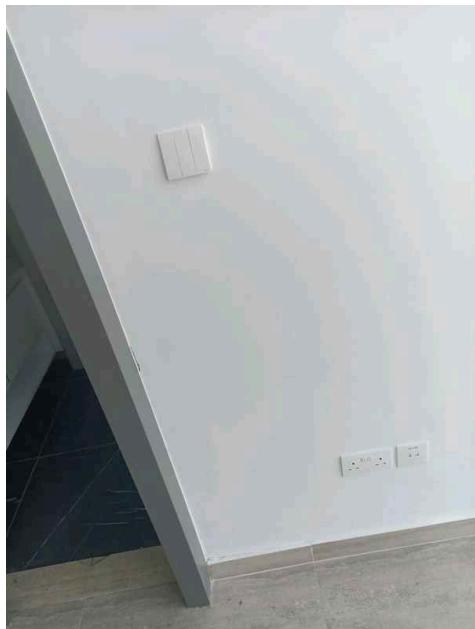
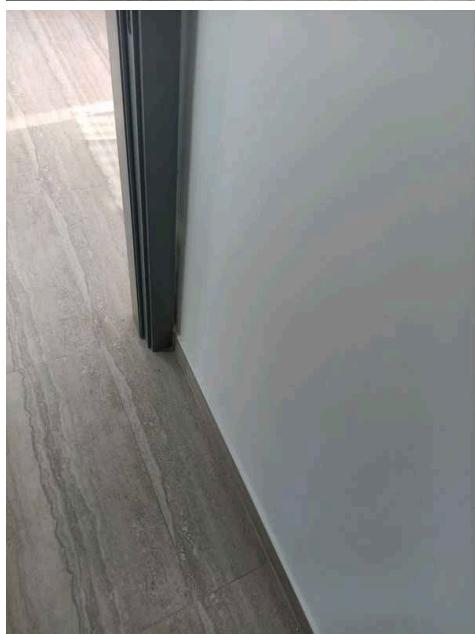
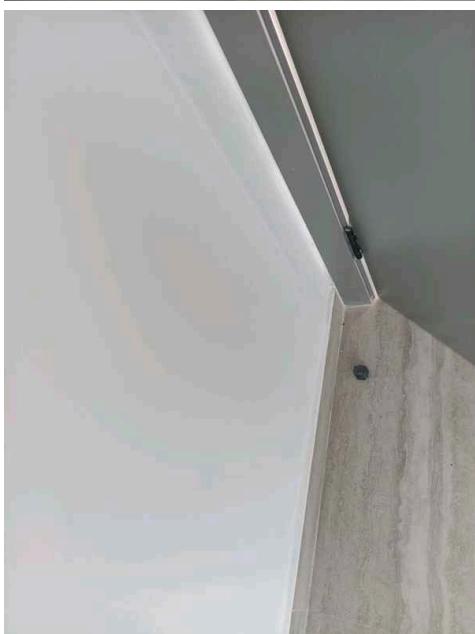
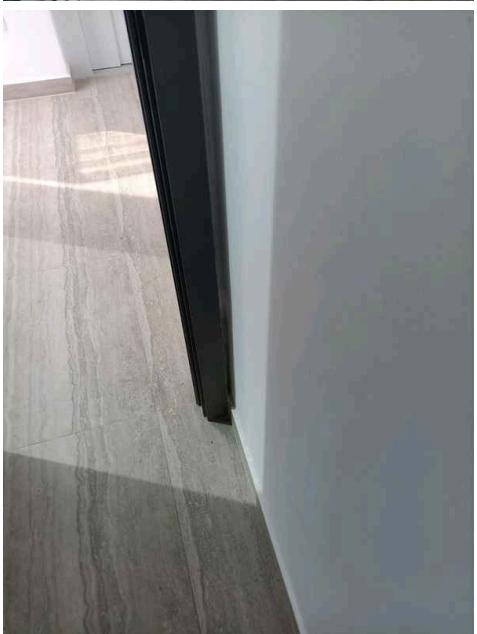
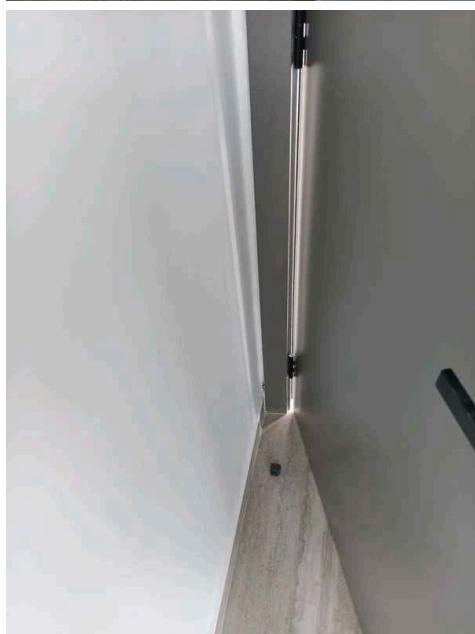
## 20.4.1 Walls

**PAINT TOUCH-UP AND FINISHING ISSUE**

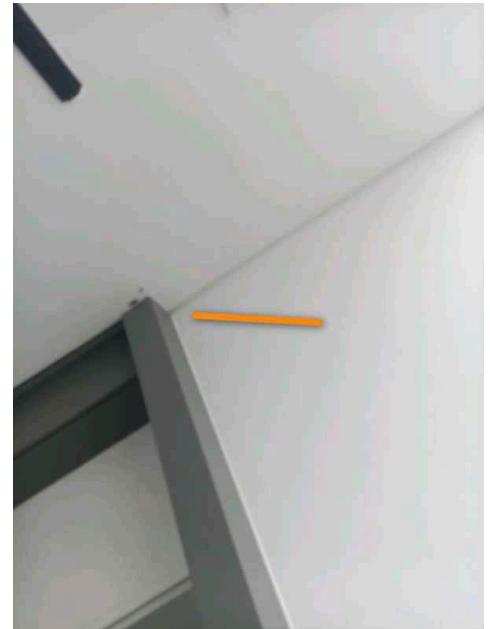
## 20.4.2 Walls

**CRACK ISSUE**

Cracks in the paint are visible on the wall, caused by substrate movement, improper application and environmental factors like humidity. This results in an unsightly finish and potential for further damage. Repainting and crack filling are needed to restore a smooth, durable surface.

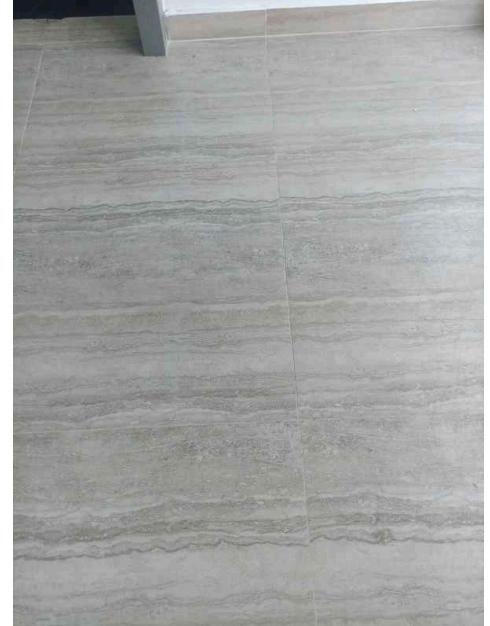
## 20.5.1 Floor

**GROUT MISSING**

Floor areas have missing and incomplete grout between tiles. Creates gaps that affect appearance and may cause water ingress. Requires proper grouting to finish the surface.

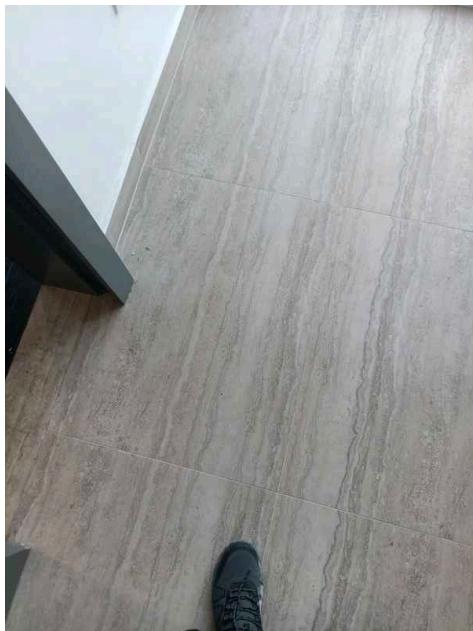
## 20.5.2 Floor

**STAINING ISSUE**

Floor shows visible stains affecting appearance and finish. Caused by spills, construction residue and improper cleaning. Requires proper cleaning or treatment to restore uniform look.

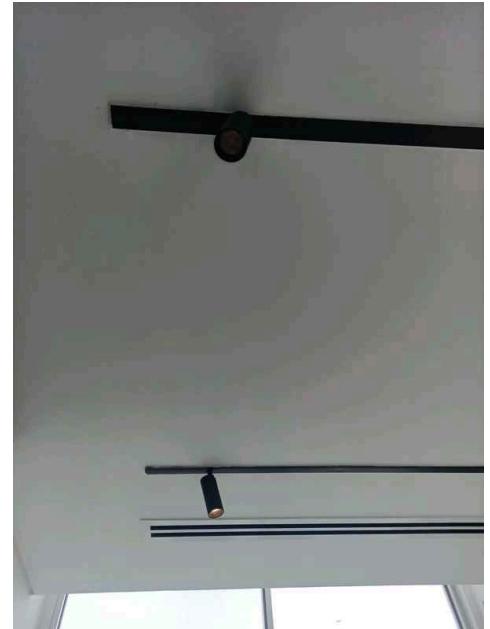
20.6.1 Lighting Fixtures, Switches & Receptacles

### **LIGHTS MALFUNCTION**

Ceiling lights are not functioning properly. Indicates electrical and fixture issues. Requires replace and repair to restore proper operation.

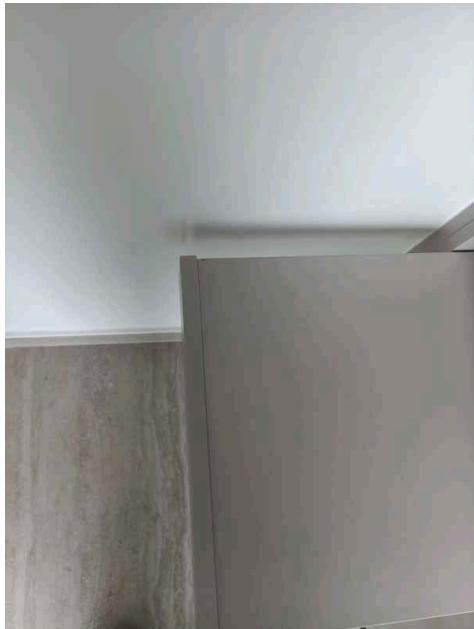
20.7.1 Cabinets

### **CHIPPING ISSUE**

Cabinet surfaces show visible chips and damage. Affects appearance and finish quality. Requires repair or replacement of affected areas.

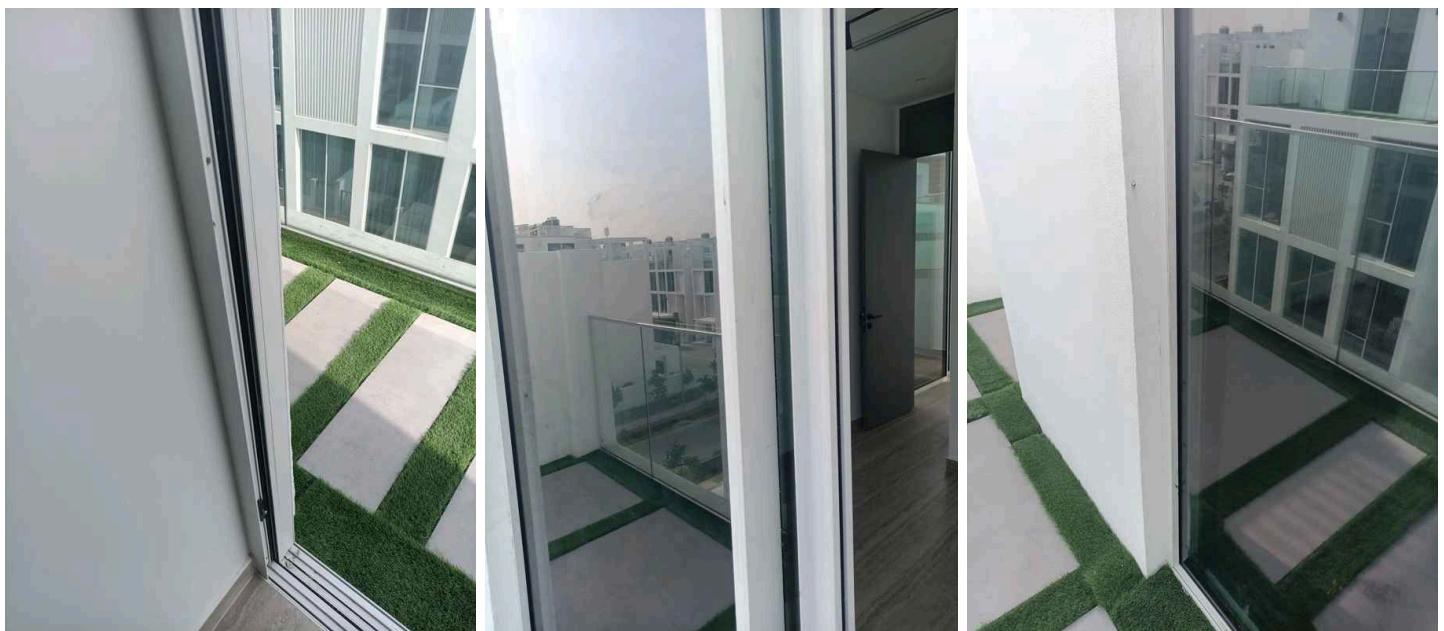
Window powder coating is uneven, chipped and peeling. Affects appearance and surface protection. Requires re-coating and touch-up for proper finish.

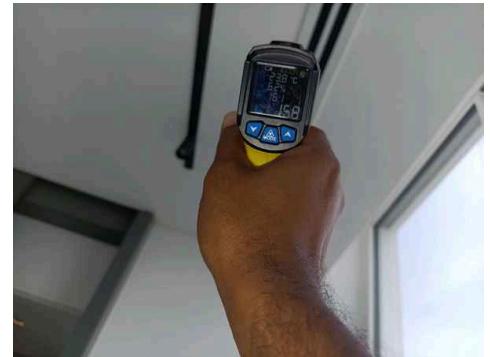
21.1.1 Air Conditioner

**IMPROPER COOLING**

Cooling system is not functioning efficiently, resulting in insufficient temperature control. Affects comfort and performance. Requires immediate corrective action.

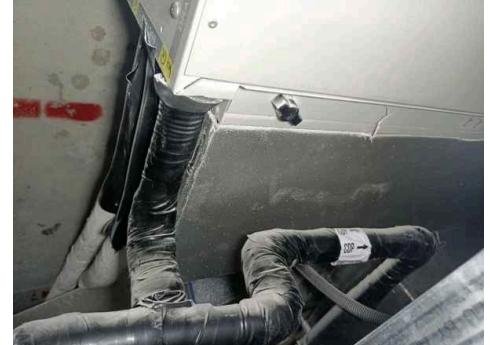
21.3.1 Over the Ceiling

**IMPROPER INSULATION**

Lack of and damaged insulation leading to temperature loss and reduced energy efficiency as well create moisture issue.

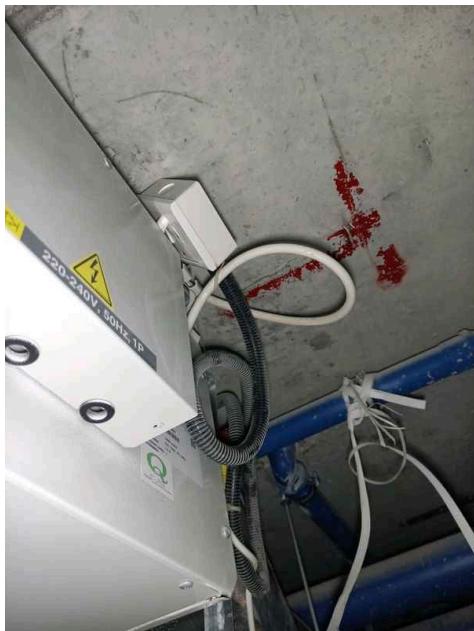
21.3.2 Over the Ceiling

**WIRE MANAGEMENT ISSUES**

Unorganized exposed electrical wiring, posing safety hazards and maintenance difficulties.

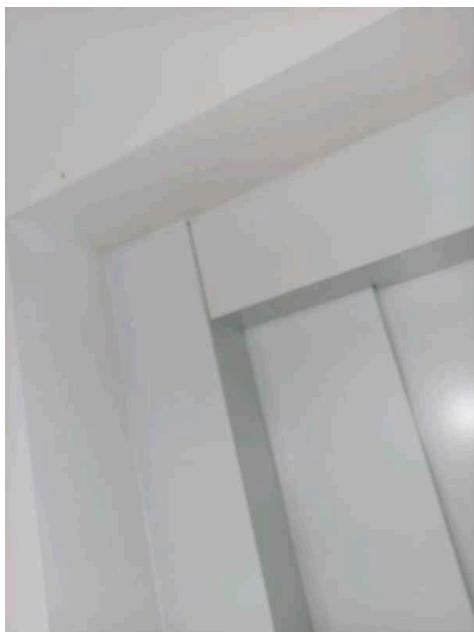
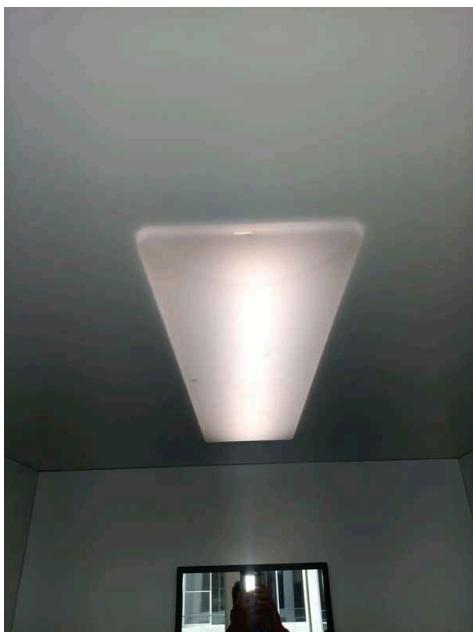
- Repair Needed
**SCRATCHES, FINISHING AND LIGHTING COVER FITTING ISSUE**

Scratches and finishing defects observed, and lighting cover is improperly fitted; rectification and proper fitting to be carried out to achieve acceptable finish and functionality.
